Report Number **BTC 13188F**

FULL SCALE FIRE RESISTANCE TEST ON A BRITISH
GYPSUM CASOLINE MF SUSPENDED CEILING CLAD
WITH A DOUBLE LAYER OF 12.5mm GYPROC FIRELINE
CONDUCTED IN ACCORDANCE WITH BS EN 1364-2:
1999.

Test Date: 15th January 2004

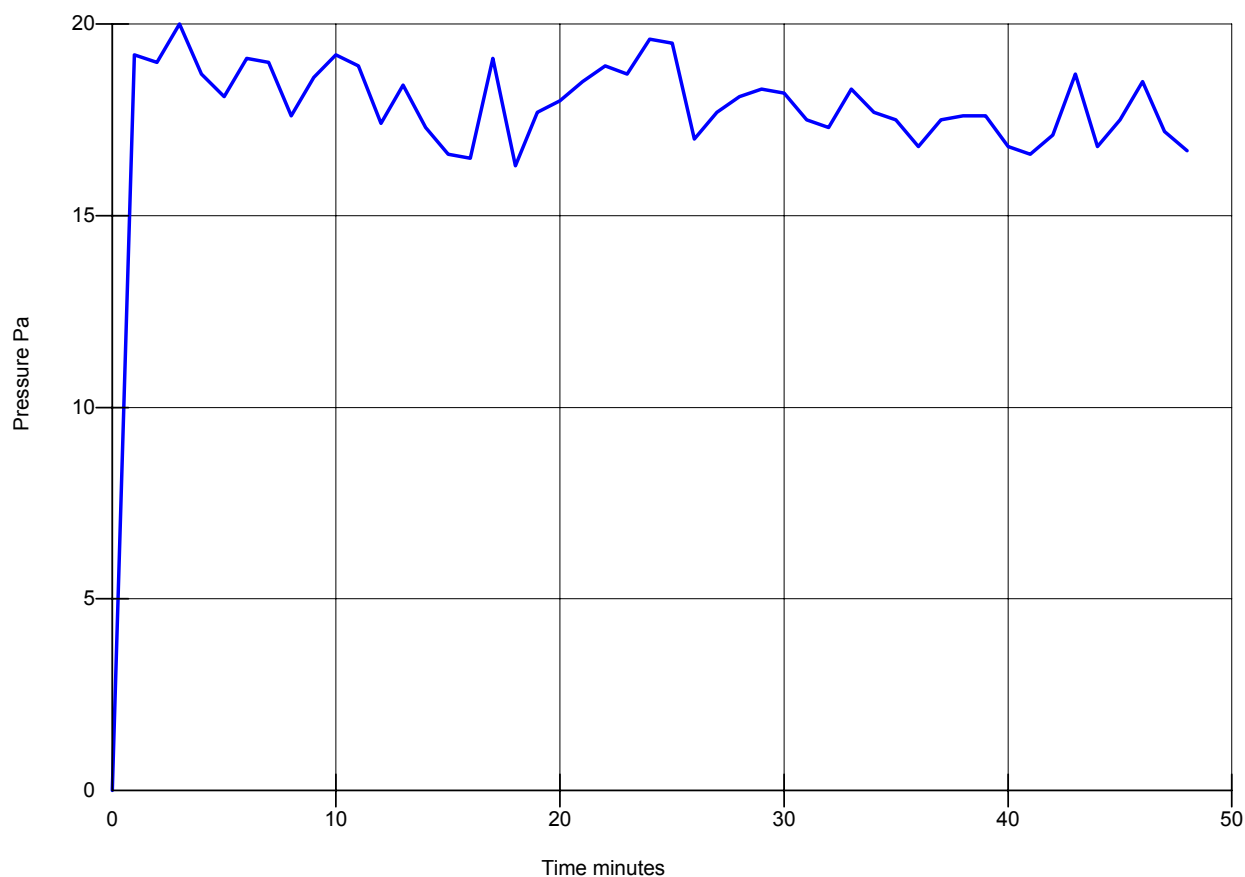
The allowable tolerances are ± 5 Pa from 5 minutes to 10 minutes and ± 3 Pa from 10 minutes onwards. It is of the opinion of the laboratory that the variations in the furnace pressure exceeding the tolerances stated in BS EN 1363-1:1999 have not unduly influenced the results of this test. The furnace pressure graph is on page 17.

Figure 4. Furnace pressure graph.

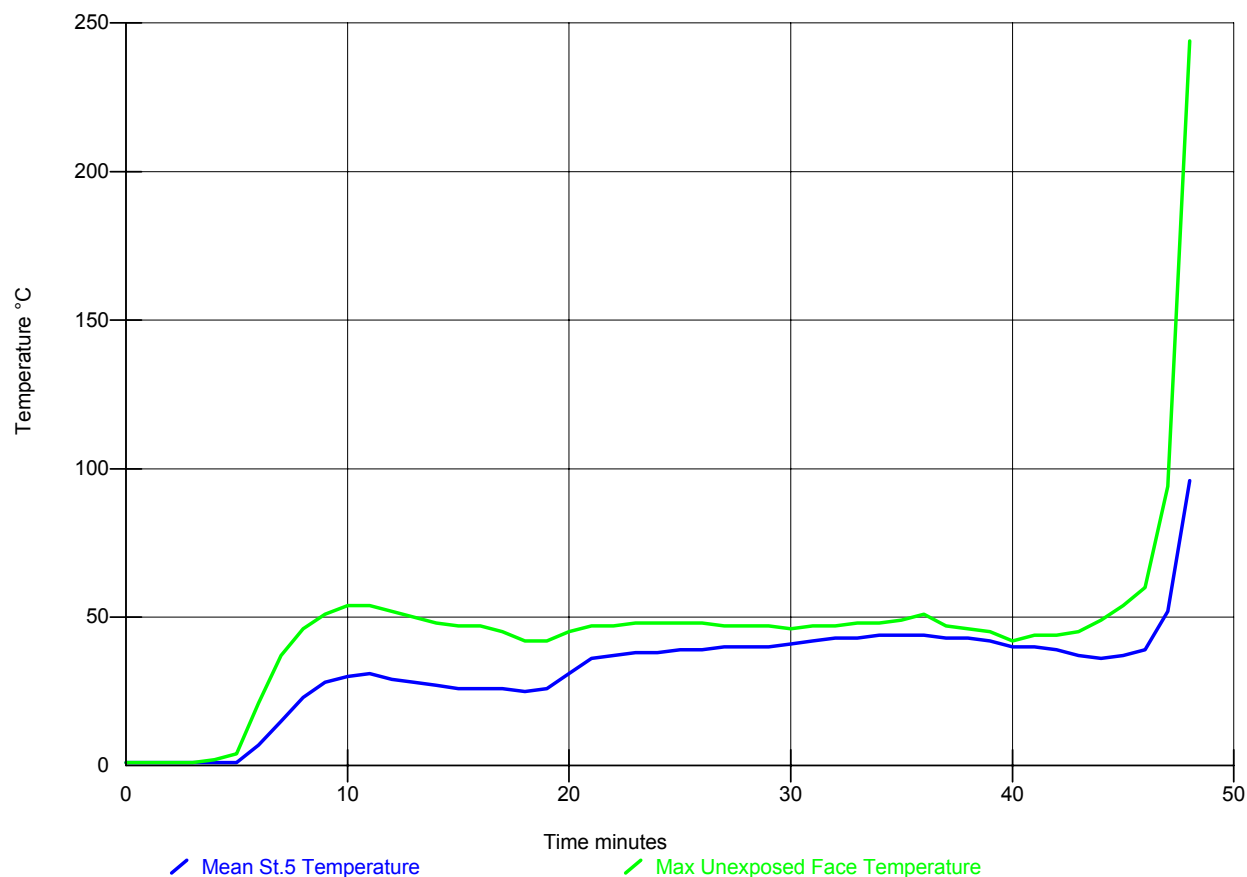
Figure 5. Unexposed face temperature graphs.

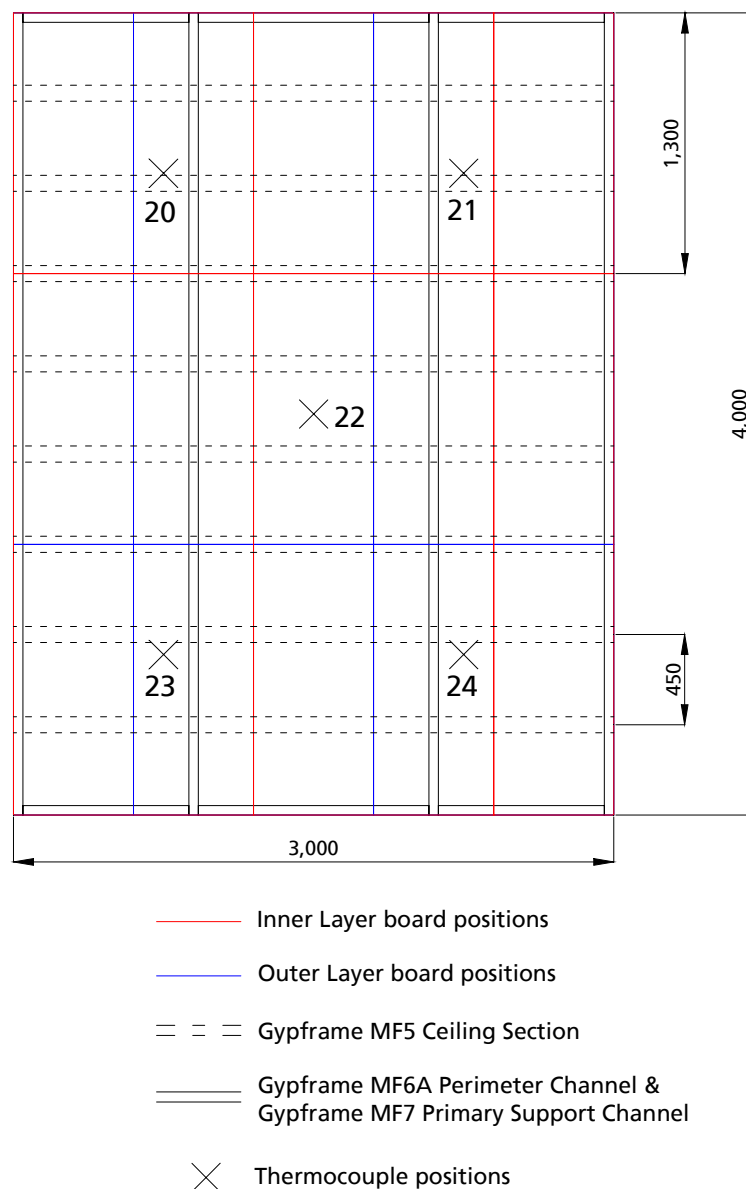
Figure 6. Unexposed face thermocouple layout.

See figure 6 for the location of the thermocouples.

Figures highlighted in red indicate time and position of insulation failure.

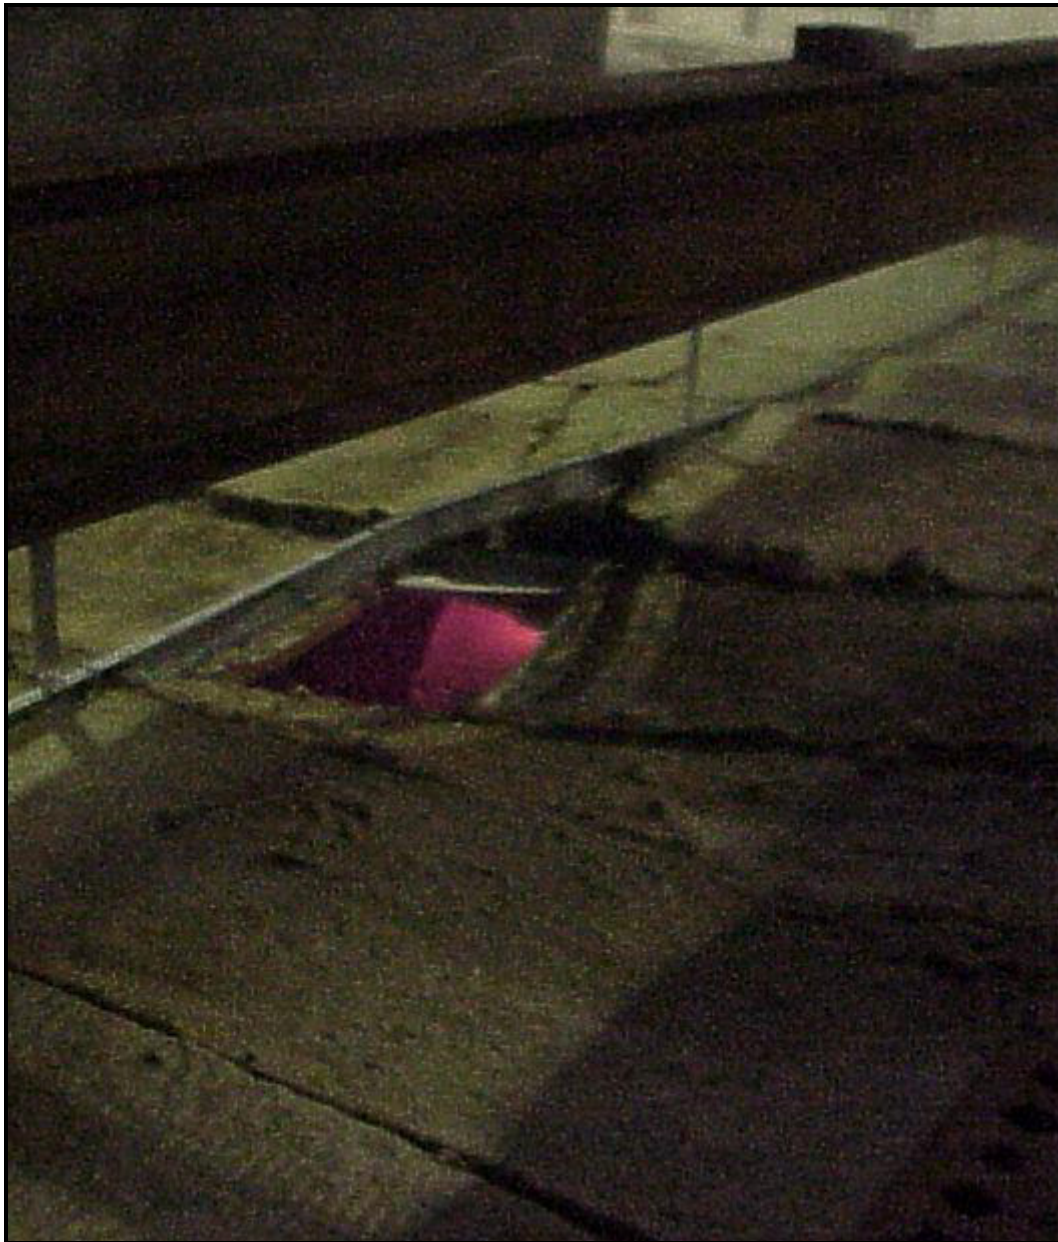
Time		Observations
hrs	mins	
		All observations refer to the exposed face unless otherwise stated.
	44	<p>A section, approximately 250mm x 1200mm, of the second row centreboard adjacent to the lateral board joint had fallen into the furnace. The left-hand corner of the second row right-hand board adjacent to the lateral board joint had fallen into the furnace.</p> <p><i>Unexposed face</i> The discolouration approximately 600mm from the right-hand side of the specimen had spread over the entire length of the specimen.</p>
	45	<p><i>Unexposed face</i> The insulation slabs in the centre of the specimen had bowed into the furnace.</p>
	46	<p>The inner layer board joints had opened to approximately 10mm where exposed.</p>
	47	<p>Sections of the centreboards and right-hand boards adjacent to the lateral board joint fell into the furnace.</p> <p><i>Unexposed face</i> INSULATION FAILURE. The roving thermocouple exceeded a temperature rise of 180°C when placed approximately 1500mm from the viewing platform and approximately 750mm from the right-hand side of the specimen. Thermocouple no.23 also exceeded a temperature rise of 180°C. The cotton pad failed to ignite or glow when placed on the specimen. A glow was visible approximately 1500mm from the viewing platform and approximately 900mm from the right-hand side of the specimen.</p>

Time		Observations
hrs	mins	
		All observations refer to the exposed face unless otherwise stated.
	48	<p><i>Unexposed face</i></p> <p>INTEGRITY FAILURE. The cotton pad ignited when placed approximately 1500mm from the viewing platform and approximately 900mm from the right-hand side of the specimen.</p> <p>FURTHER INTEGRITY FAILURE. 6mm x 150mm gap gauge would have entered the furnace through a gap at approximately 1500mm from the viewing platform and approximately 900mm from the right-hand side of the specimen.</p> <p>FURTHER INTEGRITY FAILURE. 25mm diameter gap gauge would have entered the furnace through a gap at approximately 1500mm from the viewing platform and approximately 900mm from the right-hand side of the specimen.</p> <p>TEST TERMINATED.</p>

Photograph 3. Position of integrity failure at 48 minutes.
