Report Number **BTC 13189F**

FULL SCALE FIRE RESISTANCE TEST ON A BRITISH GYPSUM CASOLINE MF SUSPENDED CEILING CLAD WITH A DOUBLE LAYER OF 15mm GLASROC FIRECASE S CONDUCTED IN ACCORDANCE WITH BS EN 1364-2: 1999.

Test Date: 21<sup>st</sup> January 2004

**Customer:** **British Gypsum Limited**  
East Leake  
Loughborough  
Leicestershire  
LE12 6HX

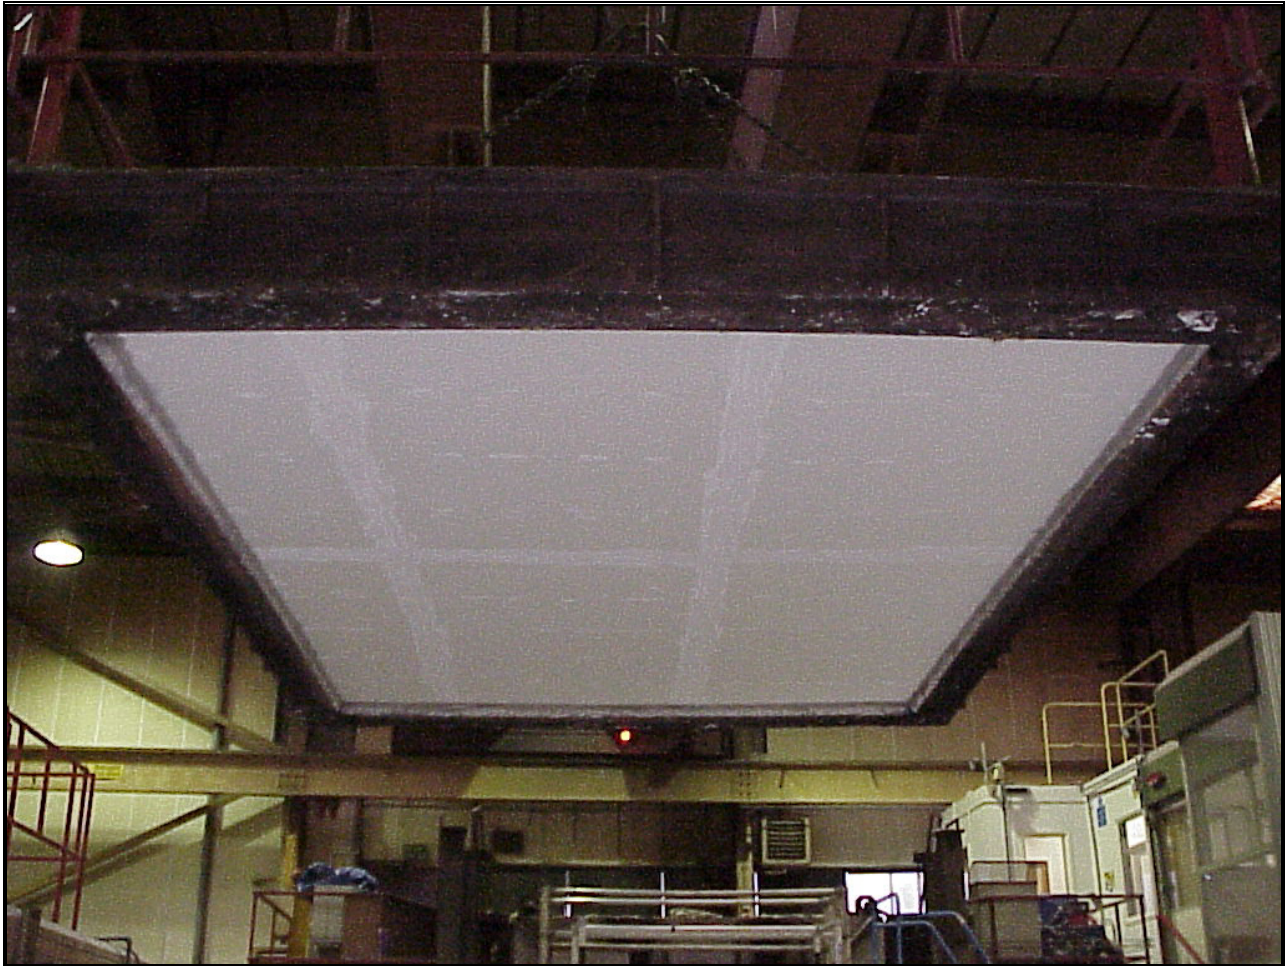
**Photograph 1.** Exposed face prior to test.

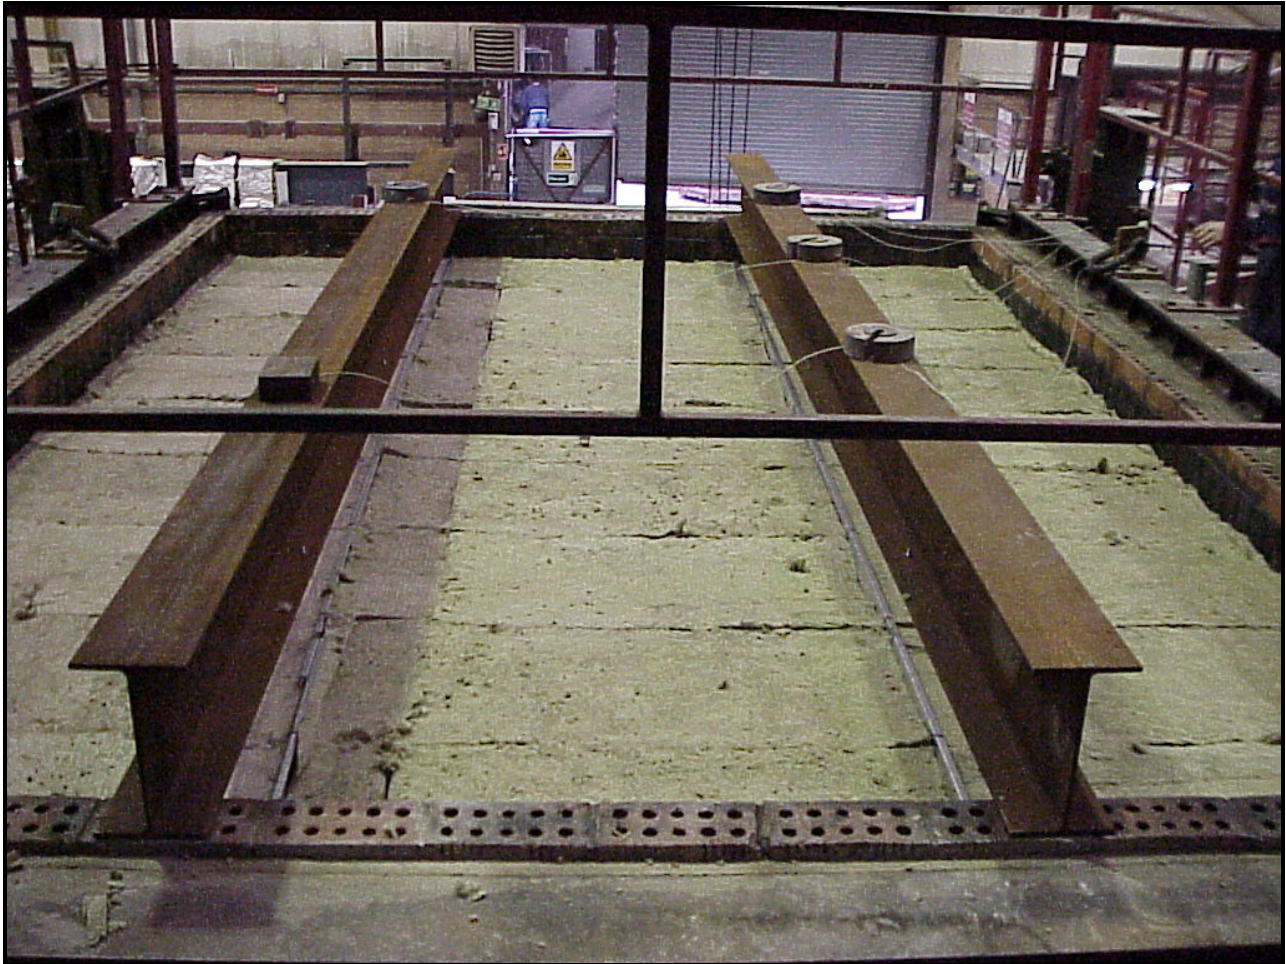
Photograph 2. Unexposed face prior to test.

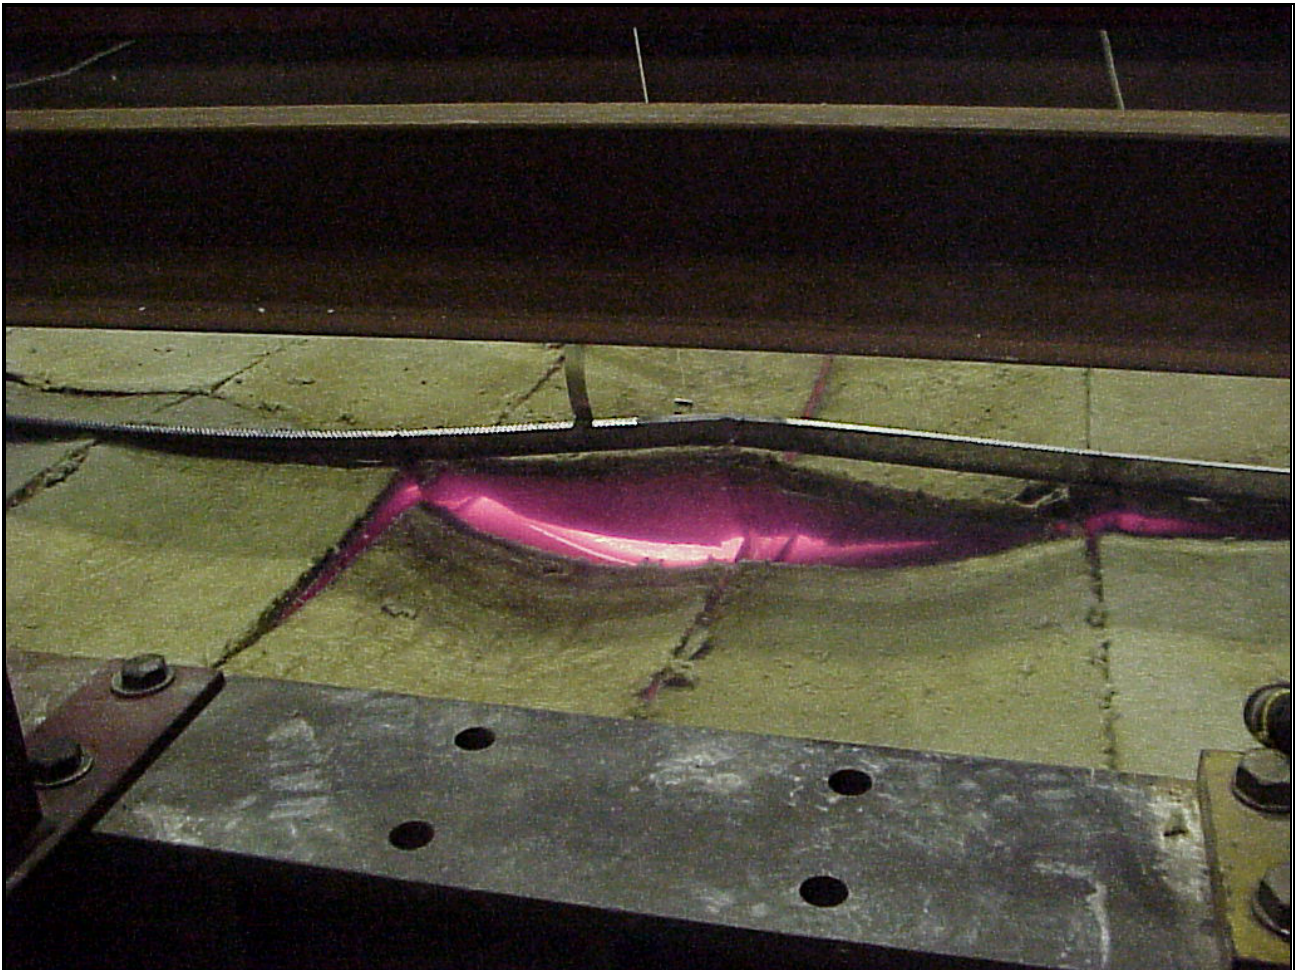
1	11	<p><i>Unexposed face</i></p> <p><b>INTEGRITY FAILURE.</b> The cotton pad glowed when placed approximately 1600mm from the viewing platform and approximately 900mm from the left-hand side of the specimen.</p> <p><b>TEST TERMINATED</b> at the request of the customer.</p>

**Photograph 3.** Position of integrity failure at 71 minutes.

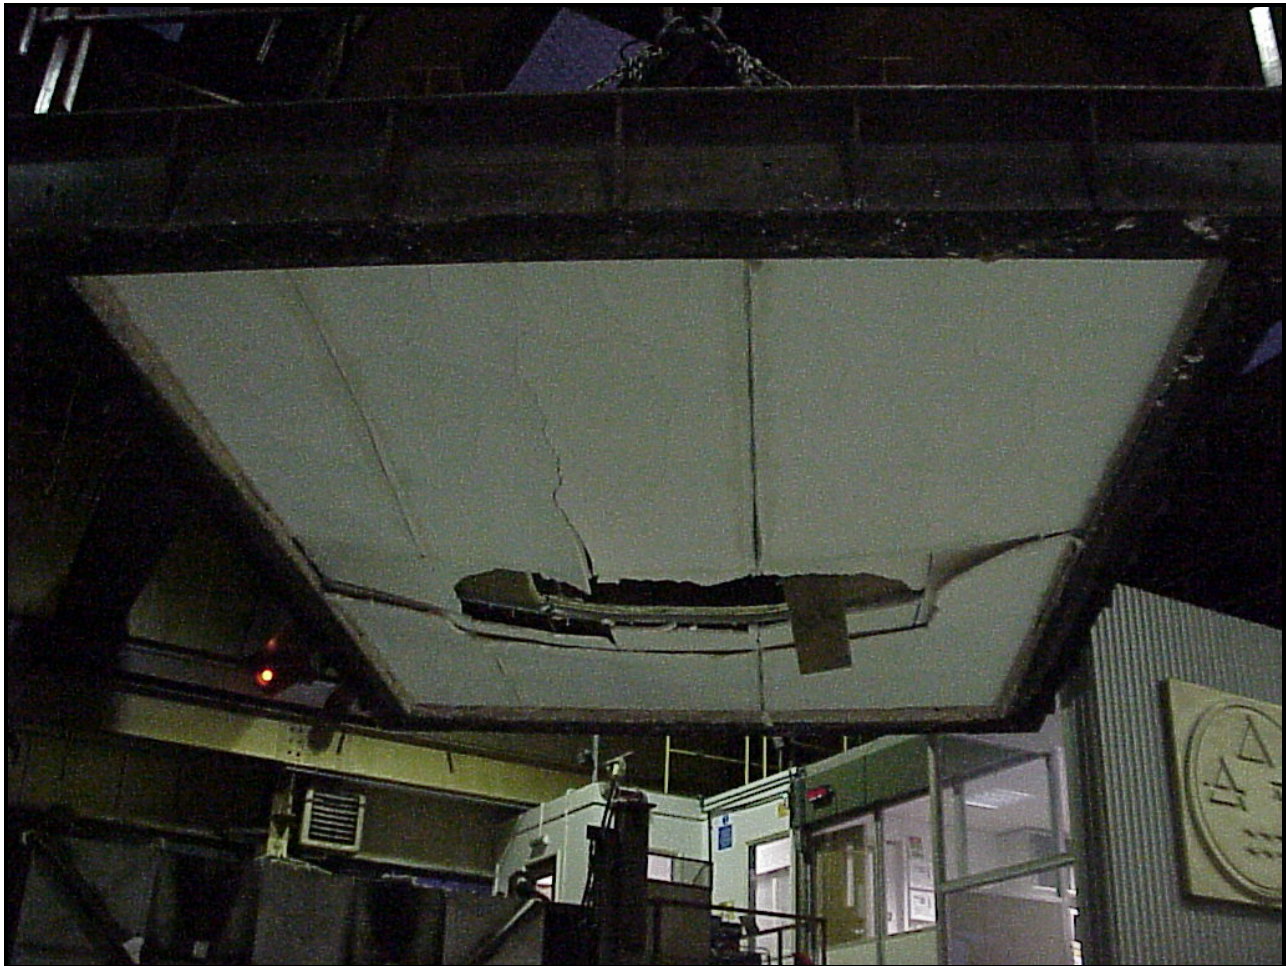
Time		Observations
hrs	mins	
1	05	<p>All observations refer to the exposed face unless otherwise stated.</p> <p>The left-hand longitudinal board joint had opened by approximately 5mm. The right-hand longitudinal board joint had opened by approximately 3-4mm.</p> <p>The left-hand corner of the first row centreboard adjacent to the lateral board joint fell into the furnace.</p> <p><i>Unexposed face</i></p> <p>The insulation slabs had started to discolour in line with the inner layer board joints.</p>
1	08	<p><i>Unexposed face</i></p> <p>A glow was visible between the insulation slab and the metal framework approximately 1600mm from the viewing platform and 900mm from the left-hand side of the specimen.</p> <p>The metal framework had started buckle at the same position.</p>
1	10	<p>A section, approximately 800mm x 1200mm, of the first row centreboard adjacent to the lateral board joint had fallen into the furnace.</p>

**Photograph 4.** Exposed face after test termination.
