### **Report Number BTC 13298F**

A FIRE RESISTANCE TEST ON A 6m HIGH BRITISH GYPSUM SHAFTWALL CLAD WITH A TRIPLE LAYER OF 15mm GYPROC FIRELINE BOARD FIRED FROM THE SHAFT SIDE, CONDUCTED IN ACCORDANCE WITH BS EN 1364-1: 1999.

Test Date: 21<sup>st</sup> April 2004  
(Report Amended: 15<sup>th</sup> June 2020)  
[www.btconline.co.uk](http://www.btconline.co.uk)

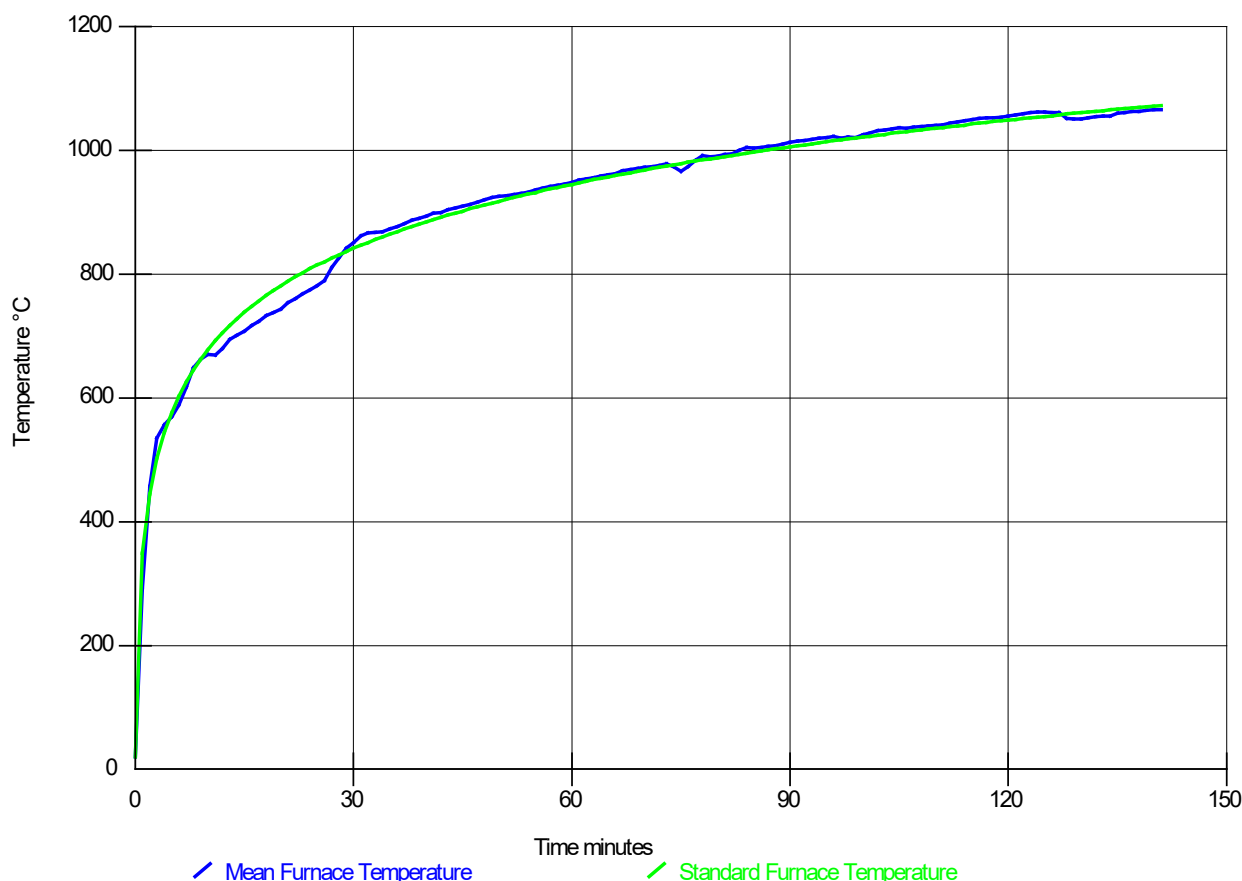
**Figure 2.** Furnace temperature graph.

The following furnace thermocouples were out of the allowed tolerance stated in BS EN 1363-1: 1999 due to a technical problem with the furnace.

Furnace thermocouple no.5 was 100°C above the standard temperature/time curve between 28-33 minutes and at 35 minutes.

Furnace thermocouple no.6 was 100°C above the standard temperature/time curve between 28-33 minutes.

Furnace thermocouple no.9 was 100°C below the standard temperature/time curve at 12 minutes and between 14-25 minutes.

Furnace thermocouple no.10 was 100°C below the standard temperature/time curve between 12-25 minutes and at 27 minutes.

Furnace thermocouple no.11 was 100°C below the standard temperature/time curve between 10-30 minutes.

Furnace thermocouple no.12 was 100°C below the standard temperature/time curve between 10-31 minutes.

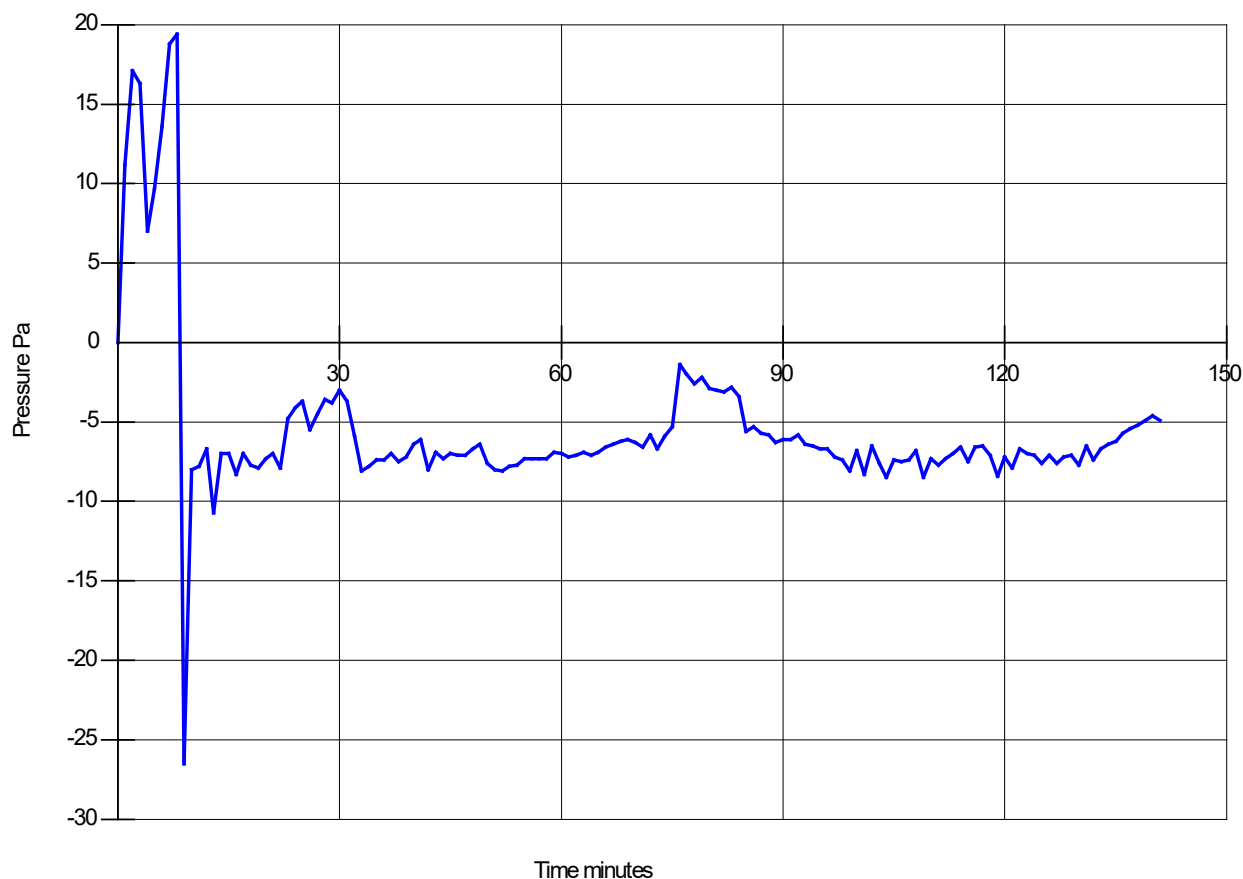
**Figure 3.** Furnace pressure graph.

The furnace pressure was out of the allowed tolerance between 5-9 minutes, at 13 minutes, between 24-25 minutes, between 28-31 minutes and between 76-84 minutes.

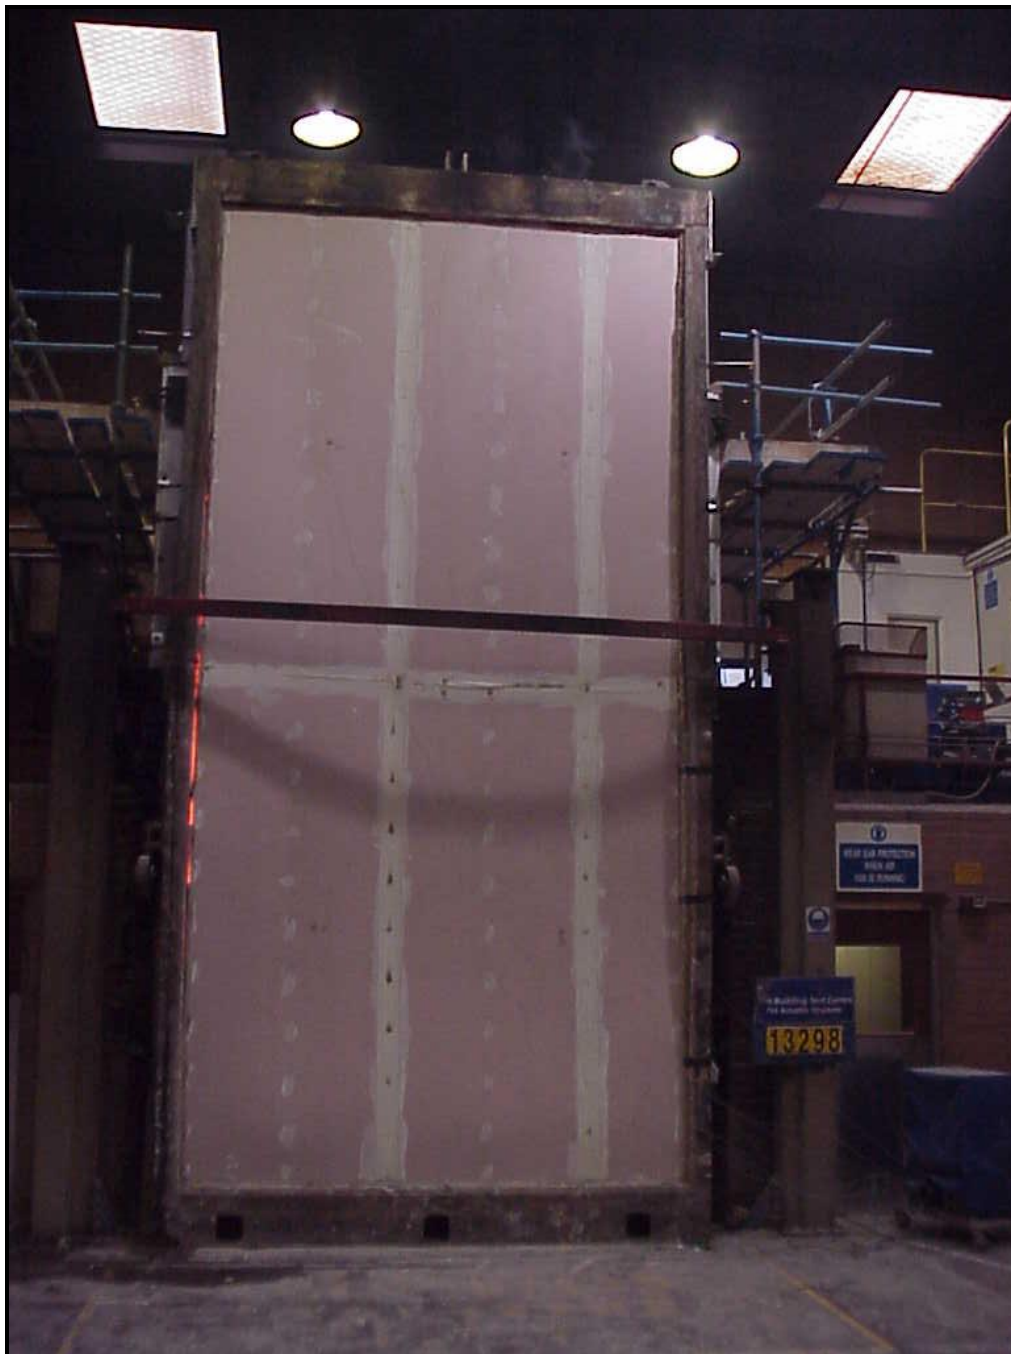
**Photograph 2.** Unexposed face after 120 minutes duration.

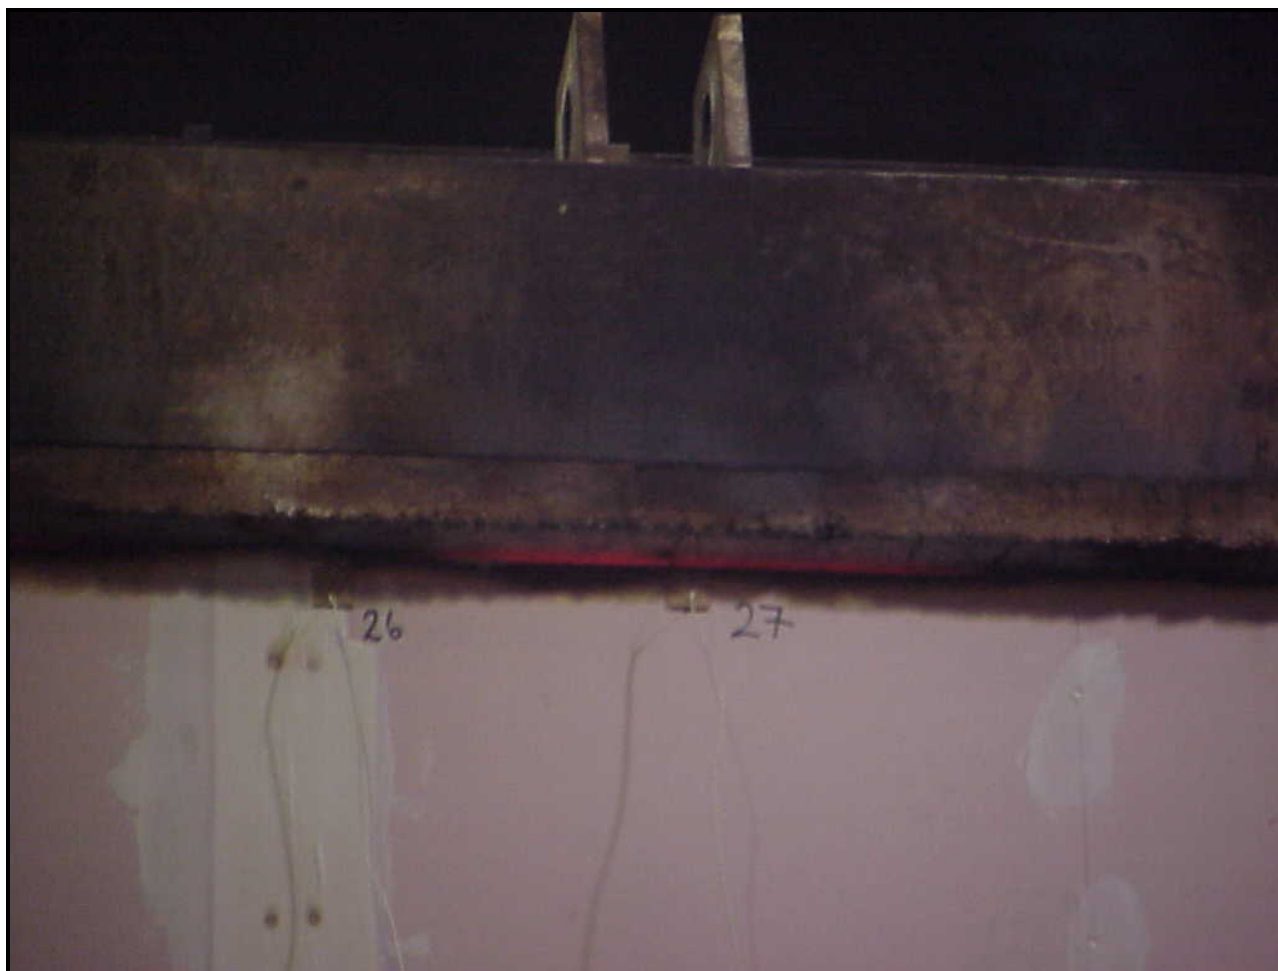
2	03	<p><i>Unexposed face</i></p> <p><b>INTEGRITY FAILURE.</b> The cotton pad glowed when placed at the head of the specimen above the upper centreboard.</p> <p>The left-hand vertical joint had discoloured adjacent to the lower centreboard.</p>
2	05	The crack in the third layer of boards had opened to approximately 8-10mm wide.
2	07	<p><i>Unexposed face</i></p> <p>A horizontal discolouration appeared in the lower centreboard at approximately 900mm height.</p> <p>A vertical discolouration appeared in the middle of the lower centreboard.</p> <p>The roving thermocouple exceeded a temperature rise of 180°C when placed on the middle of the lower centreboard approximately at 1200mm height.</p>

**Photograph 3.** Position of integrity failure after 123 minutes duration.

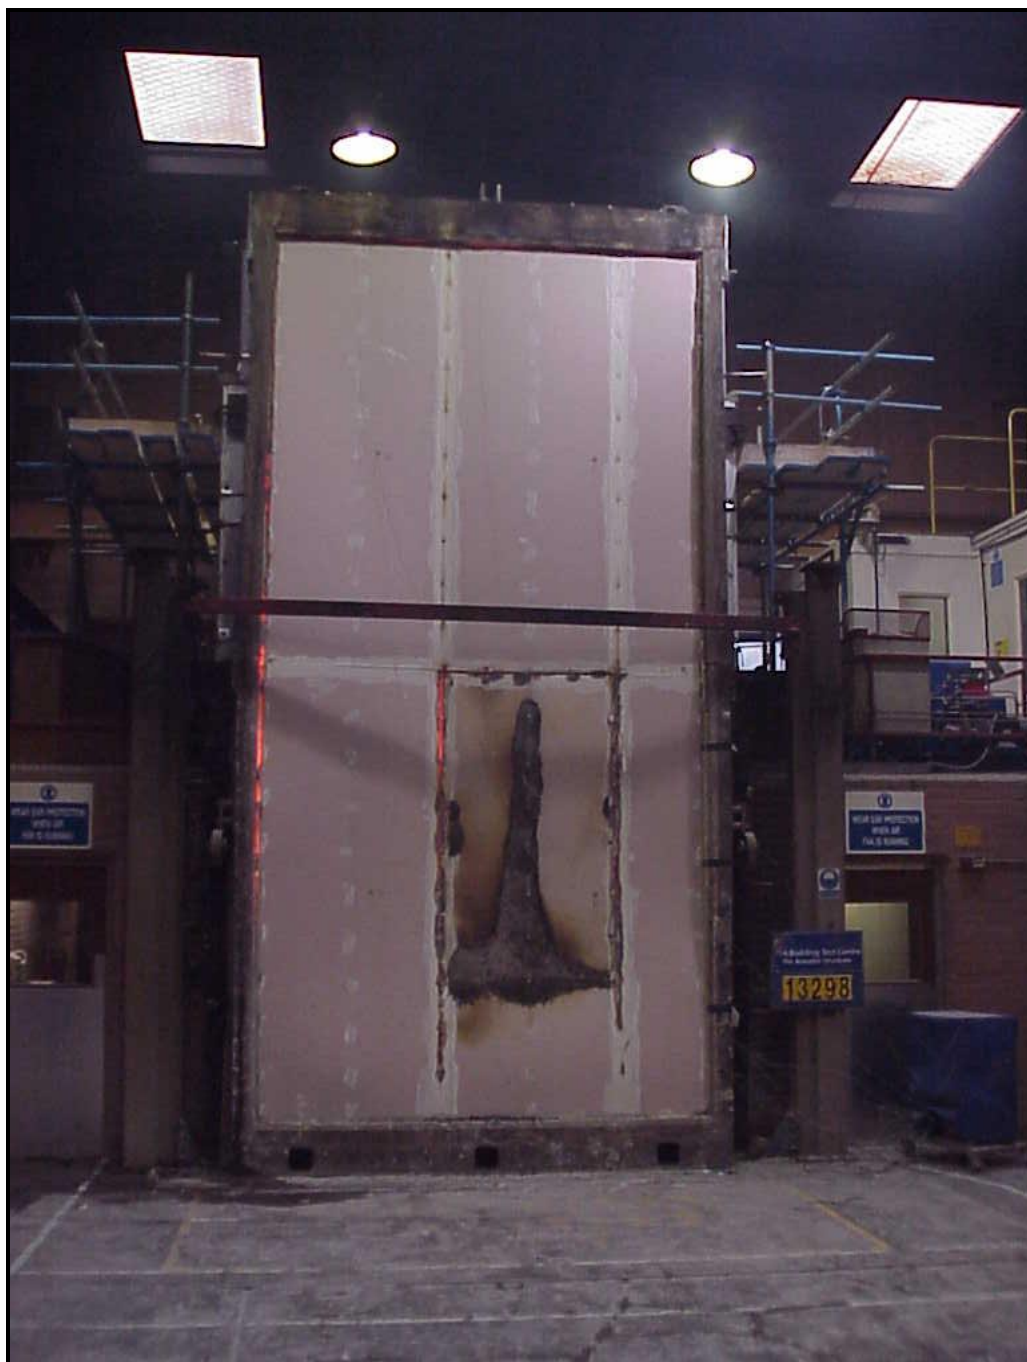
**Photograph 4.** Unexposed face after test termination at 141 minutes.
