Report Number BTC 13483F

A FIRE RESISTANCE TEST ON A BRITISH GYPSUM GYPWALL QUIET SF PARTITION CLAD WITH A DOUBLE LAYER OF 12.5mm GYPROC SOUNDBLOC EACH SIDE OF GYPFRAME 70S50 STUDS WITH GYPFRAME RB1 RESILIENT BAR ON THE UNEXPOSED FACE, CONDUCTED IN ACCORDANCE WITH BS EN 1364-1: 1999.

Test Date: 8th September 2004

Customer: British Gypsum Limited
East Leake
Loughborough
Leicestershire
LE12 6HX

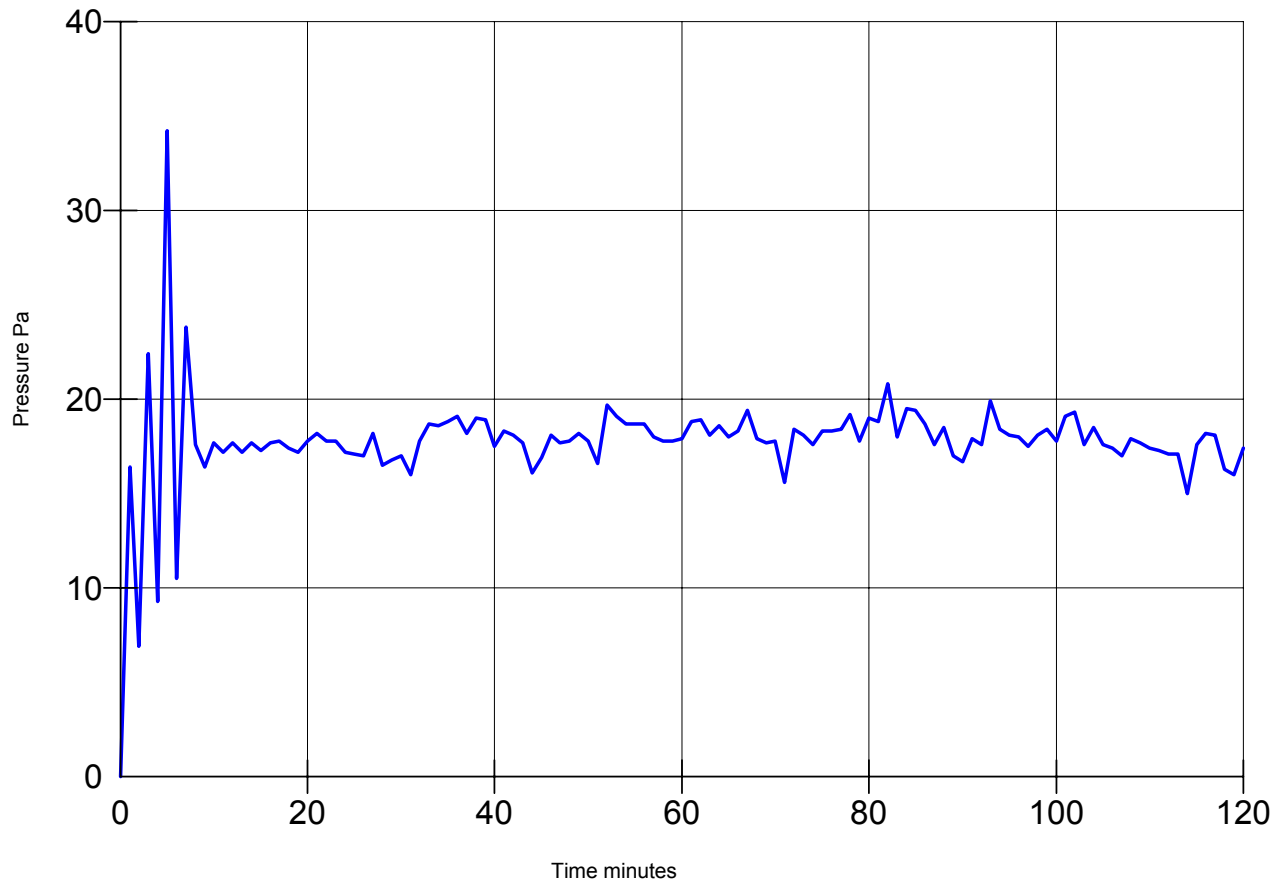
Figure 3. Furnace pressure graph.

The furnace pressure was outside of the allowable tolerance at 6-7 and 82 minutes.

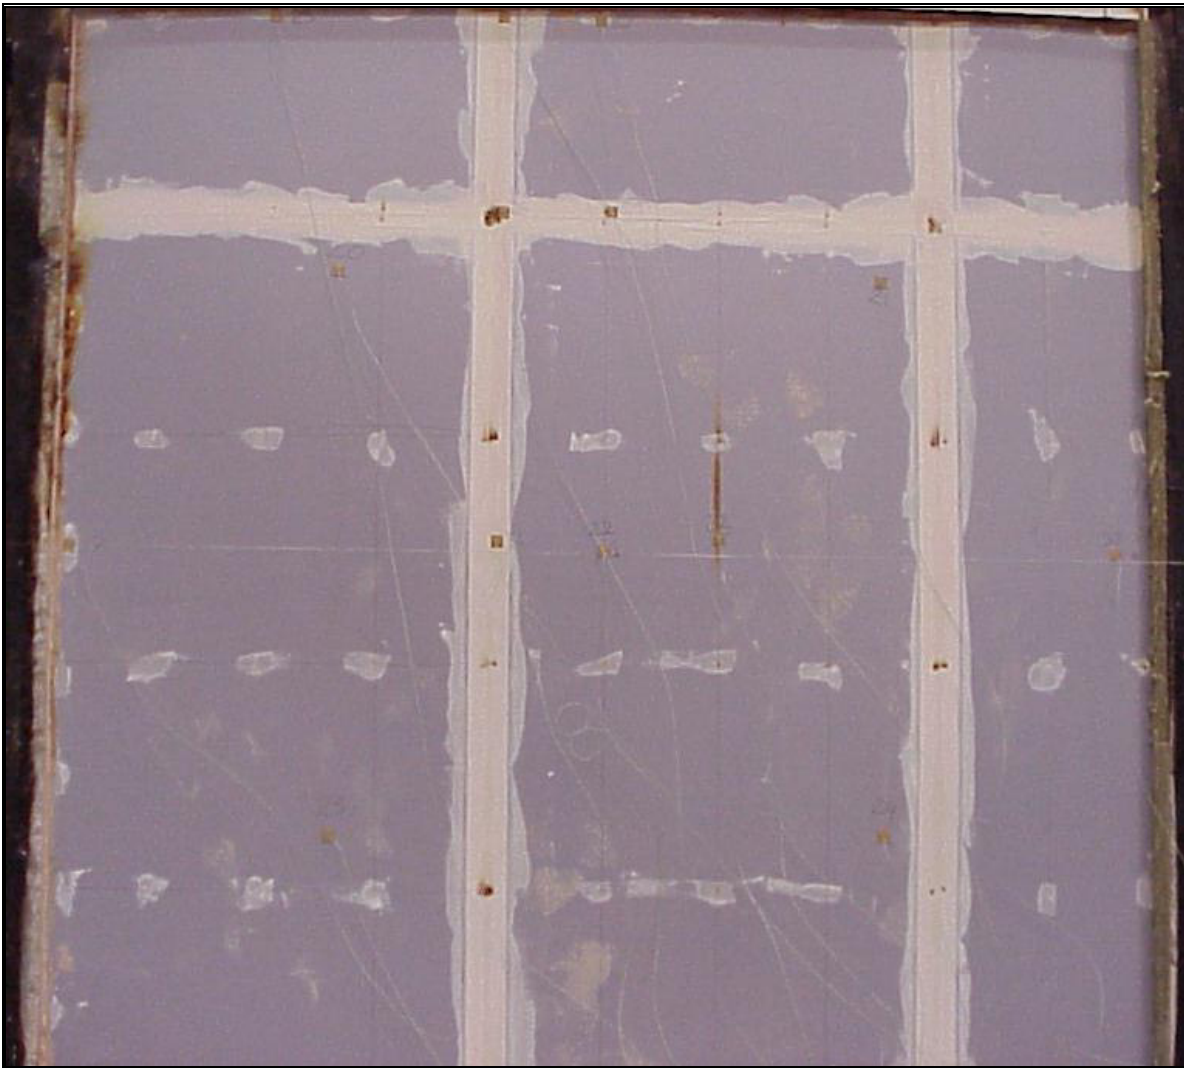
| Time | | Observations |
|---|---|--|
| 1 | 42 | <i>Unexposed face</i> INSULATION FAILURE. The temperature rise of thermocouple No. 32 exceeded 180°C. |

Photograph 3. View of the unexposed face at 102 minutes (after insulation failure).

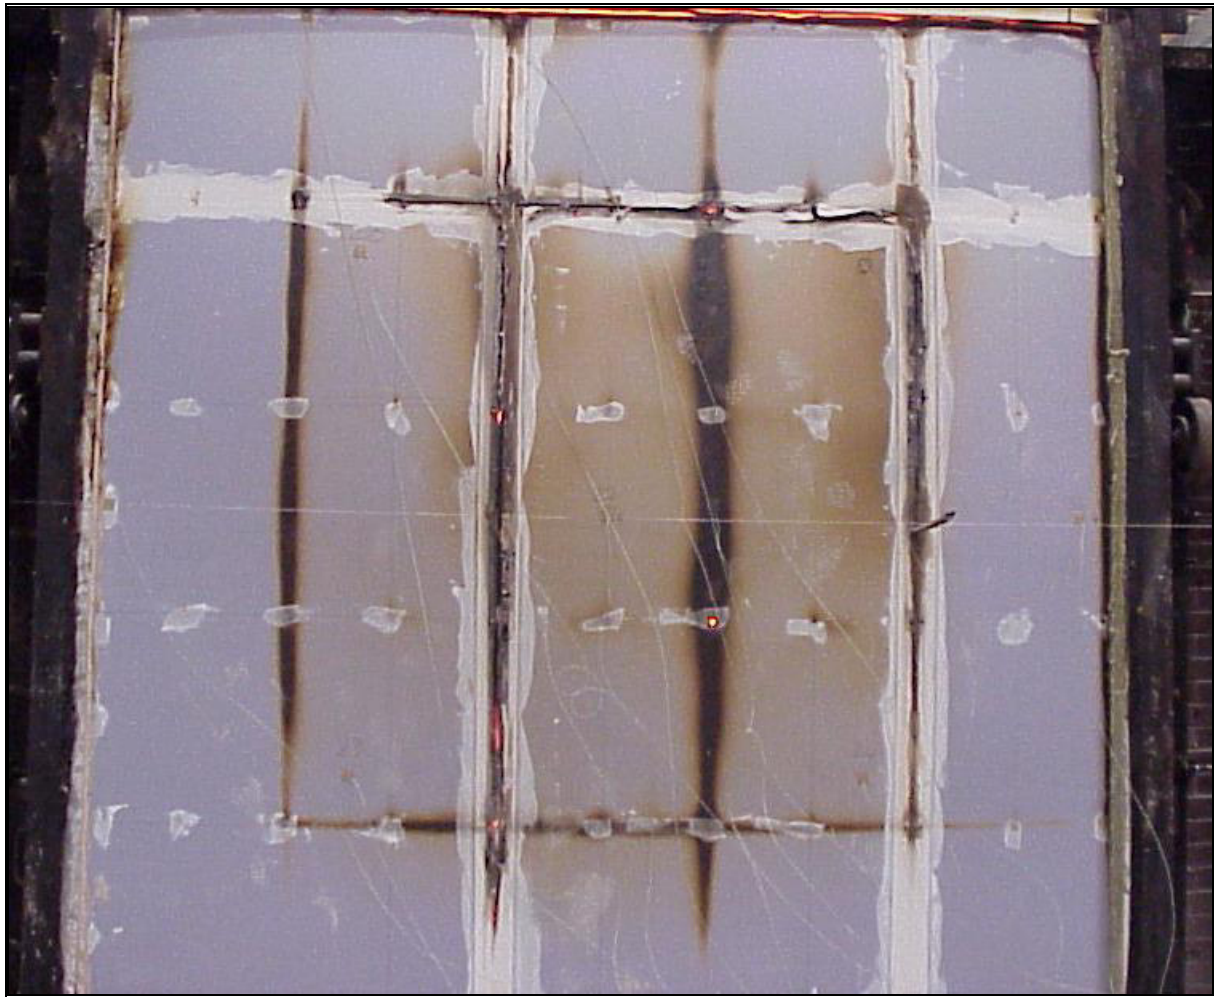
| Time | | Observations |
|---|---|--|
| 1 | 57 | <i>Unexposed face</i> INTEGRITY FAILURE. The cotton pad glowed when used at the head above the left-hand vertical joint. |

Photograph 4. View of the unexposed face at 117 minutes (after integrity failure).

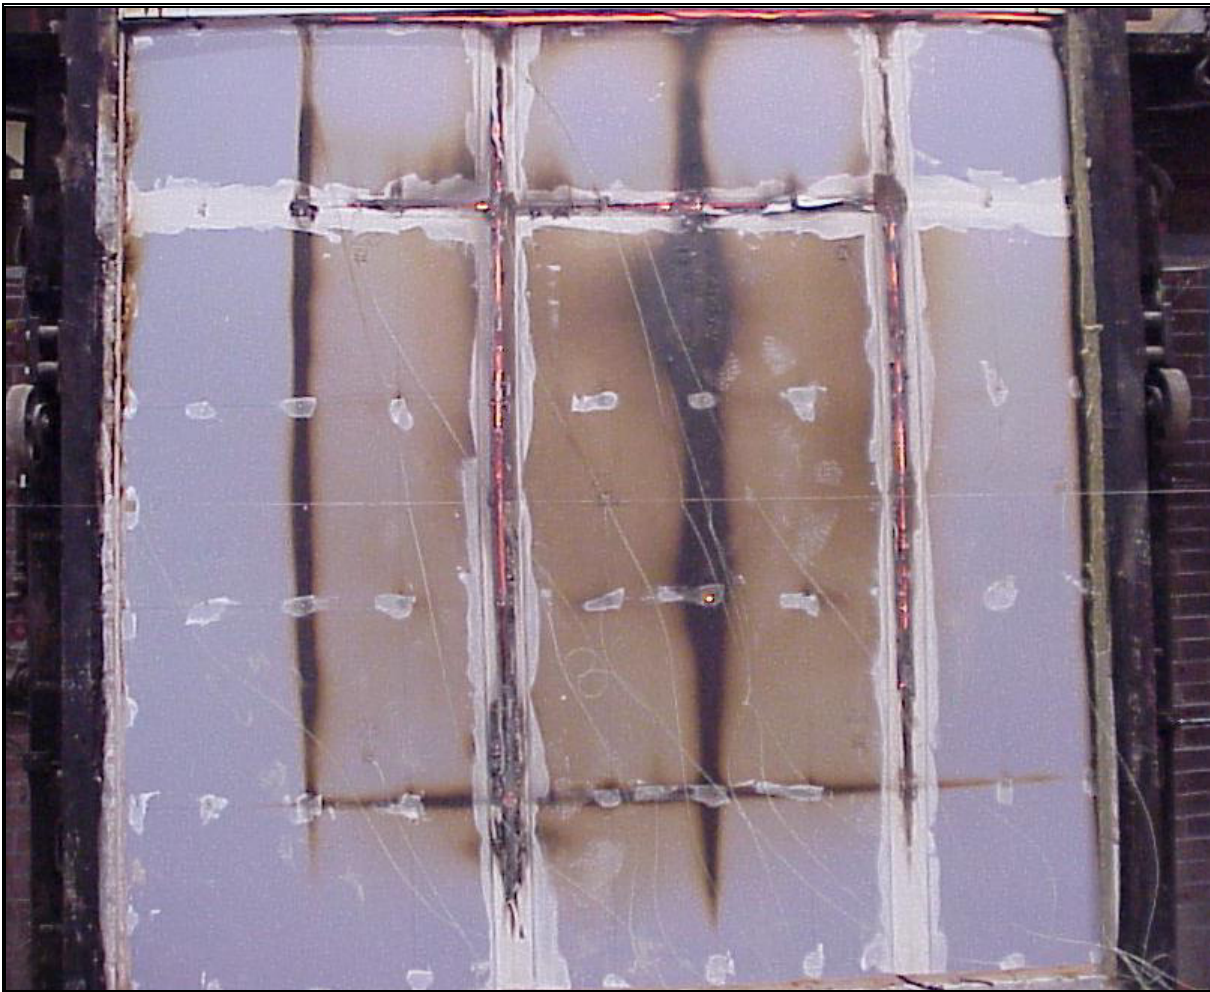
Photograph 5. View of the unexposed face at test termination (120 minutes).
