## **Report Number BTC 13304F**

A FIRE RESISTANCE TEST ON A BRITISH GYPSUM GYPWALL PARTITION CLAD WITH A SINGLE LAYER OF 15mm GYPROC WALLBOARD EACH SIDE OF GYPFRAME 70S50 STUDS AND 50mm ISOWOOL 1200 IN THE CAVITY, CONDUCTED IN ACCORDANCE WITH BS EN 1364-1: 1999.

Test Date: 21<sup>st</sup> June 2004

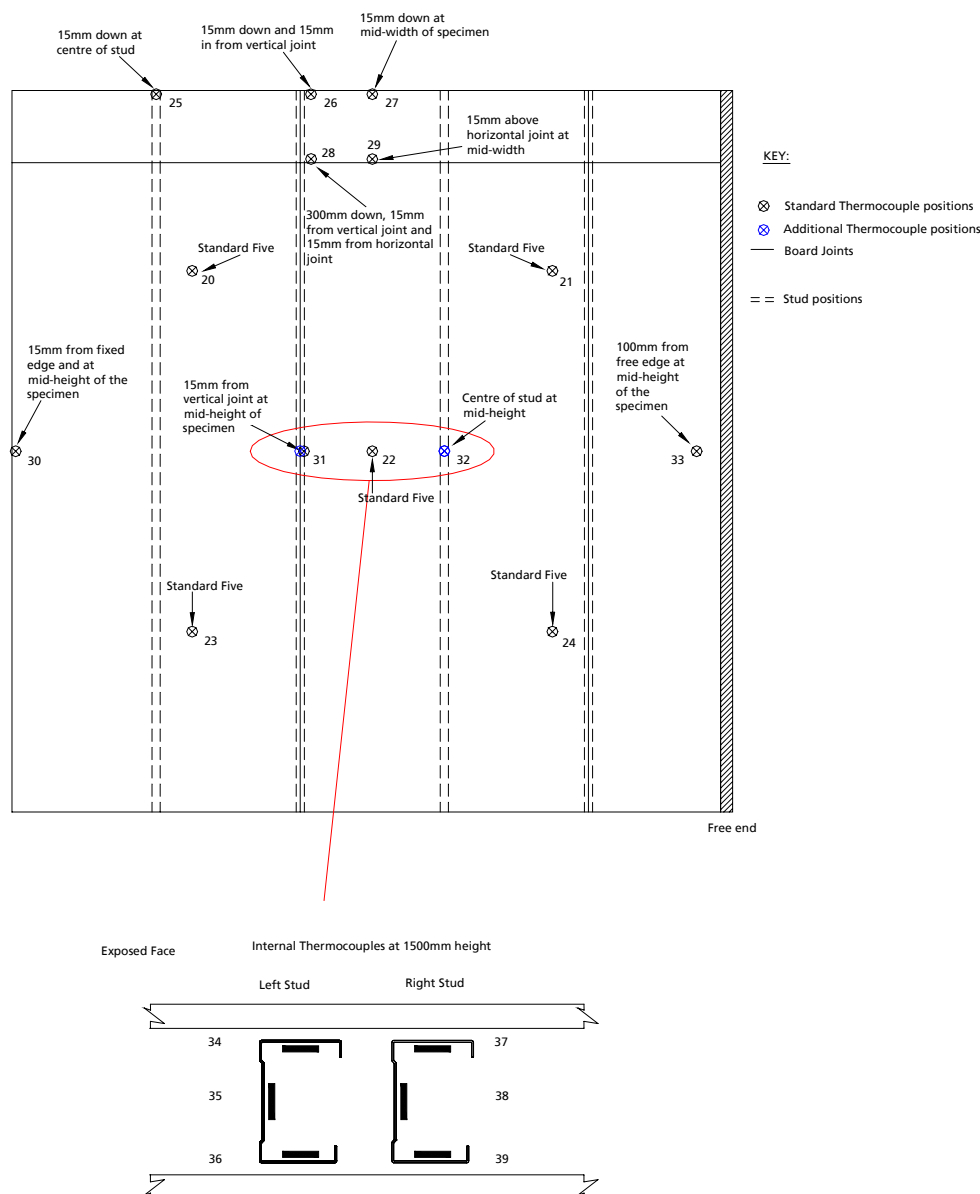
38	<i>Unexposed face</i> <b>INSULATION FAILURE.</b> The temperature rise of thermocouple No. 31 exceeded 180°C.
	39	<i>Unexposed face</i> Discolouration had developed on the left-hand vertical joint at approximately 900-1800mm height. Discolouration had developed on the right-hand vertical joint at approximately 1200mm height. Flash flaming was visible on the left-hand vertical joint at approximately 1200mm height.

Figure 5. Unexposed face thermocouple layout.

Figures shown in red indicate the time and position of insulation failure.

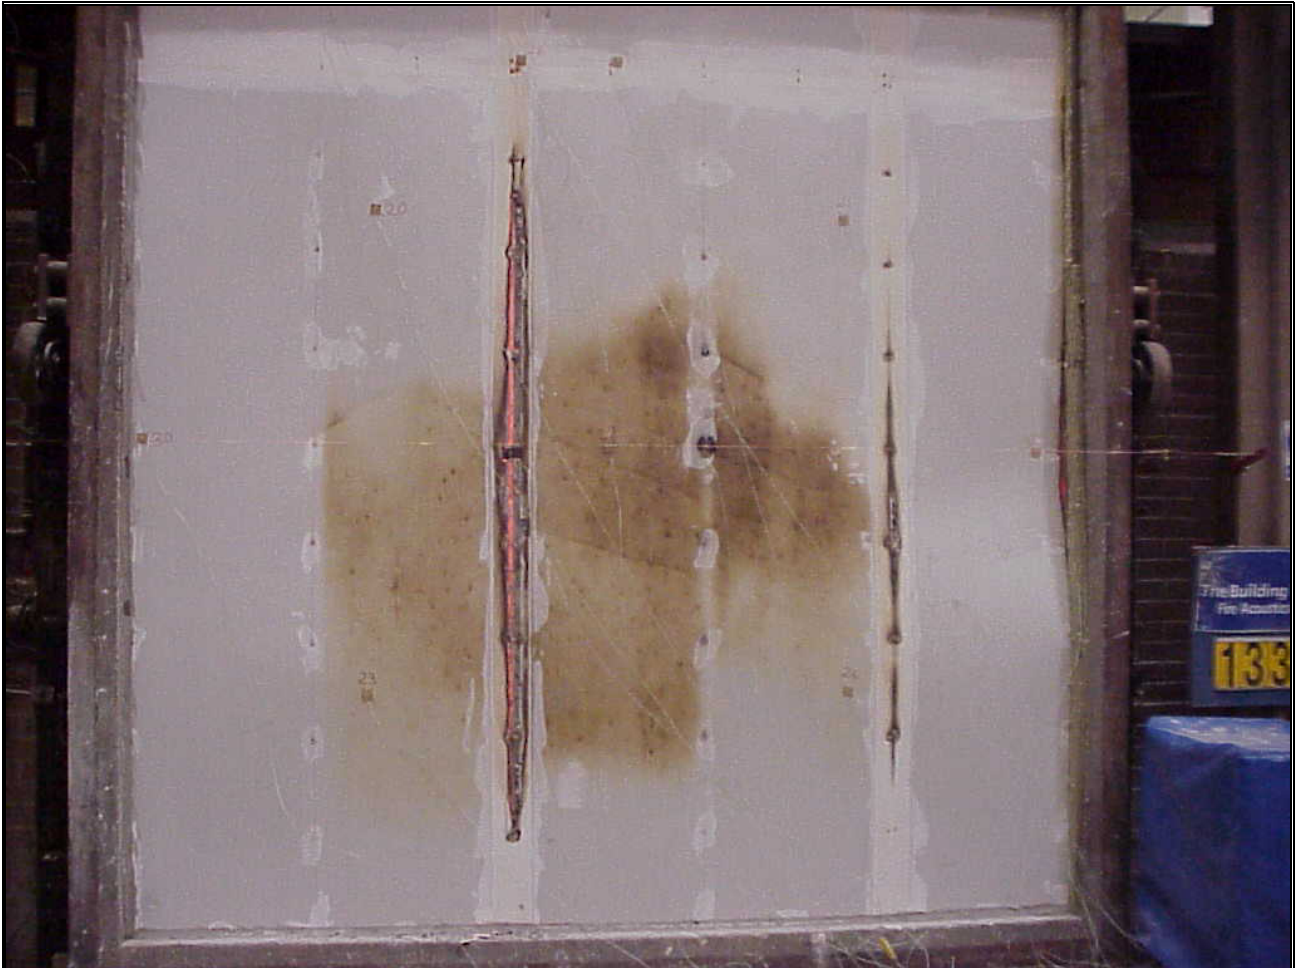
43	<p>Vertical and horizontal cracks approximately 1-2mm wide had developed on the unexposed face boards.</p> <p><i>Unexposed face</i> A glow was visible on the left-hand vertical joint at approximately 300-2400mm height. Discolouration had developed on the right-hand vertical joint at approximately 300-2100mm height. <b>FURTHER INTEGRITY FAILURE.</b> The 6mm x 150mm gap gauge entered the furnace through the left-hand vertical joint at approximately 1200-1500mm height.</p>

Time		Observations
hrs	mins	
		All observations refer to exposed face unless otherwise stated.
	44	<i>Unexposed face</i> Horizontal cracks approximately 2mm wide had developed on the lower centre board at approximately 1200-1800mm height.
	45	<i>Unexposed face</i> <b>FURTHER INTEGRITY FAILURE.</b> The 25mm gap gauge entered the furnace through the left-hand vertical joint at approximately 1500mm height.  <b>TEST TERMINATED</b> at the request of the customer.

**Photograph 3.** View of the unexposed face at 42 minutes (after integrity failure).
