The Building Test Centre

Report Number BTC 14869F

A FIRE RESISTANCE TEST ON A BRITISH GYPSUM GYPWALL PARTITION CLAD WITH AN INNER LAYER OF 15mm GYPROC WALLBOARD AND AN OUTER LAYER OF 12.5mm GLASROC RIGIDUR H, CONDUCTED IN ACCORDANCE WITH BS EN 1364-1: 1999.

Test Date: 4th December 2006

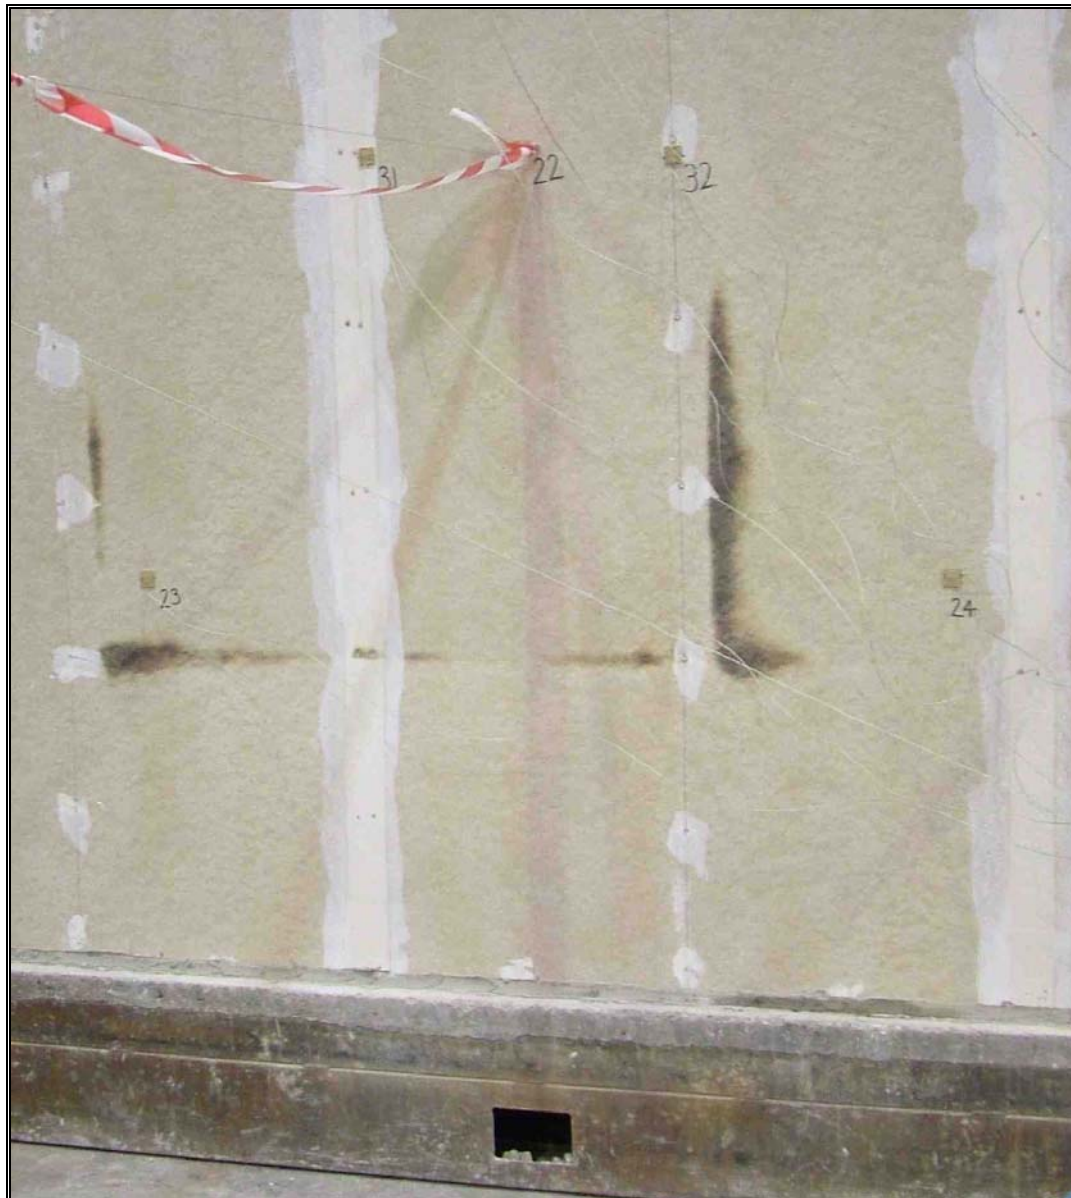
Integrity:	Sustained flaming	108 minutes (no failure test discontinued)
	25mm gap gauge	108 minutes
	6mm gap gauge	105 minutes
	Cotton pad	104 minutes
Insulation:		82 minutes

Photograph 3. Position of insulation failure at 82 minutes.

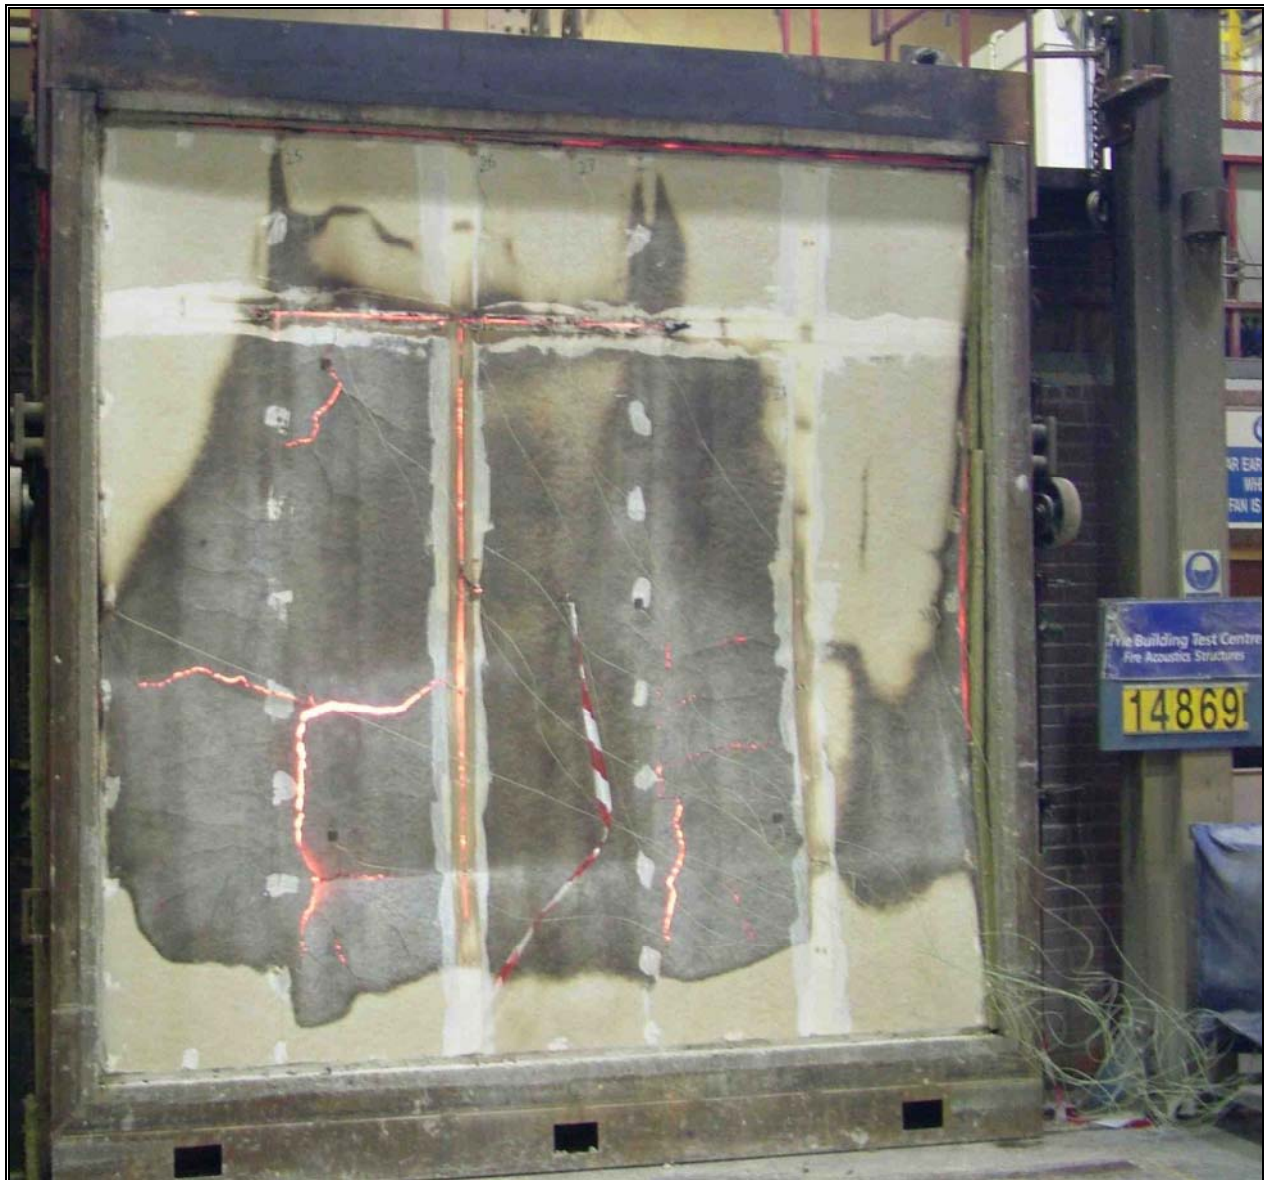
1	45	Approximately 25% of the third layer had fallen into the furnace. <i>Unexposed face</i> FURTHER INTEGRITY FAILURE. 6mm x 150mm gap gauge entered the furnace through a crack in the middle of the lower left-hand board at approximately 1200mm height.
1	48	<i>Unexposed face</i> FURTHER INTEGRITY FAILURE. 25mm diameter gap gauge entered the furnace through a crack in the middle of the lower left-hand board at approximately 1200mm height. TEST TERMINATED at the request of the customer.

Photograph 4. View of the unexposed face at test termination (108 minutes).
