Report Number BTC 13478F

A FIRE RESISTANCE TEST ON A BRITISH GYPSUM GYPWALL PARTITION CLAD WITH A SINGLE LAYER OF 15mm GYPROC SOUNDBLOC EACH SIDE OF GYPFRAME 92S50 STUDS AND 3 LAYERS OF 25mm ISOWOOL 1200 IN THE CAVITY, CONDUCTED IN ACCORDANCE WITH BS EN 1364-1: 1999.

Test Date: 26th August 2004

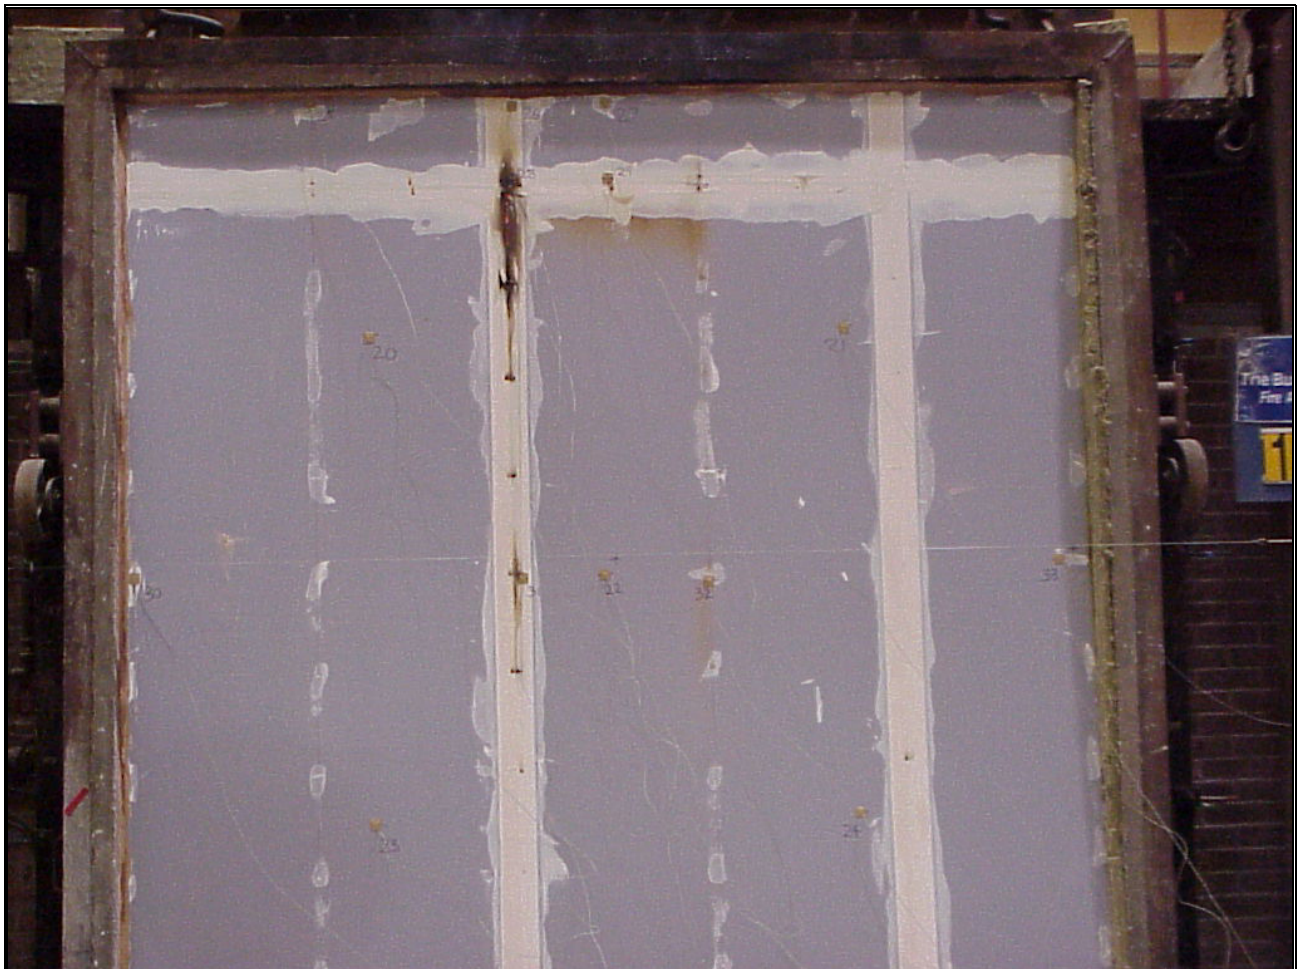
Time		Observations
hrs	mins	
		All observations refer to exposed face unless otherwise stated.
	57	<i>Unexposed face</i> Discolouration had developed on the top left-hand corner of the lower centre board. A slight glow was visible on the left-hand vertical joint at approximately 2400-2700mm height.
	58	<i>Unexposed face</i> INSULATION FAILURE. The temperature rise of the thermocouple No. 31 and thermocouple No. 32 exceeded 180°C.
	59	<i>Unexposed face</i> Discolouration had developed on the centre line of the lower centre board at approximately 1200-1500mm height. Discolouration had developed on the left-hand vertical joint at approximately 1200-2700mm height.
1	00	A further section of the lower centre board approximately 1000mm x 1200mm had fallen into the furnace. A section of the lower left-hand board approximately 2000mm x 600mm had fallen into the furnace. <i>Unexposed face</i> A cotton pad was used on the left-hand vertical joint / horizontal joint junction but did not glow or ignite.

Photograph 3. View of the unexposed face at 58 minutes (after insulation failure).

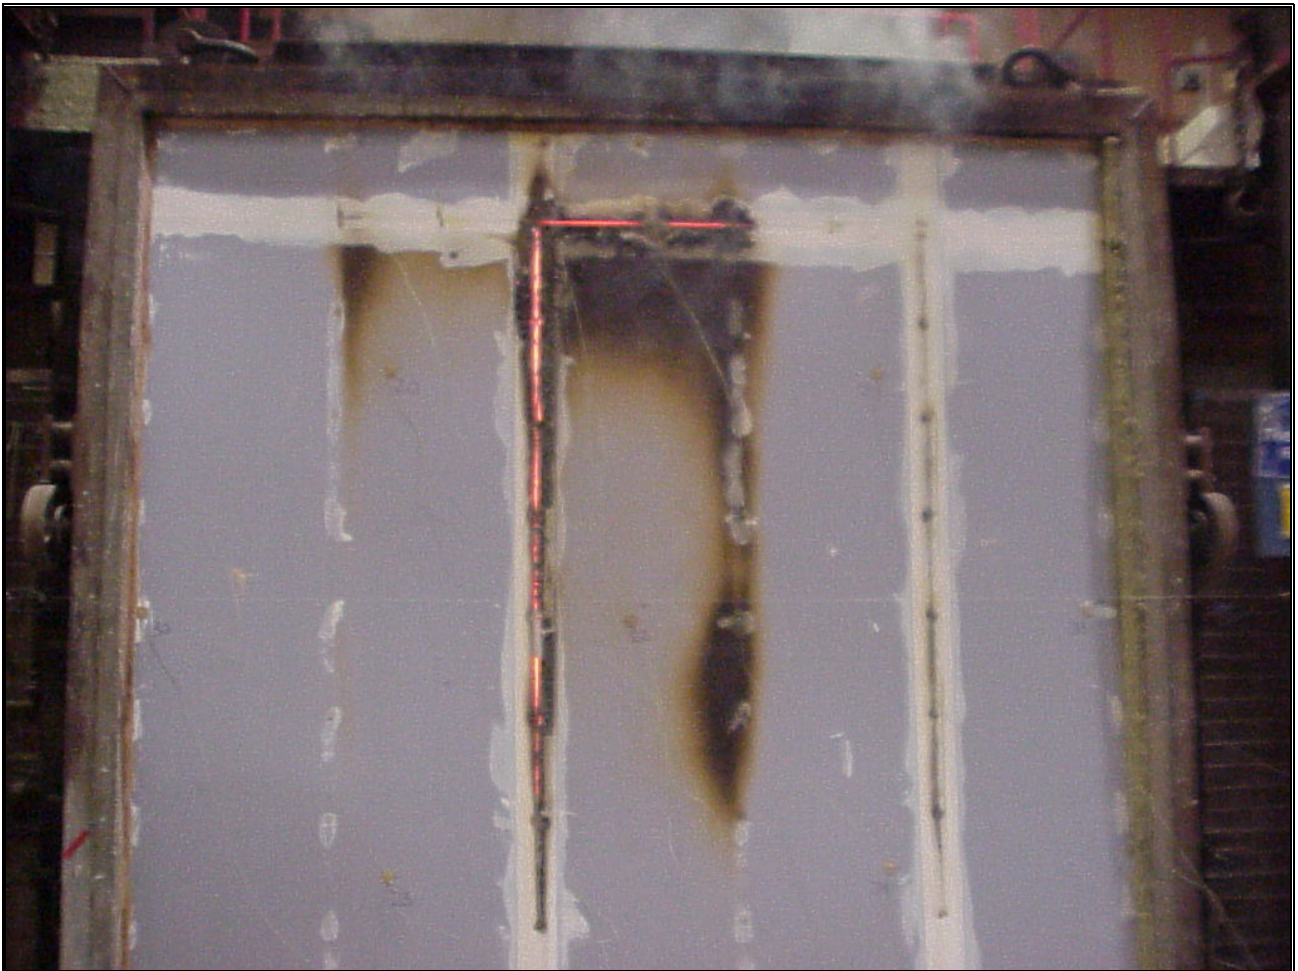
Time		Observations
hrs	mins	
		All observations refer to exposed face unless otherwise stated.
1	02	<i>Unexposed face</i> A glow was visible on the left-hand vertical joint at approximately 2100-2700mm height. A glow was visible on the horizontal joint at approximately mid-width. A cotton pad was used on the left-hand vertical joint at approximately 1500mm but did not glow or ignite.
1	03	<i>Unexposed face</i> A cotton pad was used on the left-hand vertical joint / horizontal joint junction but did not glow or ignite.
1	04	<i>Unexposed face</i> INTEGRITY FAILURE. The cotton pad glowed when used on the left-hand vertical joint at approximately 2600mm height. Discolouration had developed on the right-hand vertical joint at approximately 1200-2700mm height.
1	05	No visible change to the specimen. <i>Unexposed face</i> A glow was visible on the left-hand vertical joint at approximately 1200-2700mm height. FURTHER INTEGRITY FAILURE. The 6mm x 150mm gap gauge entered the furnace through the left-hand vertical joint at approximately 2400-2700mm height.

Photograph 4. View of the unexposed face at 64 minutes (after integrity failure).

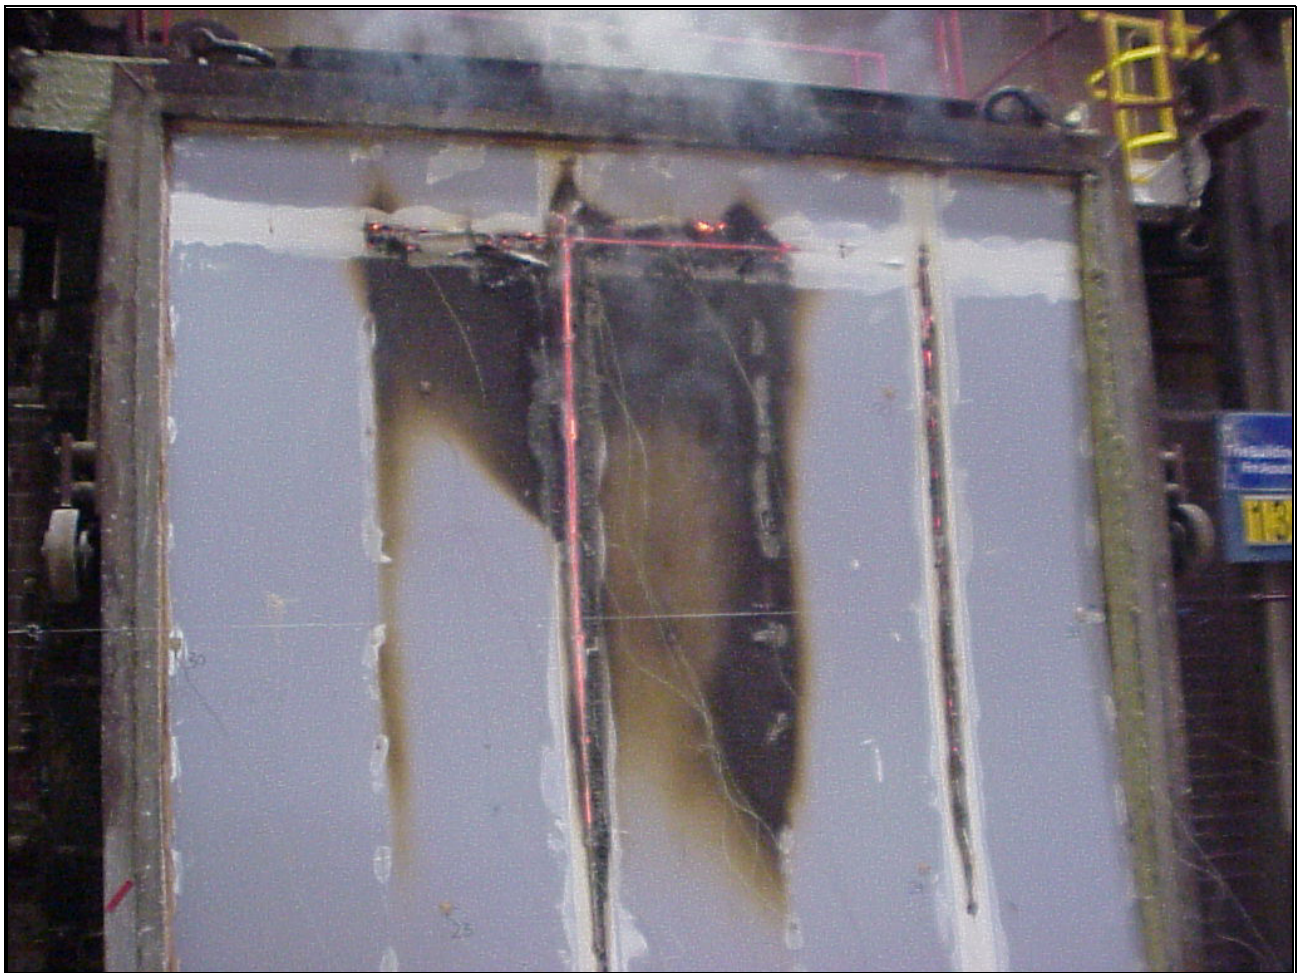
1	06	<i>Unexposed face</i> FURTHER INTEGRITY FAILURE. The 25mm gap gauge entered the furnace through the left-hand vertical joint at approximately 2100mm height. TEST TERMINATED at the request of the customer.

Photograph 5. View of the unexposed face at test termination (66 minutes).
