Report Number **BTC 12026F**

A FIRE RESISTANCE TEST ON A GYPROC GYPWALL PARTITION INCORPORATING A SINGLE LAYER OF 12.5mm SOUNDBLOC EACH SIDE OF 48550 STUDS WITH 25mm ISOWOOL 1200 IN THE CAVITY, CONDUCTED IN ACCORDANCE WITH BS EN 1364-1:1999.

Test Date: 10th July 2002

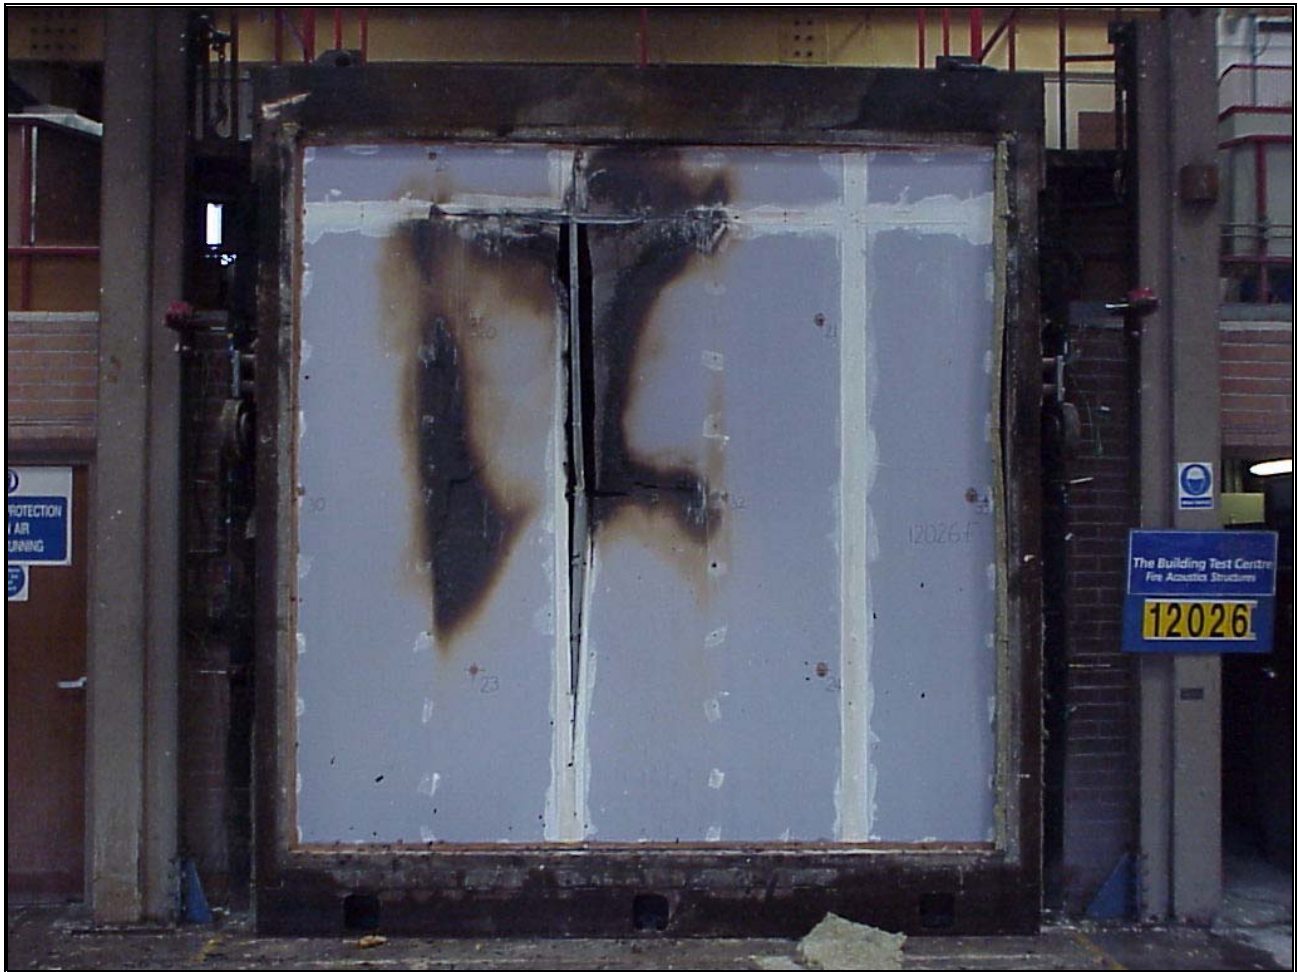
Time		Observations
hrs	Mins	
		All observations refer to the exposed face unless otherwise stated.
	44	<i>Unexposed face</i> INSULATION FAILURE. The temperature rise exceeded 180°C on thermocouple No. 31 (15mm from vertical joint at mid-height of specimen). INTEGRITY FAILURE. Sustained flaming left hand vertical joint mid-height for 30 seconds.
	45	<i>Unexposed face</i> INTEGRITY FAILURE. Cotton pad glowing left hand vertical joint.
	48	Lower centre board left hand side, a piece approximately 600mm x 1200mm peeled away from stud into furnace.
	49	<i>Unexposed face</i> INTEGRITY FAILURE. Inner board fell through left hand vertical joint. 6mm x 150mm gap and 25mm gap visual failure. TEST TERMINATED.

Photo 4. View of the unexposed face after test termination showing areas of insulation and integrity failure.
