Report Number BTC 13485F

A FIRE RESISTANCE TEST ON A BRITISH GYPSUM GYPWALL QUIET SF PARTITION CLAD WITH AN INNER LAYER OF 19mm GYPROC PLANK AND AN OUTER LAYER OF 12.5mm GYPROC SOUNDBLOC EACH SIDE OF GYPFRAME 70S50 STUDS WITH GYPFRAME RB1 RESILIENT BAR ON THE EXPOSED FACE, CONDUCTED IN ACCORDANCE WITH BS EN 1364-1: 1999.

Test Date: 20th September 2004

Customer: British Gypsum Limited
East Leake
Loughborough
Leicestershire
LE12 6HX

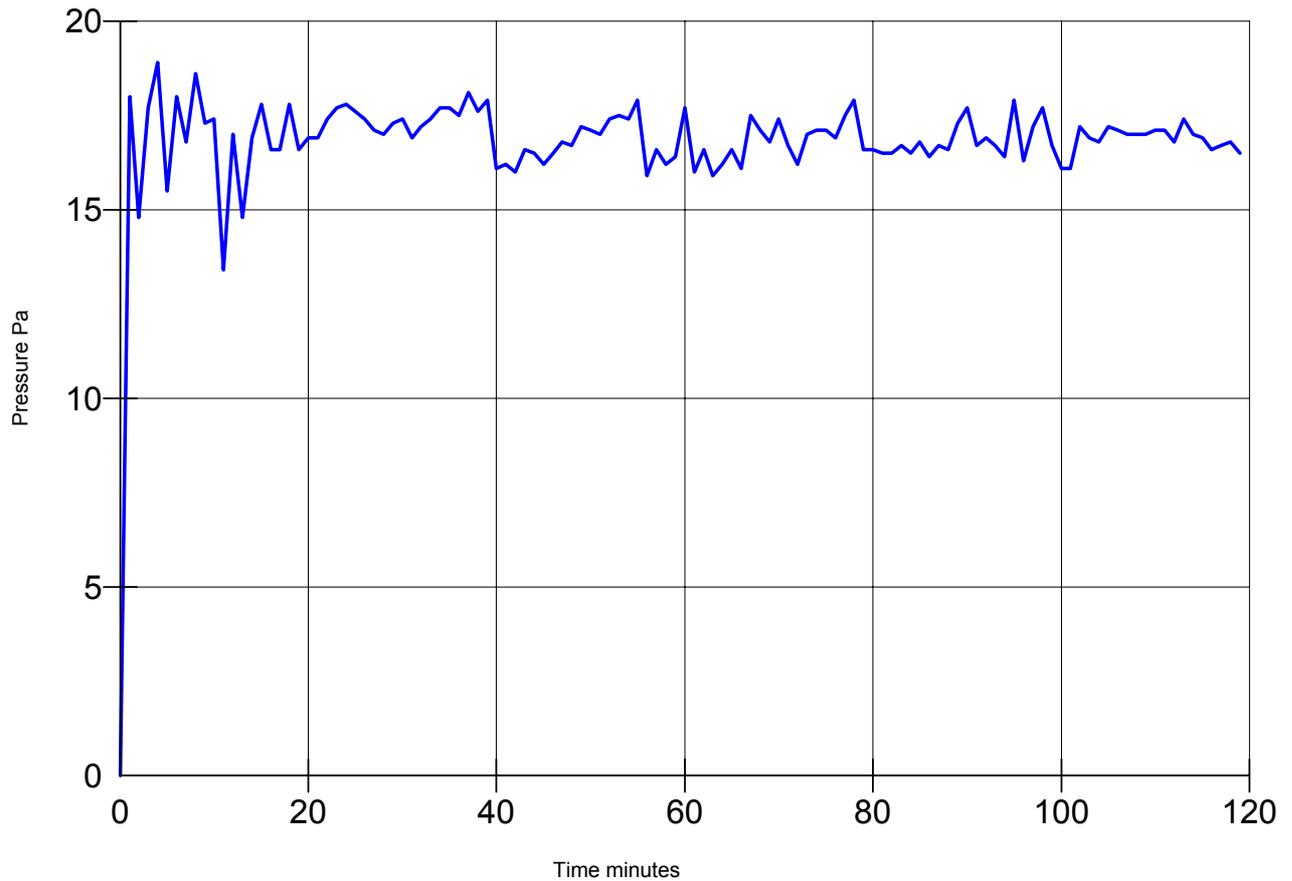
Figure 4. Furnace pressure graph.

The allowable tolerances are ± 5 Pa from 5 minutes to 10 minutes and ± 3 Pa from 10 minutes onwards. It is of the opinion of the laboratory that the variations in the furnace pressure exceeding the tolerances stated in BS EN 1363-1:1999 have not unduly influenced the results of this test. Furnace pressure data is shown on page 20.

The furnace pressure was outside of the allowable tolerance at 11 and 13 minutes.

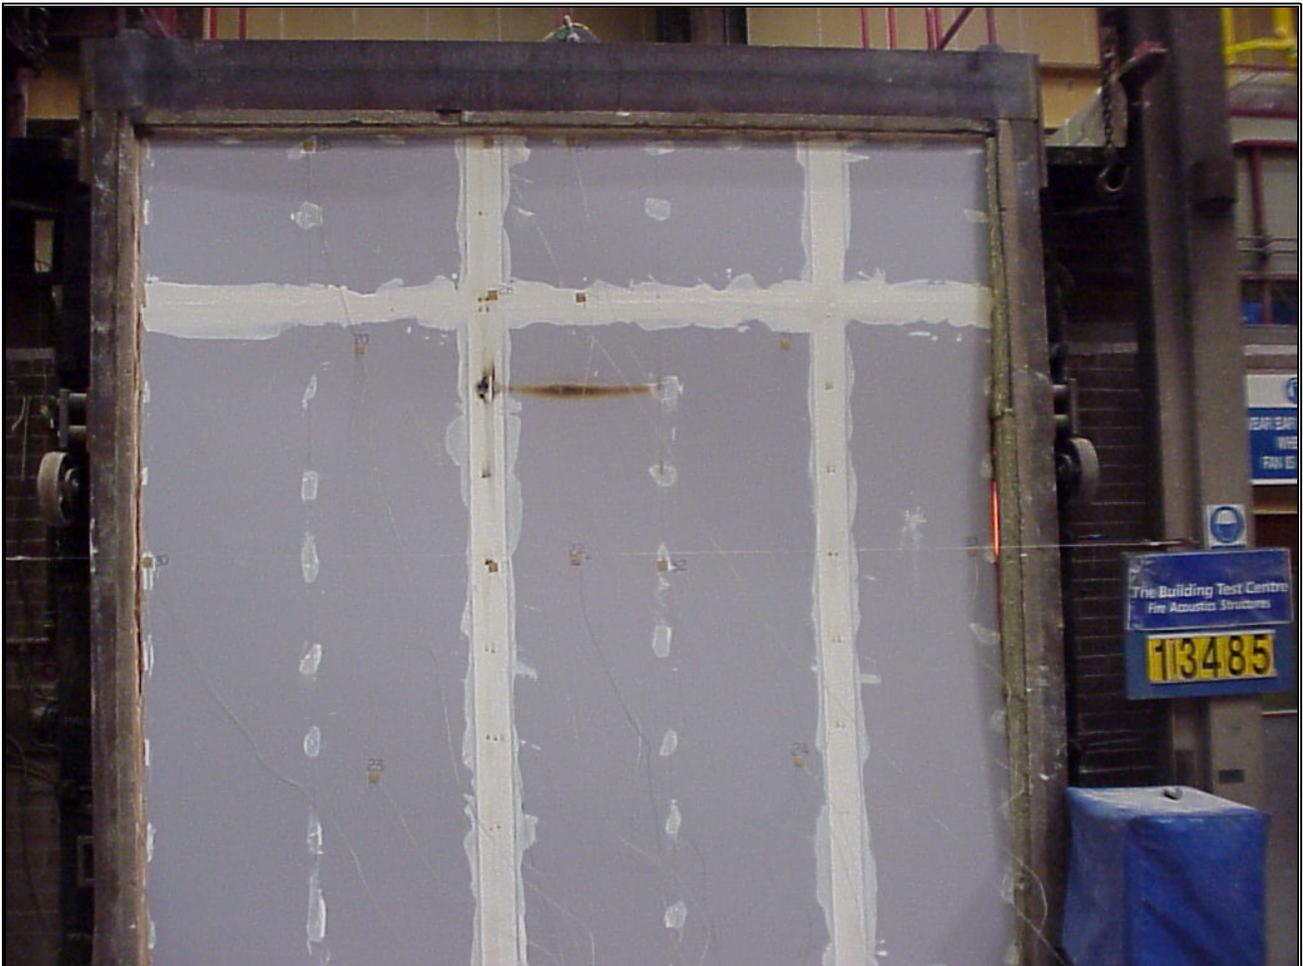
Time		Observations
hrs	mins	
		All observations refer to exposed face unless otherwise stated.
1	46	<i>Unexposed face</i> INSULATION FAILURE. The temperature rise of the roving thermocouple exceeded 180°C on lower centre board at approximately 2100mm height and mid-width of the specimen (in line with an inner layer horizontal joint). Discolouration had developed on the left-hand vertical joint at approximately 1800-2100mm height.
1	47	<i>Unexposed face</i> A slight glow was visible on the left-hand vertical joint at approximately 2100mm height.
1	50	No visible change to the specimen. <i>Unexposed face</i> A cotton pad was used on the left-hand vertical joint at approximately 2100mm height but did not glow or ignite. Discolouration had developed on lower left-hand board at approximately 2100mm height (in line with an inner layer horizontal joint).
1	51	<i>Unexposed face</i> Discolouration had developed on the centre line of the lower centre board at approximately 1500-2100mm height. Discolouration had developed on the left-hand vertical joint at approximately 1800-2400mm height. A cotton pad was used on the left-hand vertical joint at approximately 2100mm height but did not glow or ignite.

Photograph 3. View of the unexposed face at 106 minutes (after insulation failure).

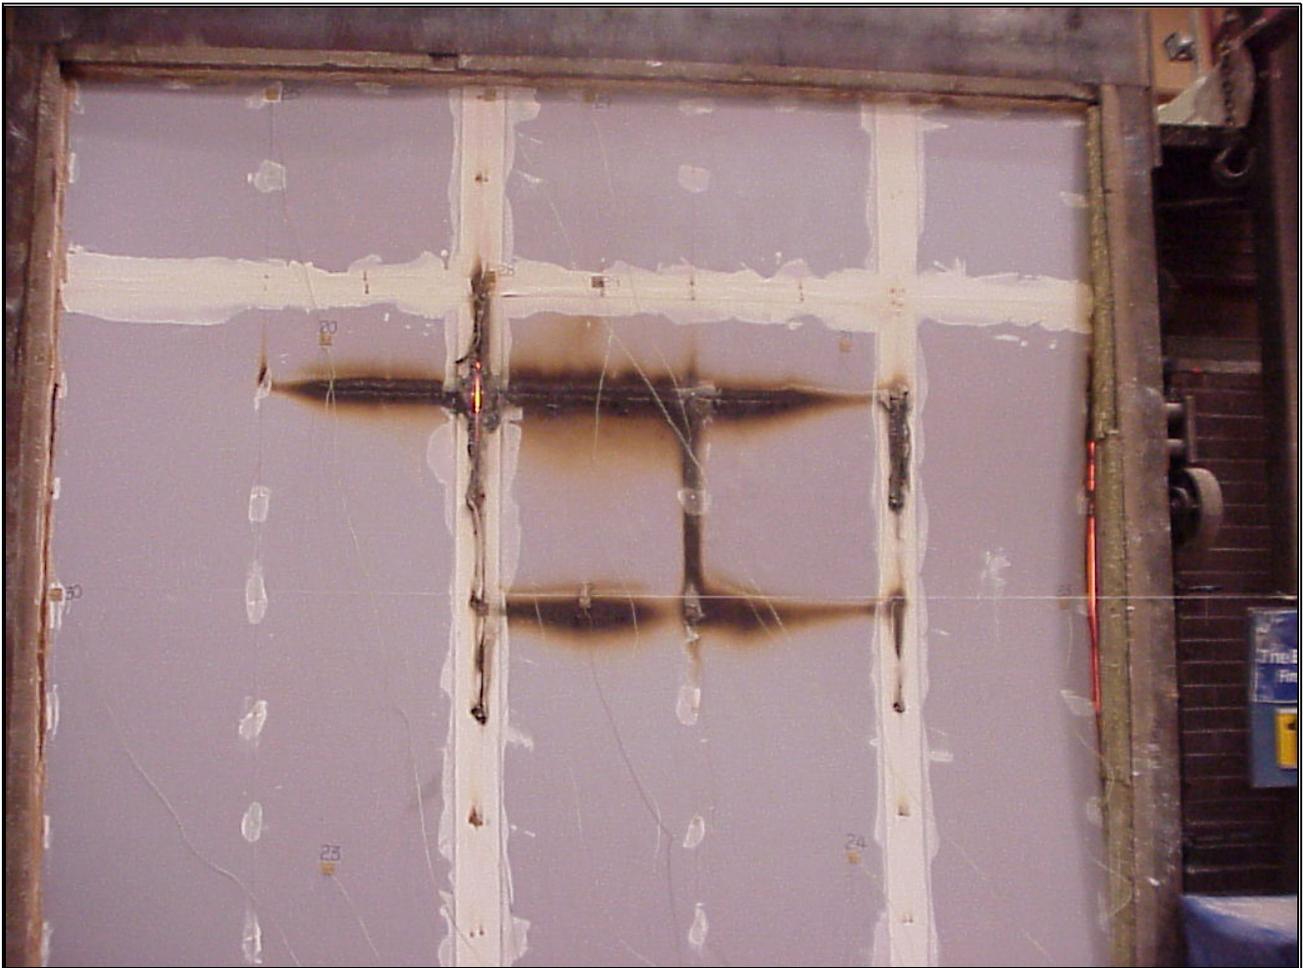
Photograph 4. View of the unexposed face at 114 minutes (after integrity failure).

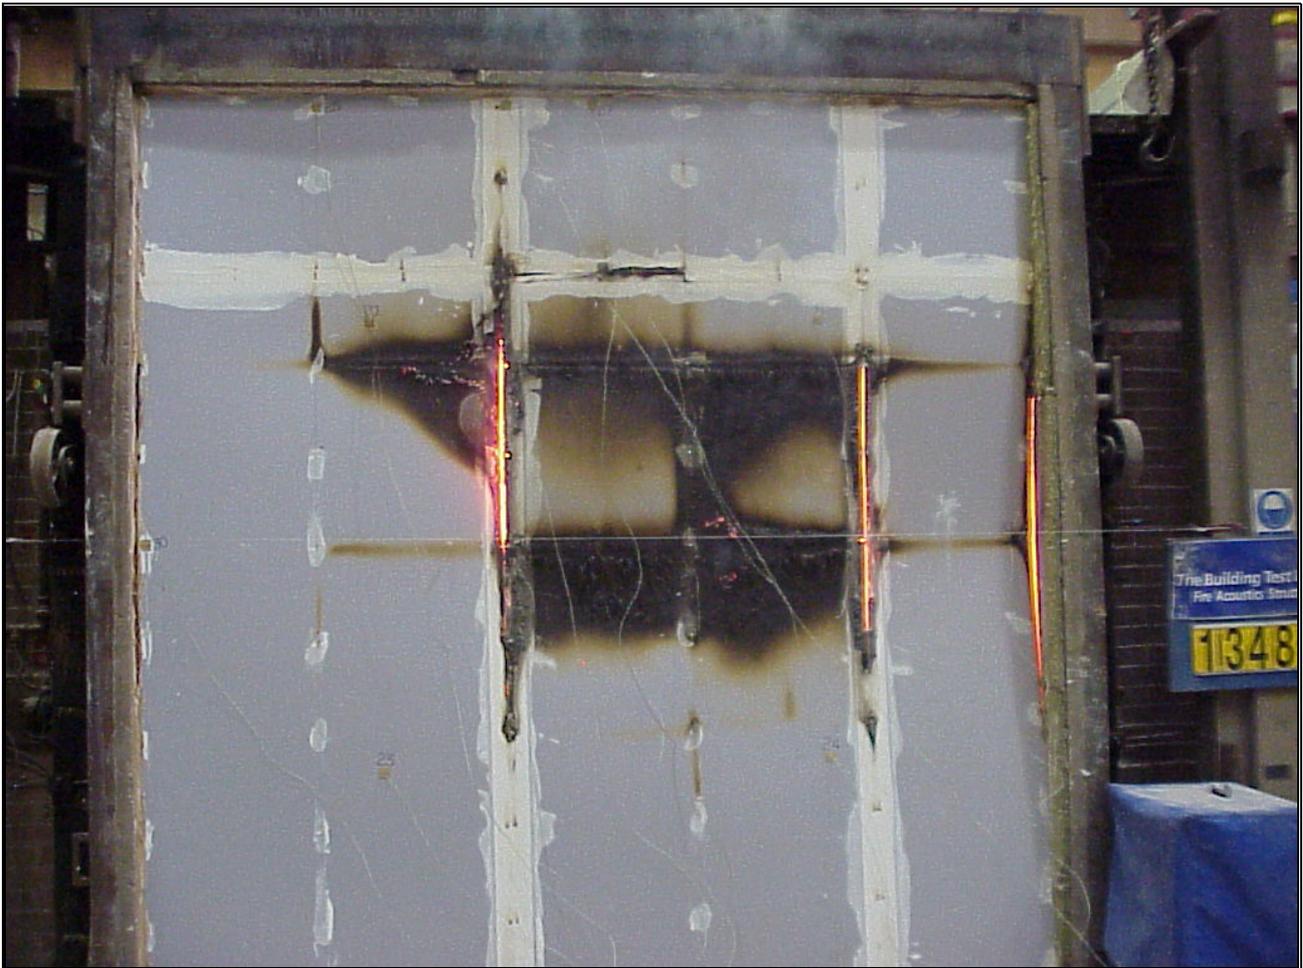
1	58	<i>Unexposed face</i> FURTHER INTEGRITY FAILURE. The 6mm x 150mm gap gauge entered the furnace through the left-hand vertical joint at approximately 1500-2100mm height. FURTHER INTEGRITY FAILURE. The 25mm gap gauge entered the furnace through the left-hand vertical joint at approximately 1800mm height.
1	59	TEST TERMINATED at the request of the customer.

Photograph 5. View of the unexposed face at test termination (119 minutes).
