Report Number BTC 18407F

A FIRE RESISTANCE TEST ON A GYPWALL METAL STUD PARTITION WITH 92MM STUD FRAMEWORK CLAD EACH SIDE WITH A SINGLE LAYER OF 15MM GYPROC SOUNDBLOC F EX KIRKBY THORE AND 100mm ISOVER MODULAR ROLL IN THE CAVITY, CONDUCTED IN ACCORDANCE WITH BS EN 1364-1:1999.

Test Date: 13th August 2013

Customer: British Gypsum
East Leake
Loughborough
Leicestershire
LE12 6HX

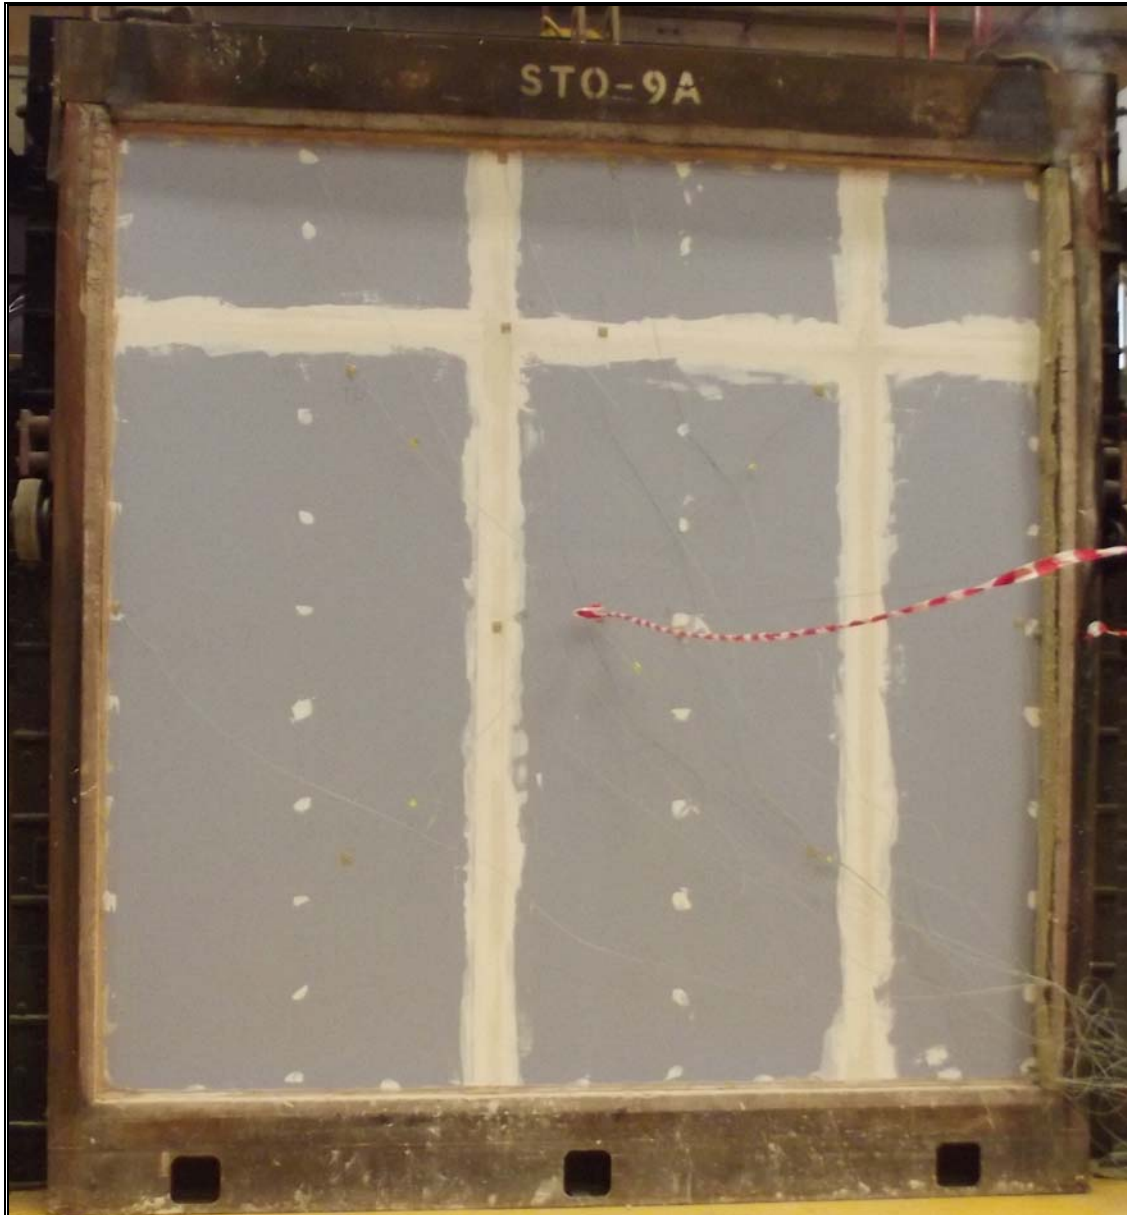
10.3 Unexposed face at 30 minutes

| Time | | Observations |
|---|---|---|
| 0 | 30 | Left-hand vertical joint had opened to approximately 6mm. Right-hand vertical joint had opened to approximately 3mm. Horizontal joint had opened to approximately 4mm. Cracks around screw heads adjacent to horizontal joints. <i>Unexposed face</i> No visible change |

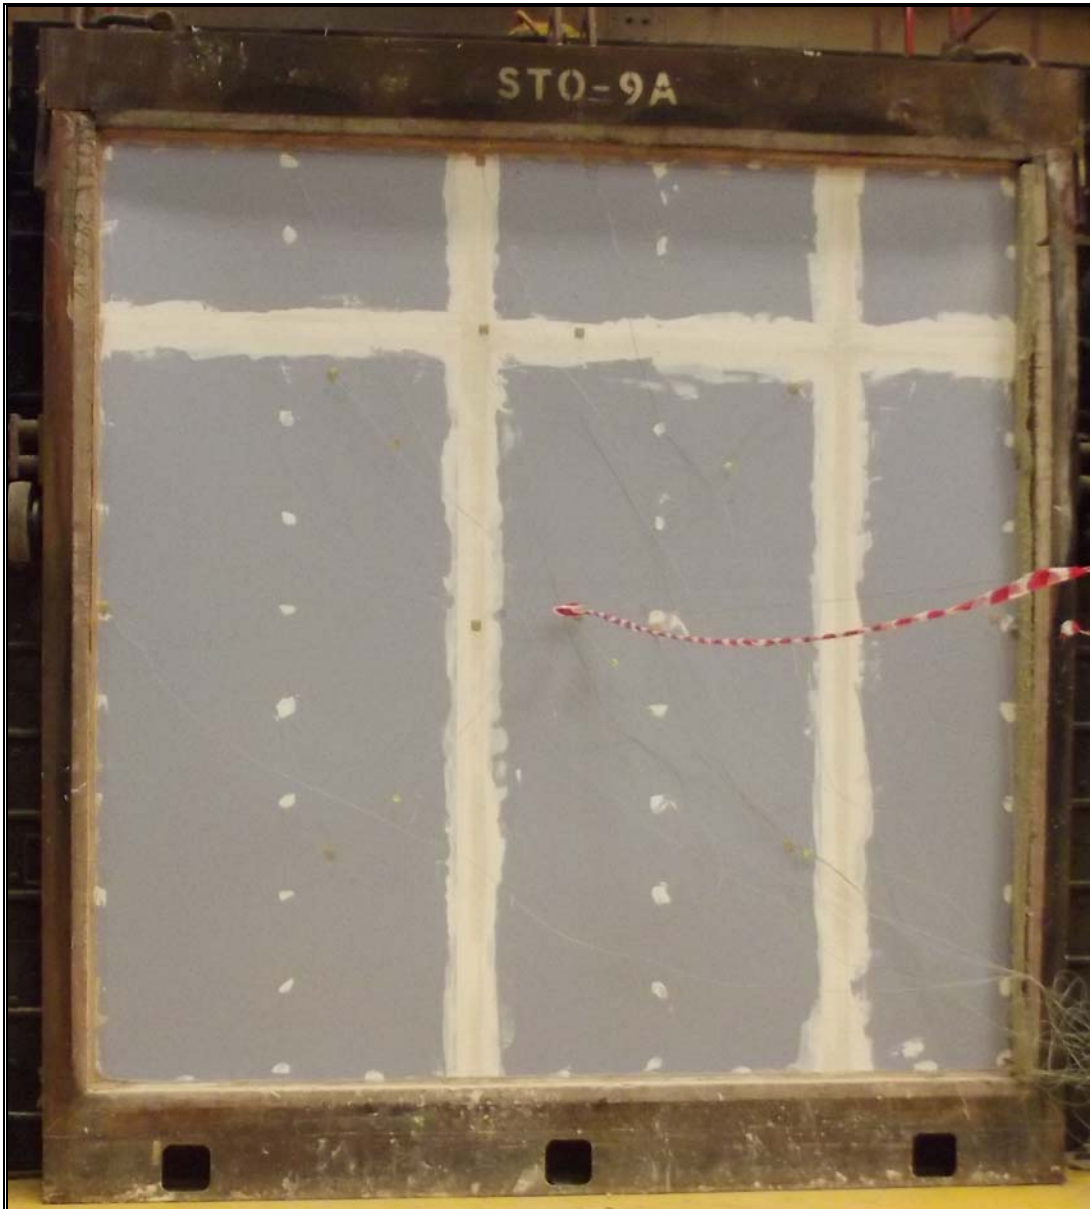
10.4 Unexposed face at 1 hour

| Time | | Observations |
|---|---|--|
| 1 | 00 | <p>Left-hand vertical joint had opened to approximately 25mm. Right-hand vertical joint had opened to approximately 10mm. Horizontal joint had opened to approximately 5-10mm. Vertical crack at mid-span, at top of lower left-hand board approximately 150mm long. Lower left-hand board broken away from screw heads adjacent to left-hand vertical joint.</p> <p><i>Unexposed face</i> No visible change</p> |

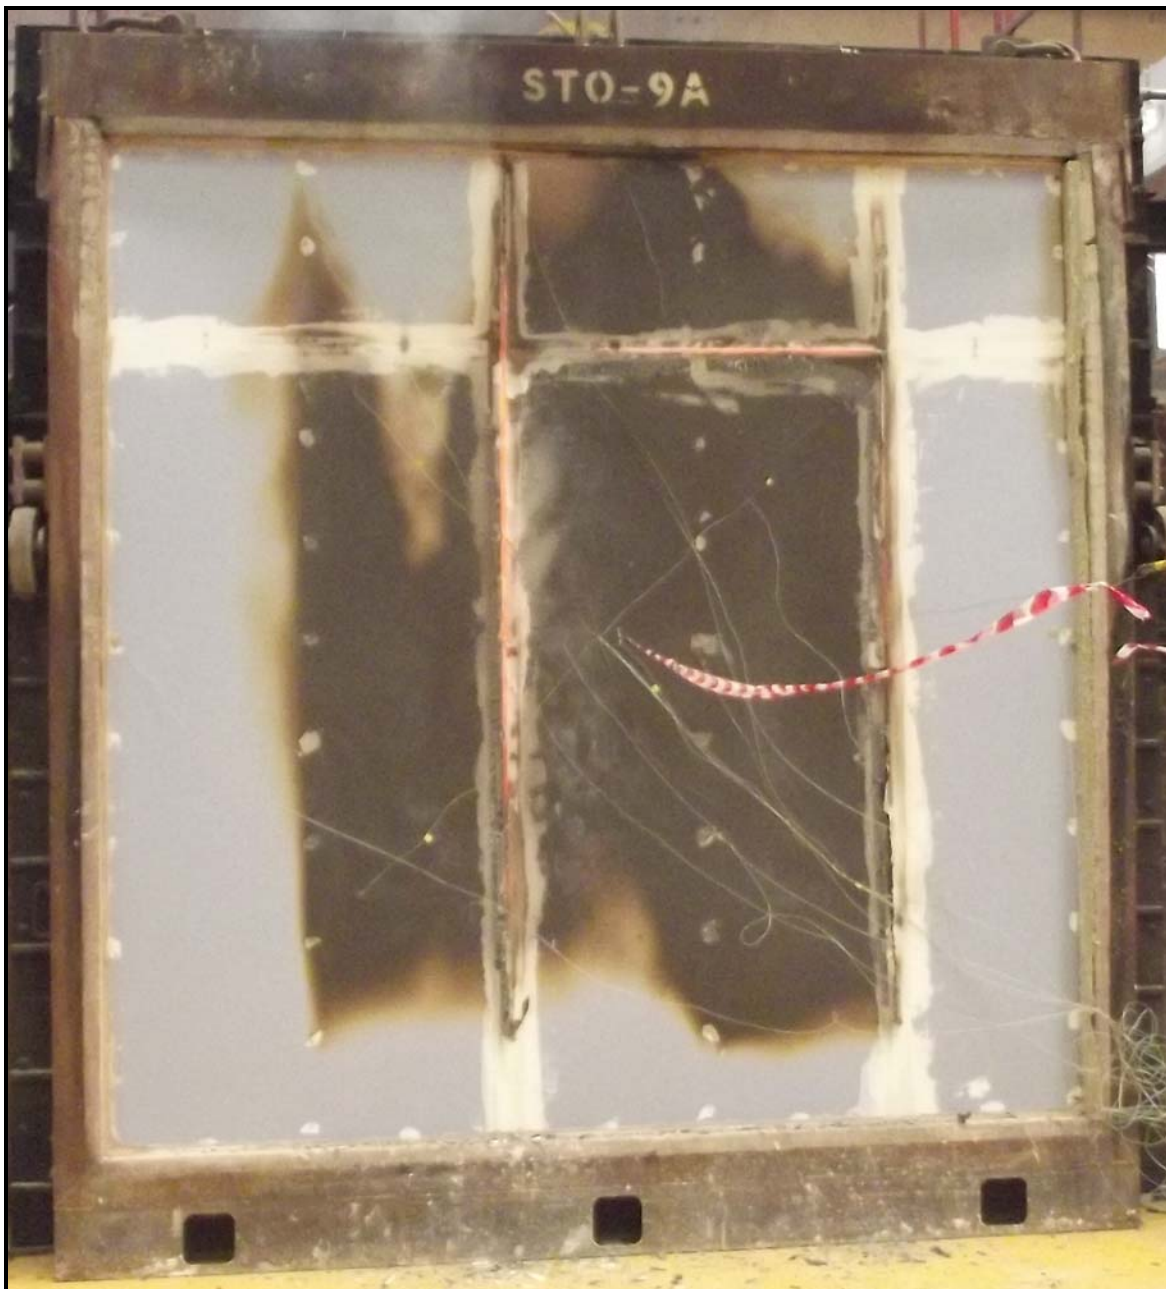
10.5 Unexposed face at 1 hour, 30 minutes at test termination

| Time | | Observations |
|---|---|---|
| 1 | 22 | <p>Lower centre board fell and part of lower left-hand board fell approximately 600mm x 600mm from right-hand corner.</p> <p><i>Unexposed face</i> INTEGRITY FAILURE. The cotton pad ignited (flamed) when placed on the right hand left hand vertical joint at approximately 2100mm height.</p> |
| 1 | 23 | <p><i>Unexposed face</i> FURTHER INTEGRITY FAILURE. The gap at approximately 1500mm height on the left hand vertical joint exceeded 6mm x 150mm (6mm gap gauge).</p> |
| 1 | 28 | <p><i>Unexposed face</i> FURTHER INTEGRITY FAILURE. The gap at approximately 1500mm height on the left hand vertical joint exceeded 25mm diameter (25mm gap gauge).</p> |
| 1 | 30 | TEST TERMINATED at the request of the sponsor. |
