Report Number BTC 13488F

A FIRE RESISTANCE TEST ON A 5m (HIGH) x 3m (WIDE) BRITISH GYPSUM GYPWALL STAGGERED PARTITION CLAD WITH A DOUBLE LAYER OF 15mm GYPROC SOUNDBLOC EACH SIDE OF GYPFRAME 60I70 STUDS AND 50mm ISOWOOL 1200 IN THE CAVITY, CONDUCTED IN ACCORDANCE WITH BS EN 1364-1: 1999.

Test Date: 24th September 2004

Customer: British Gypsum Limited
East Leake
Loughborough
Leicestershire
LE12 6HX

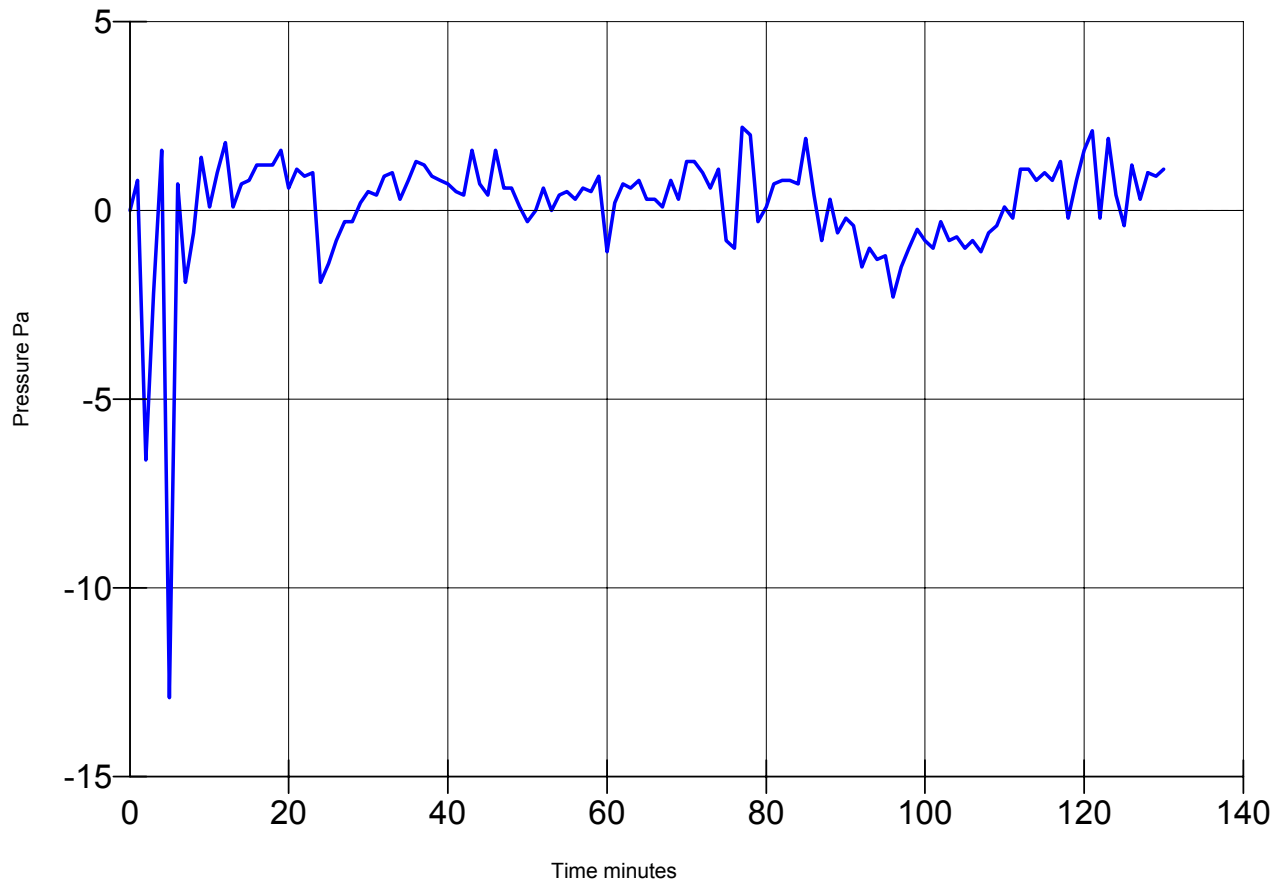
Figure 3. Furnace pressure graph.

The pressure was outside of the allowable tolerance at 96 minutes.

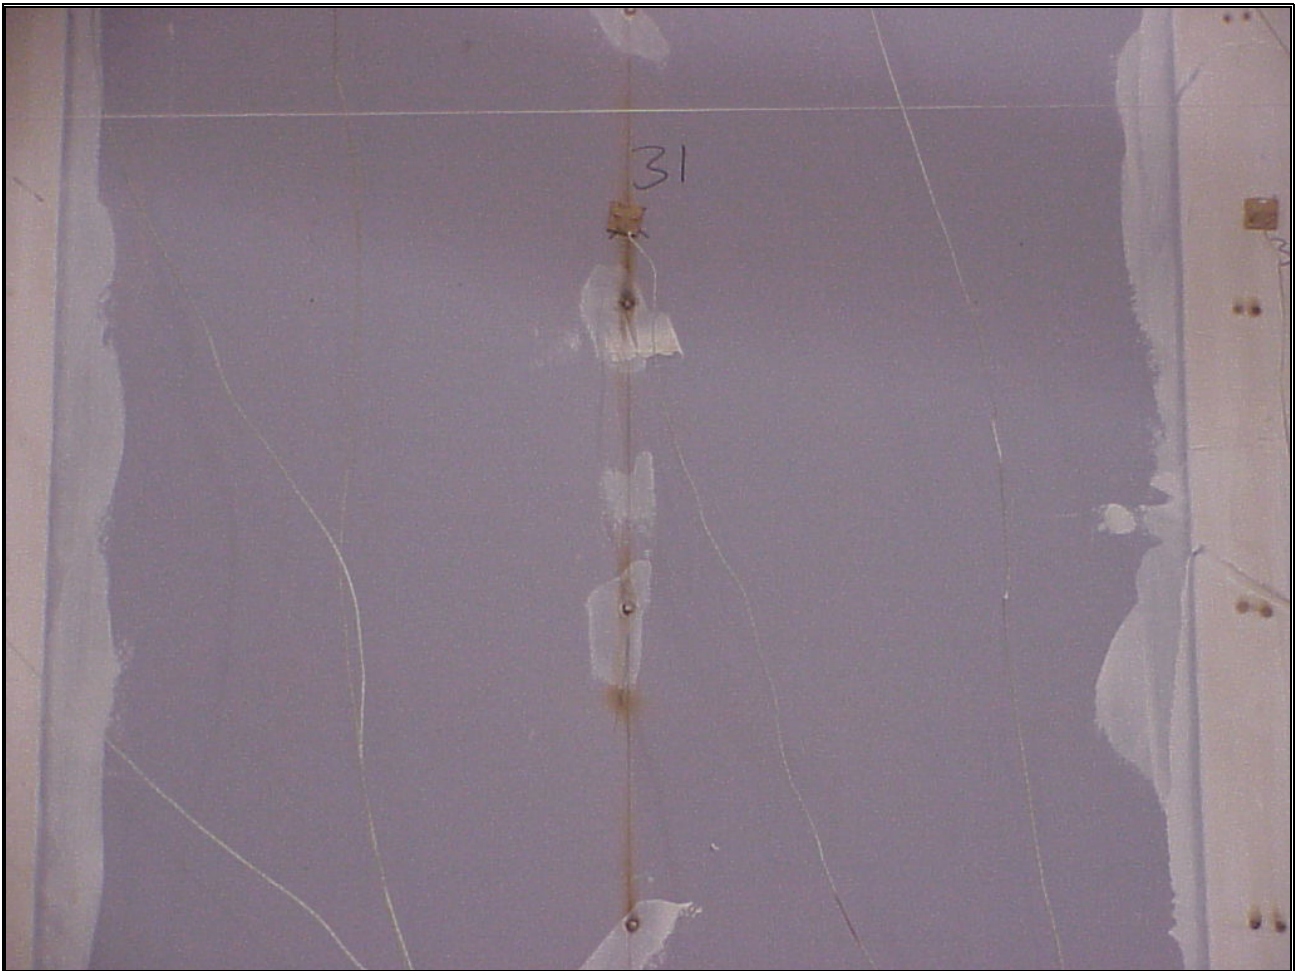
Integrity:	Sustained flaming	130 minutes (no failure test discontinued at the request of the customer)
	Cotton pad	130 minutes (no failure test discontinued at the request of the customer)
	25mm Gap gauge	120 minutes
	6mm Gap gauge	118 minutes
Insulation:		105 minutes

1	57	<i>Unexposed face</i> Discolouration had developed on the centre line of the lower left-hand full board at approximately 1200-3000mm height. Discolouration had developed on the centre line of the lower right-hand full board at approximately 1200-3000mm height. Discolouration had developed on the left-hand vertical joint at approximately 2100-2400mm height. Discolouration had developed on the centre vertical joint at approximately 1800-2400mm height. A glow was visible on the centre line of the lower left-hand full board at approximately 2000mm height. A cotton pad was used on the above location but did not glow or ignite.

Photograph 3. Position of insulation failure at 105 minutes.

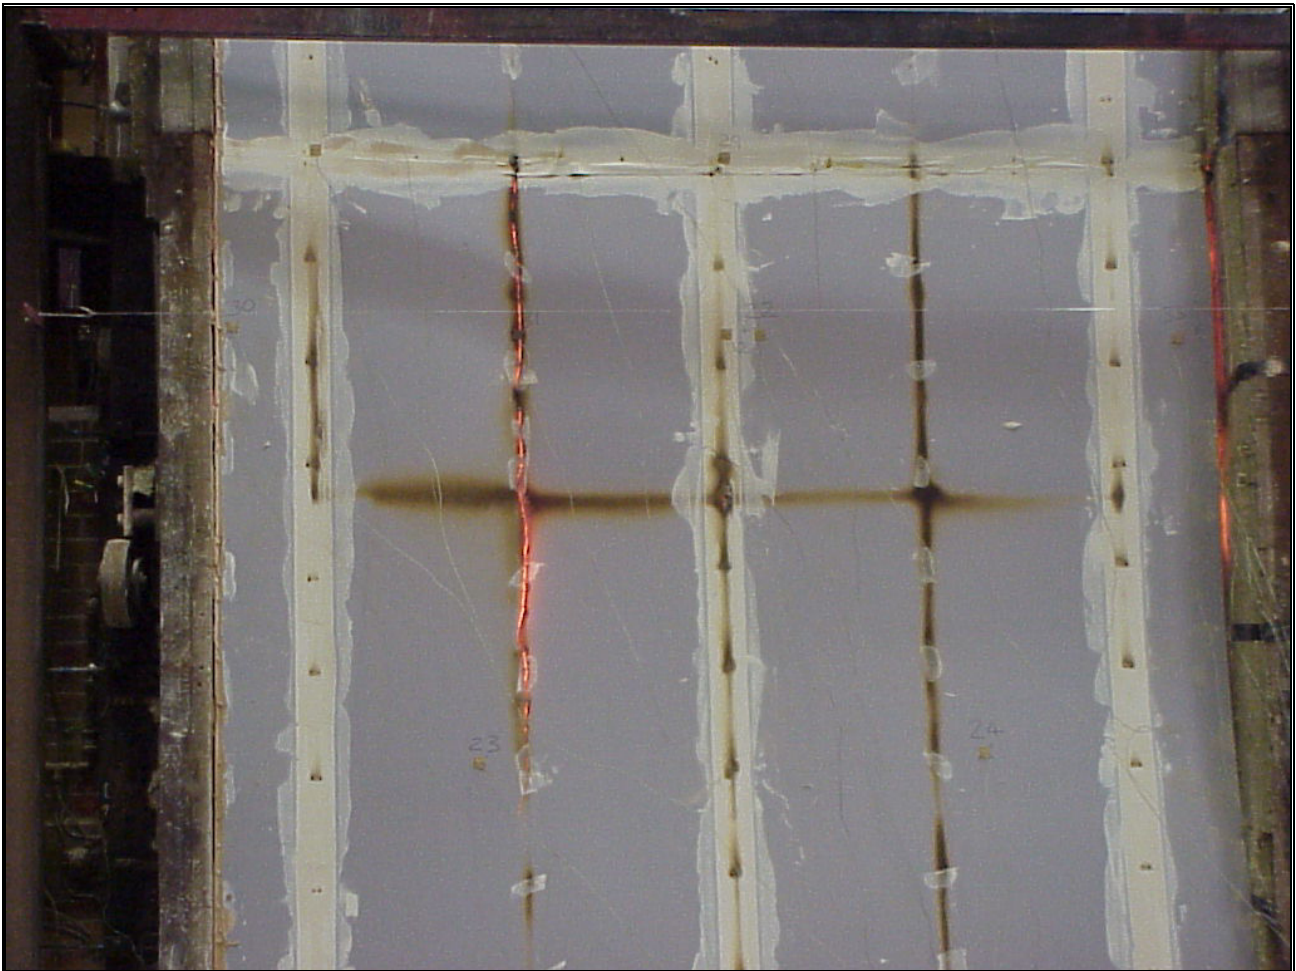
Time		Observations
hrs	mins	
		All observations refer to exposed face unless otherwise stated.
1	58	<i>Unexposed face</i> INTEGRITY FAILURE. The 6mm x 150mm gap gauge entered the furnace through a crack along the centre line of the lower left-hand full board at approximately 1800-2100mm height.
2	00	Visibility inside the furnace was poor. <i>Unexposed face</i> FURTHER INTEGRITY FAILURE. The 25mm gap gauge entered the furnace through a crack along the centre line of the lower left-hand full board at approximately 2000mm height. Discolouration had developed on the field of the lower left-hand full board.
2	05	<i>Unexposed face</i> Discolouration had developed on the centre line of the lower left-hand full board at approximately 600-3300mm height. Discolouration had developed on the centre line of the lower right-hand full board at approximately 600-3000mm height. Discolouration had developed on the left-hand vertical joint at approximately 2100-2700mm height. Discolouration had developed on the centre vertical joint at approximately 600-3000mm height. Discolouration had developed on the right-hand vertical joint at approximately 900-3000mm height. Discolouration had developed on the field of the lower right-hand full board. A glow was visible along the centre line of the lower left-hand full board at approximately 1500-2100mm height A glow was visible on the centre vertical joint at approximately 1800-2100mm height.

Photograph 4. Position of integrity failure at 118 minutes.

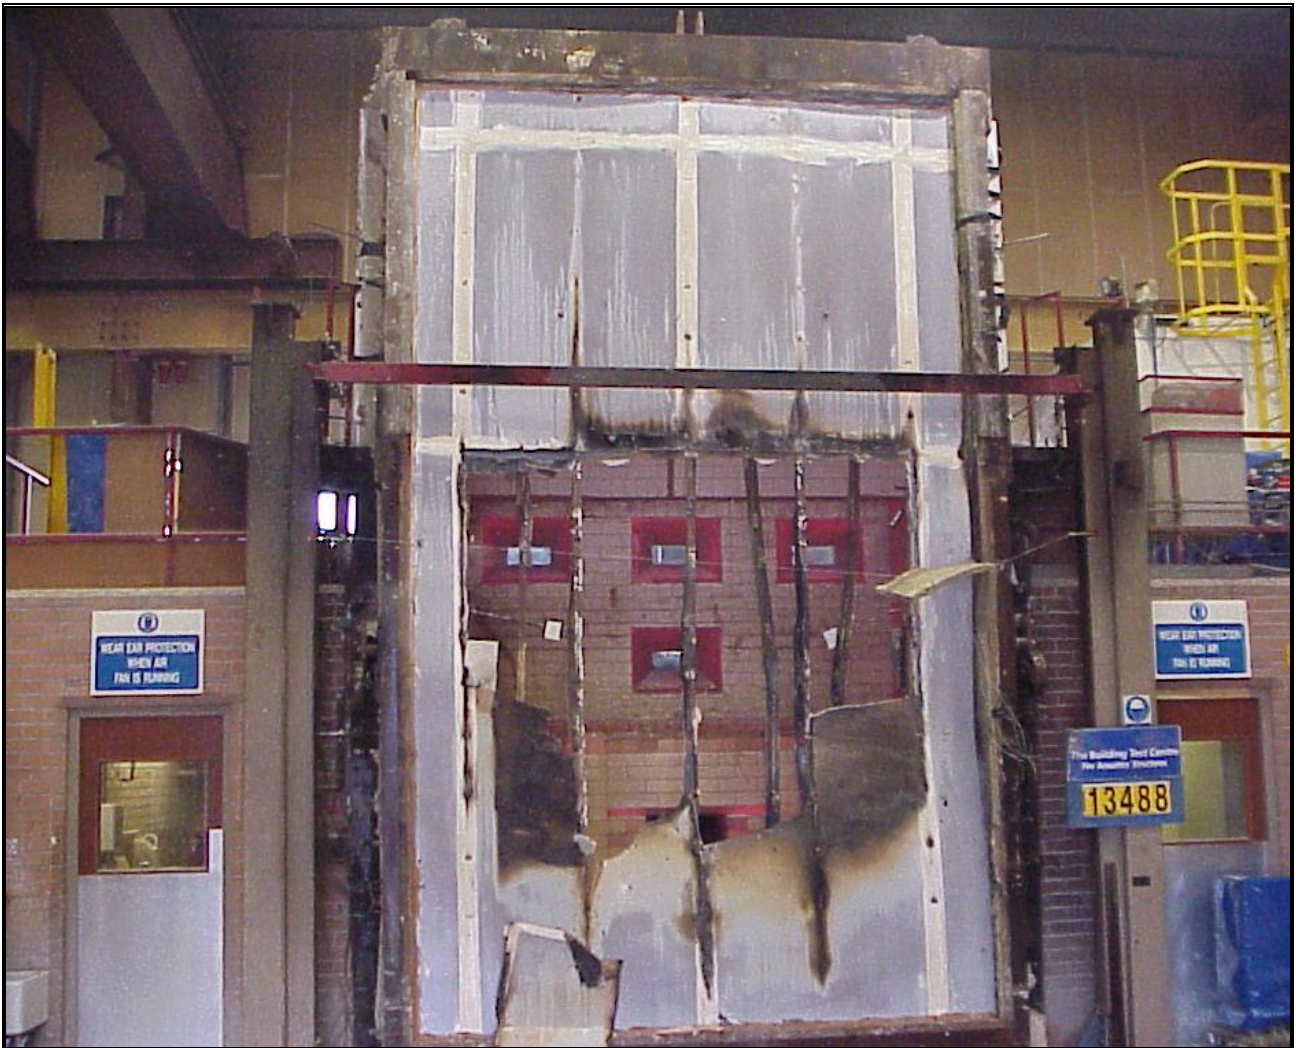
Time		<i>Observations</i>
hrs	mins	
		All observations refer to exposed face unless otherwise stated.
2	10	<p><i>Unexposed face</i> Sections of the lower left-hand and right-hand full boards collapsed and fell out of the furnace.</p> <p>TEST TERMINATED at the request of the customer.</p>

Photograph 5. View of the unexposed face at test termination (130 minutes).
