## **Report Number BTC 12728F**

A FIRE RESISTANCE TEST ON A BRITISH GYPSUM GYPWALL PARTITION CLAD WITH A SINGLE LAYER OF 15mm GYPROC FIRELINE BOARD EACH SIDE OF GYPFRAME 70S50 STUDS, CONDUCTED IN ACCORDANCE WITH BS EN 1364-1: 1999.

Test Date: 19<sup>th</sup> May 2003

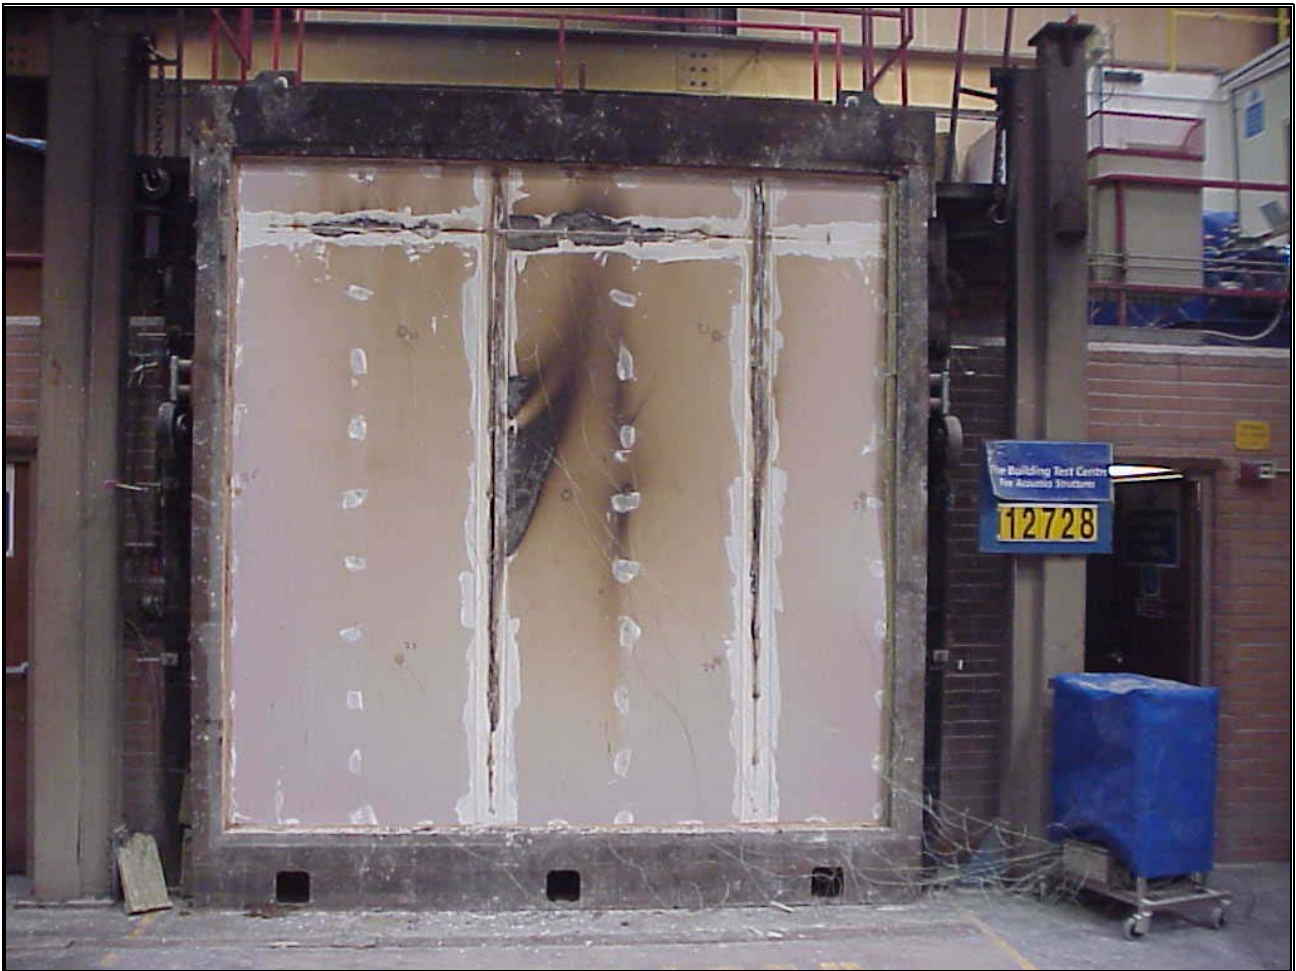
Time		Observations
hrs	mins	
		All observations refer to exposed face unless otherwise stated.
1	04	<i>Unexposed face</i> <b>INSULATION FAILURE.</b> The temperature rise of thermocouple numbers 28, 29 and 32 exceeded 180°C. In addition the average temperature rise of the standard five thermocouples exceeded 140°C.
1	05	No visible change to the specimen.  <i>Unexposed face</i> A crack had developed on the horizontal joint adjacent to the top left-hand corner of the lower centre board.
1	10	The lower centre board was bowing into the partition cavity adjacent to the left-hand vertical joint.
1	11	<i>Unexposed face</i> <b>INTEGRITY FAILURE.</b> The cotton pad ignited when used on the left-hand vertical joint at approximately 1500mm height.
1	15	No visible change to the specimen.  <b>TEST TERMINATED</b> at the request of the customer.

**Photograph 3.** View of the unexposed face at 74 minutes.

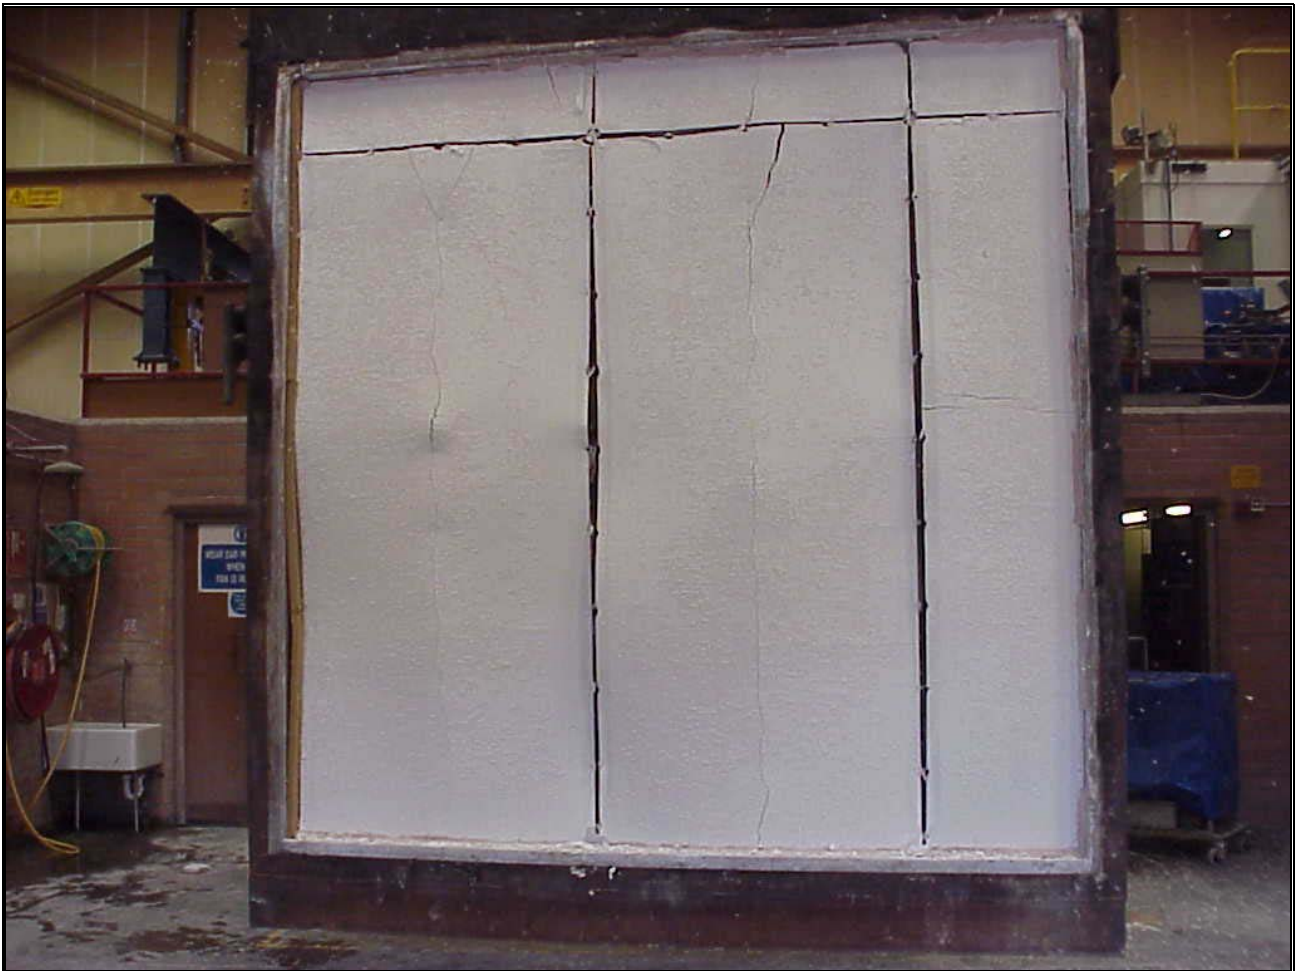
**Photograph 4.** View of the exposed face after test termination.
