Report Number BTC 13482F

A FIRE RESISTANCE TEST ON A BRITISH GYPSUM GYPWALL QUIET SF PARTITION CLAD WITH A DOUBLE LAYER OF 12.5mm GYPROC SOUNDBLOC EACH SIDE OF GYPFRAME 70S50 STUDS WITH GYPFRAME RB1 RESILIENT BAR ON THE EXPOSED FACE, CONDUCTED IN ACCORDANCE WITH BS EN 1364-1: 1999.

Test Date: 2nd September 2004

Customer: British Gypsum Limited
East Leake
Loughborough
Leicestershire
LE12 6HX

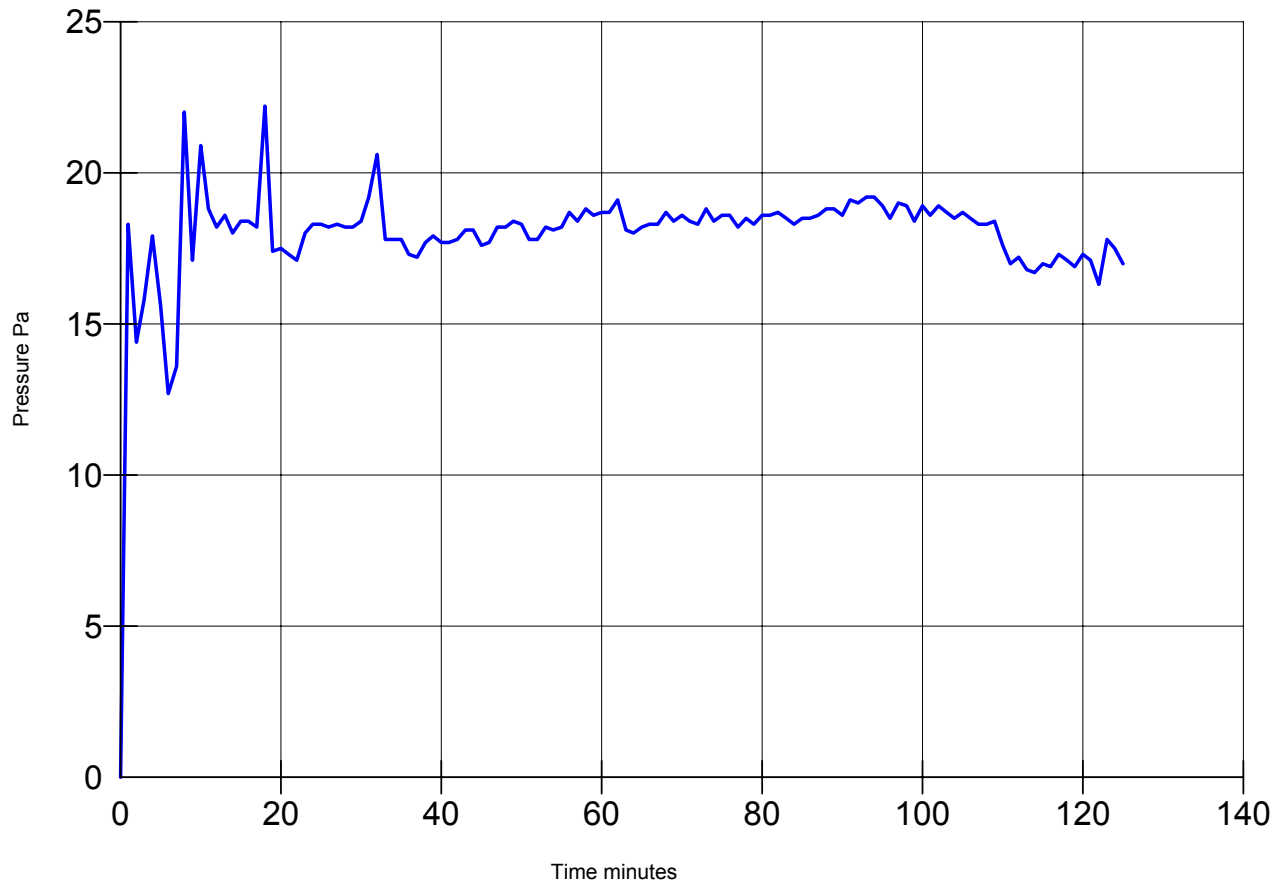
Figure 3. Furnace pressure graph.

The furnace pressure was outside of the allowable tolerance at 6-8, 10, 18 and 32 minutes.

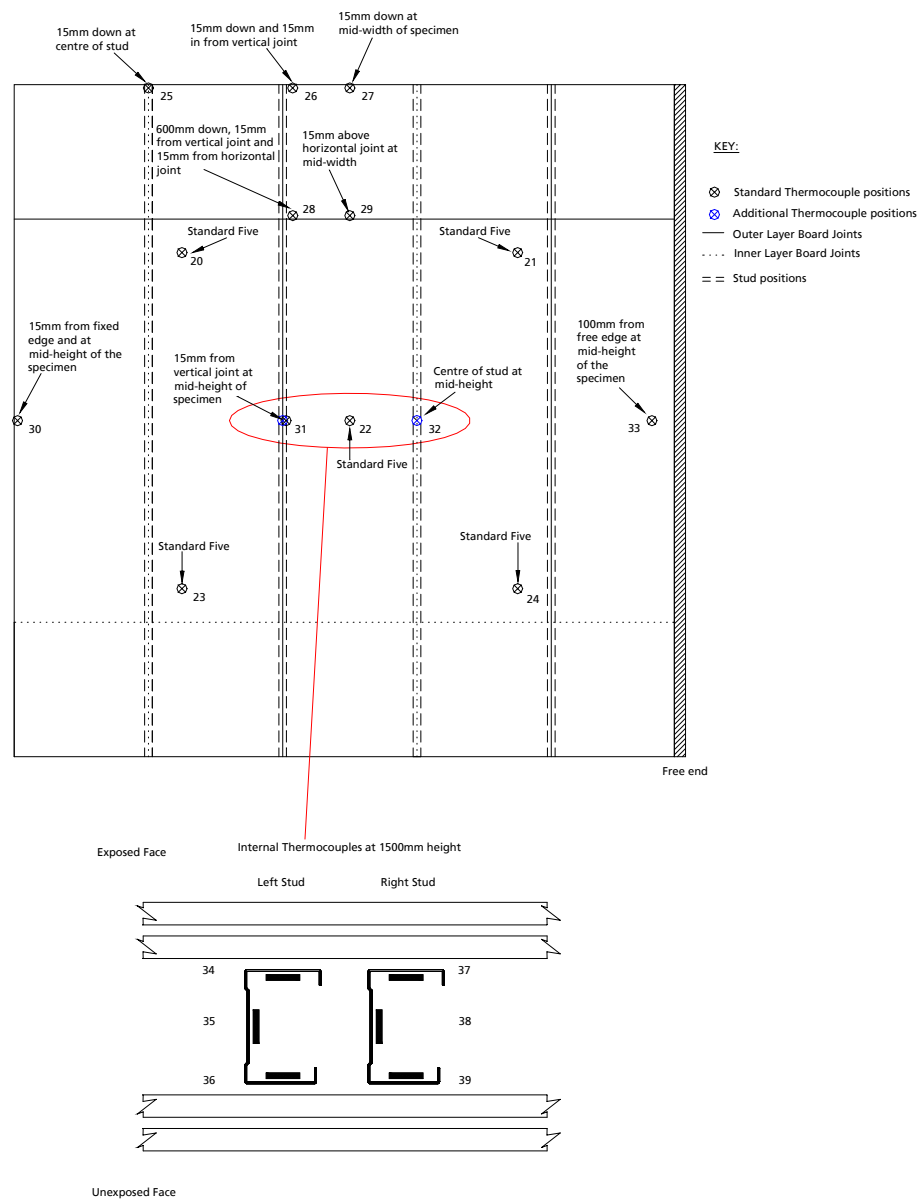
Figure 5. Unexposed face thermocouple layout.

Figures shown in red indicate the time and position of insulation failure.

Thermocouple No. 31 was located on a screw head therefore is discounted from the failure criteria.

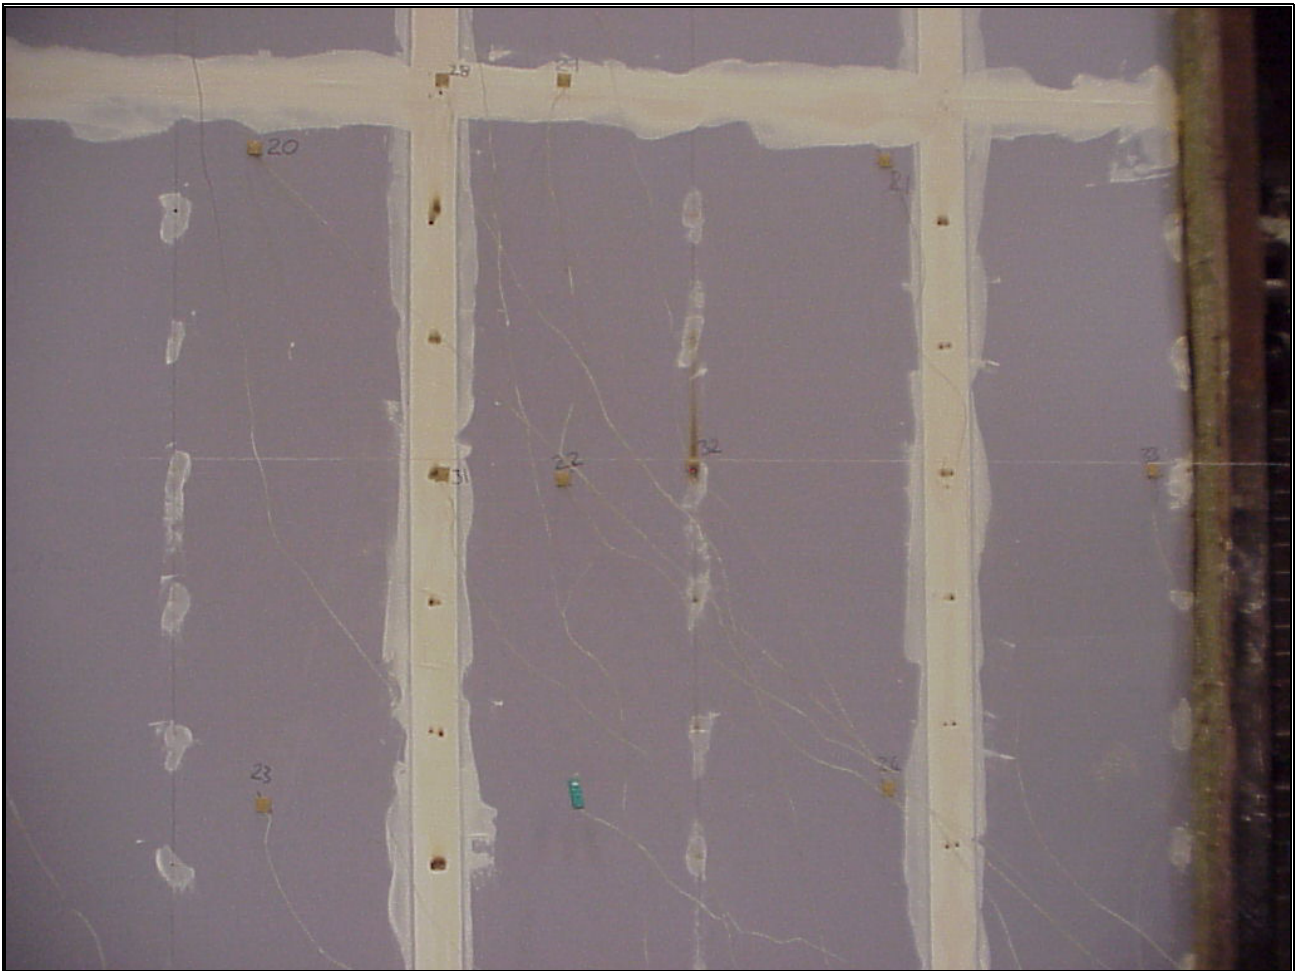
Integrity:	Sustained flaming	125 minutes (no failure test discontinued at the request of the customer)
	25mm Gap gauge	125 minutes (no failure test discontinued at the request of the customer)
	6mm Gap gauge	124 minutes
	Cotton pad	120 minutes
Insulation:		96 minutes

Photograph 3. View of the unexposed face at 96 minutes (after insulation failure).

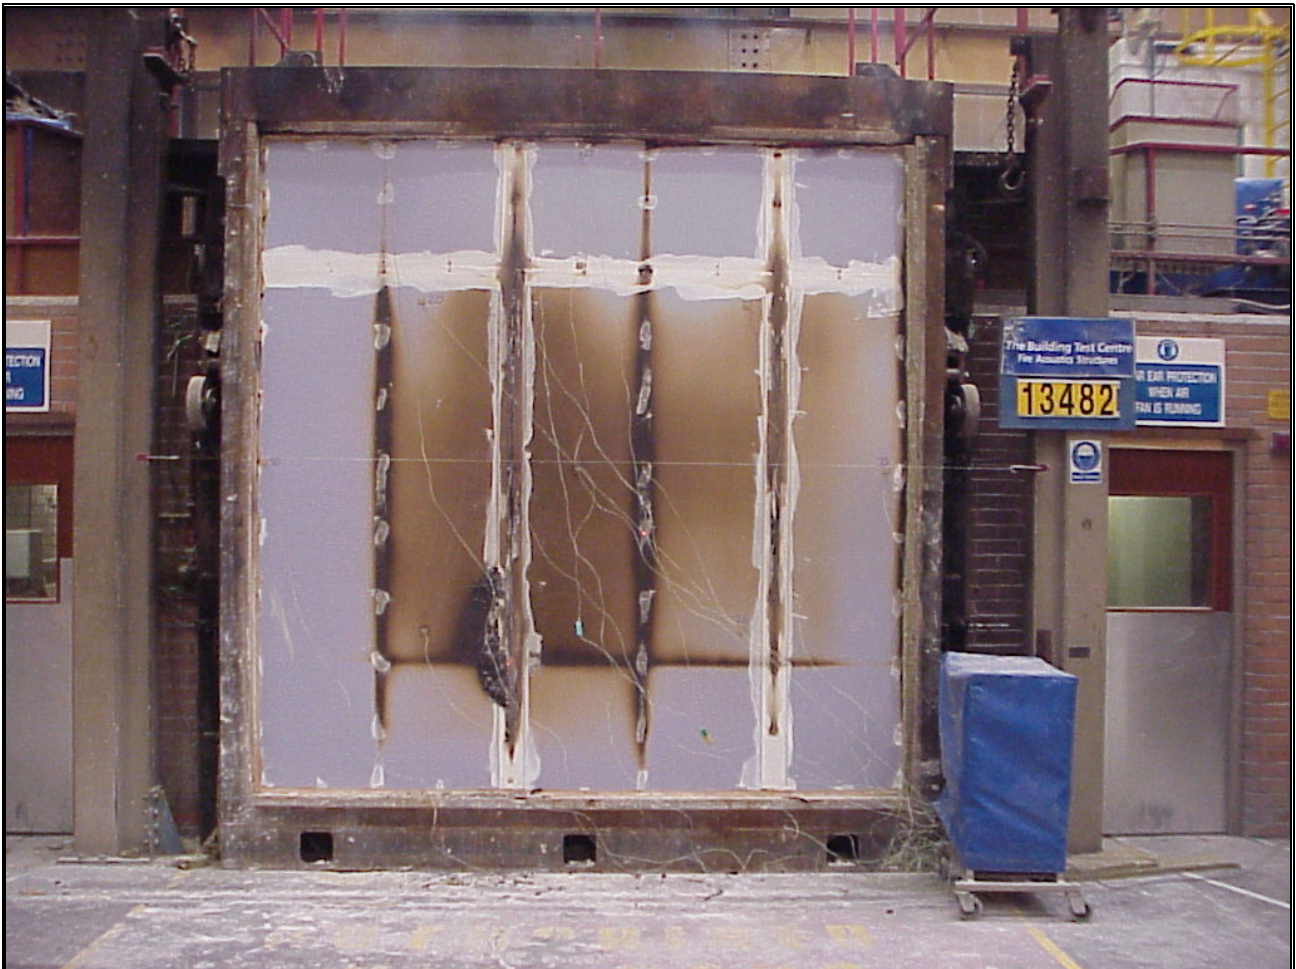
Time		Observations
hrs	mins	
		All observations refer to exposed face unless otherwise stated.
2	00	<i>Unexposed face</i> INTEGRITY FAILURE. The cotton pad glowed when used at the head approximately 1200mm from the free end of the specimen.
2	04	<i>Unexposed face</i> FURTHER INTEGRITY FAILURE. The 6mm x 150mm gap gauge entered the furnace through the head approximately 600mm from the free end of the specimen.
2	05	TEST TERMINATED at the request of the customer.

Photograph 4. View of the unexposed face at 120 minutes (after integrity failure).

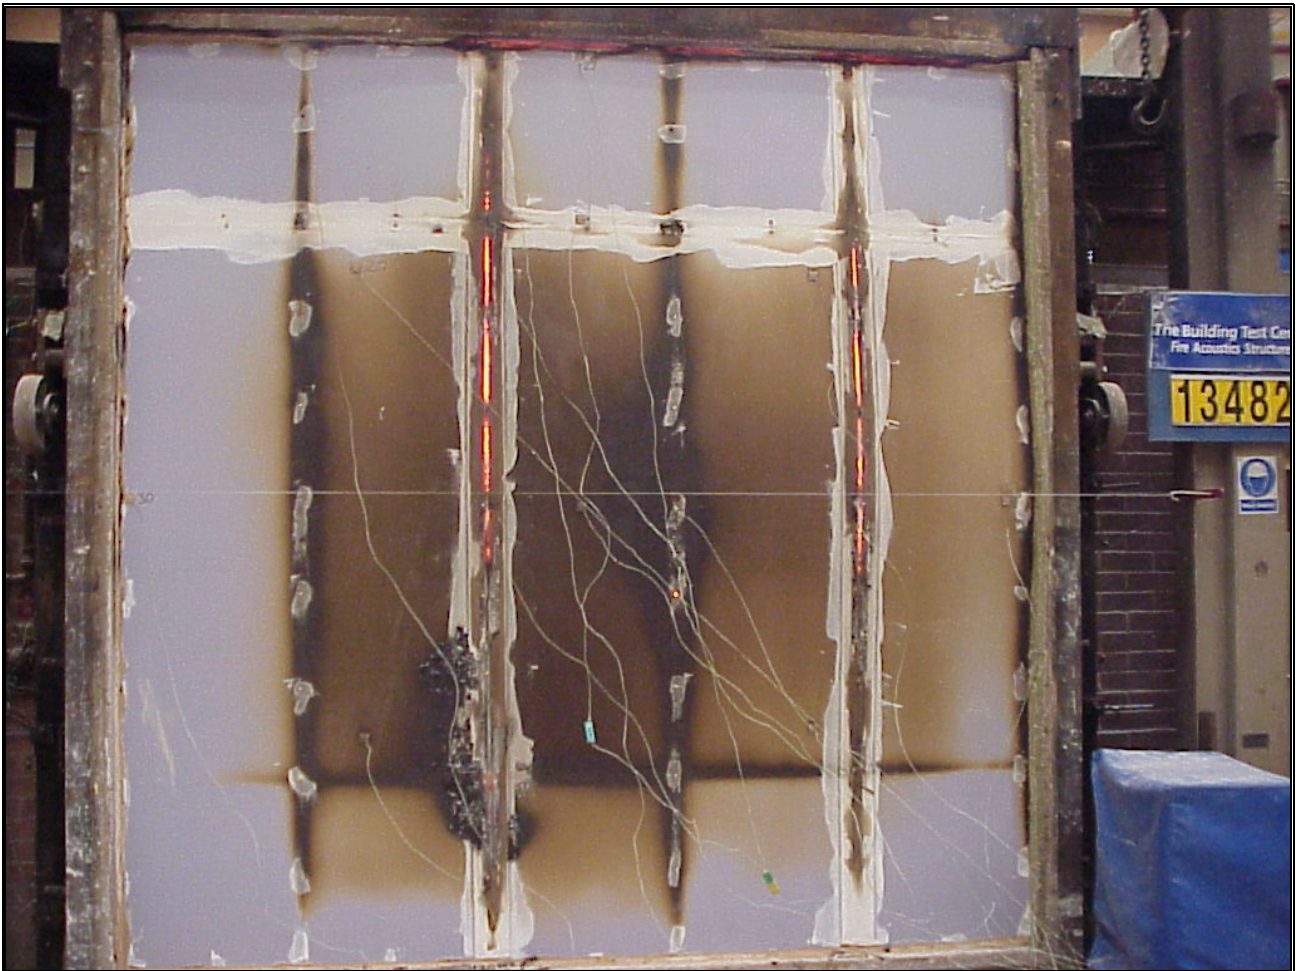
The test was terminated at 125 minutes at the request of the customer.

Photograph 5. View of the unexposed face at test termination (125 minutes).
