Report Number: **BTC 21558F**

A FIRE RESISTANCE TEST ON A GYPWALL STAGGERED METAL STUD PARTITION WITH 60 MM GYPFRAME I STUD FRAMEWORK CLAD EACH SIDE WITH A DOUBLE LAYER OF 12.5 MM GYPROC SOUNDBLOC AND 25 MM ISOVER ACOUSTIC PARTITION ROLL IN THE CAVITY, CONDUCTED IN ACCORDANCE WITH BS EN 1364-1: 2015.

Test Date: 3<sup>rd</sup> November 2020

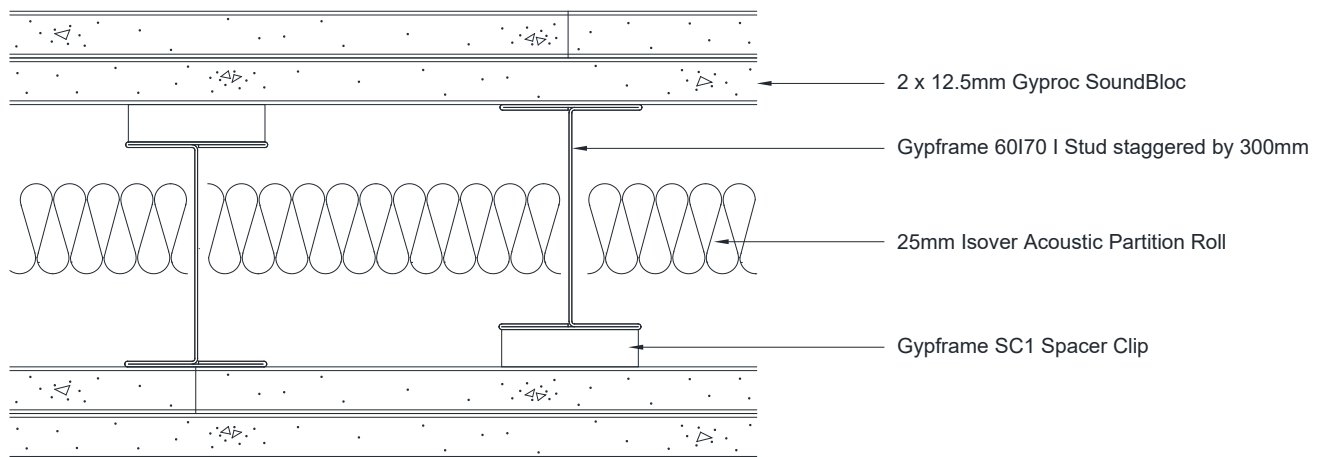
**Figure 1** – Cross sectional view through the test specimen.

Gypframe 60I70 I Studs were positioned at 300 mm staggered centres between the head and base channels. Gypframe SC1 Spacer Clips were used at the head and base of the studs to stagger the studs either side of the centre line of the channels.

The right hand stud viewed from the unexposed face was not fixed to the perimeter of the test frame, and the gap between the stud and the frame lining was filled with a 25 mm thick rock mineral fibre gasket.

At the left-hand edge, a Gypframe 70S50 'C' Stud was fixed the partition to the test frame, using 60 mm fire resistance fixings at 600 mm centres.

A layer of 25 mm Isover Acoustic Partition Roll (APR 1200) was positioned the in the stud cavity.

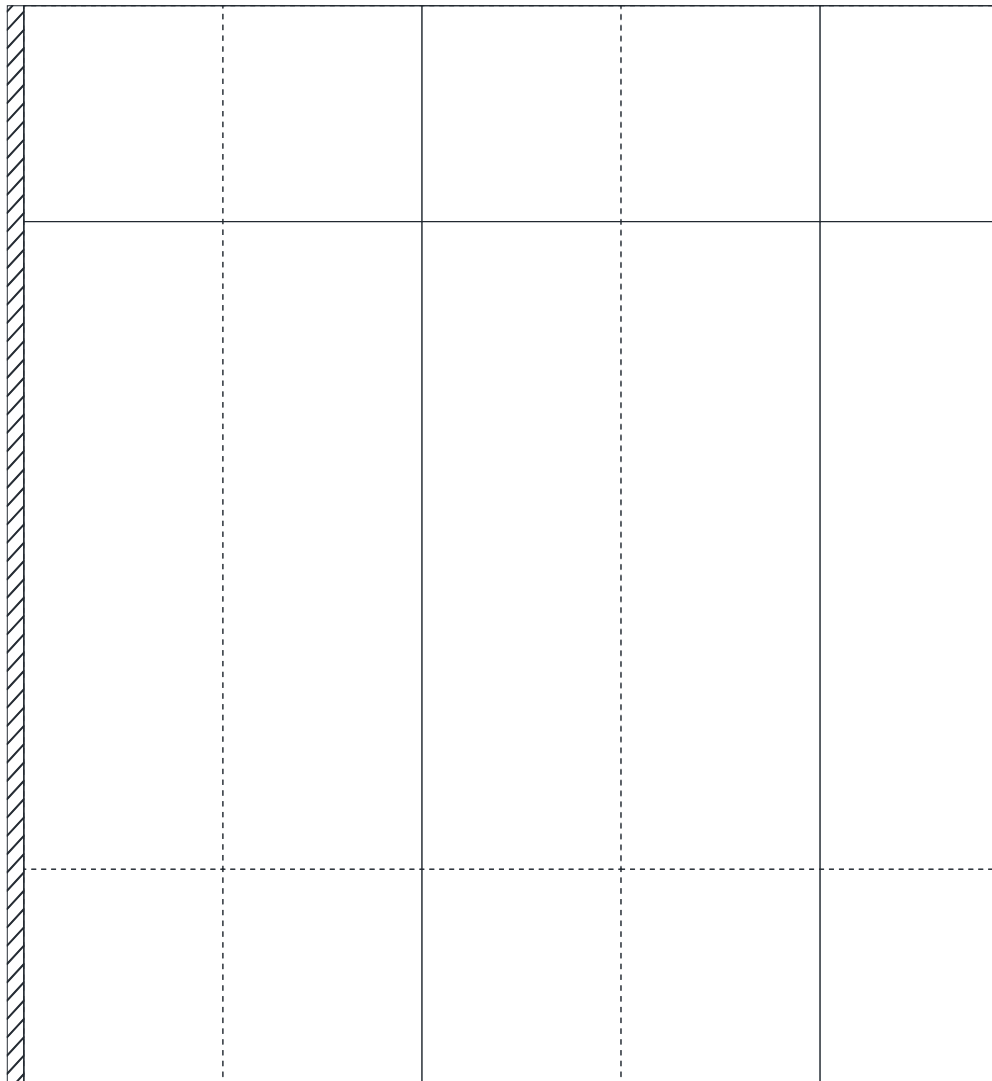
----- Inner layer board layout

————— Outer layer board layout

**Figure 2** – Exposed face elevation.

All vertical joints were staggered between layers, with a full board at the free end of the exposed face. A horizontal joint was positioned at 2400 mm from the base on the outer layer boards and at 600 mm from the base on the inner layer boards, on both faces of the specimen. A Gypframe GFS1 Fixing Strap was used behind the horizontal outer layer board joint.

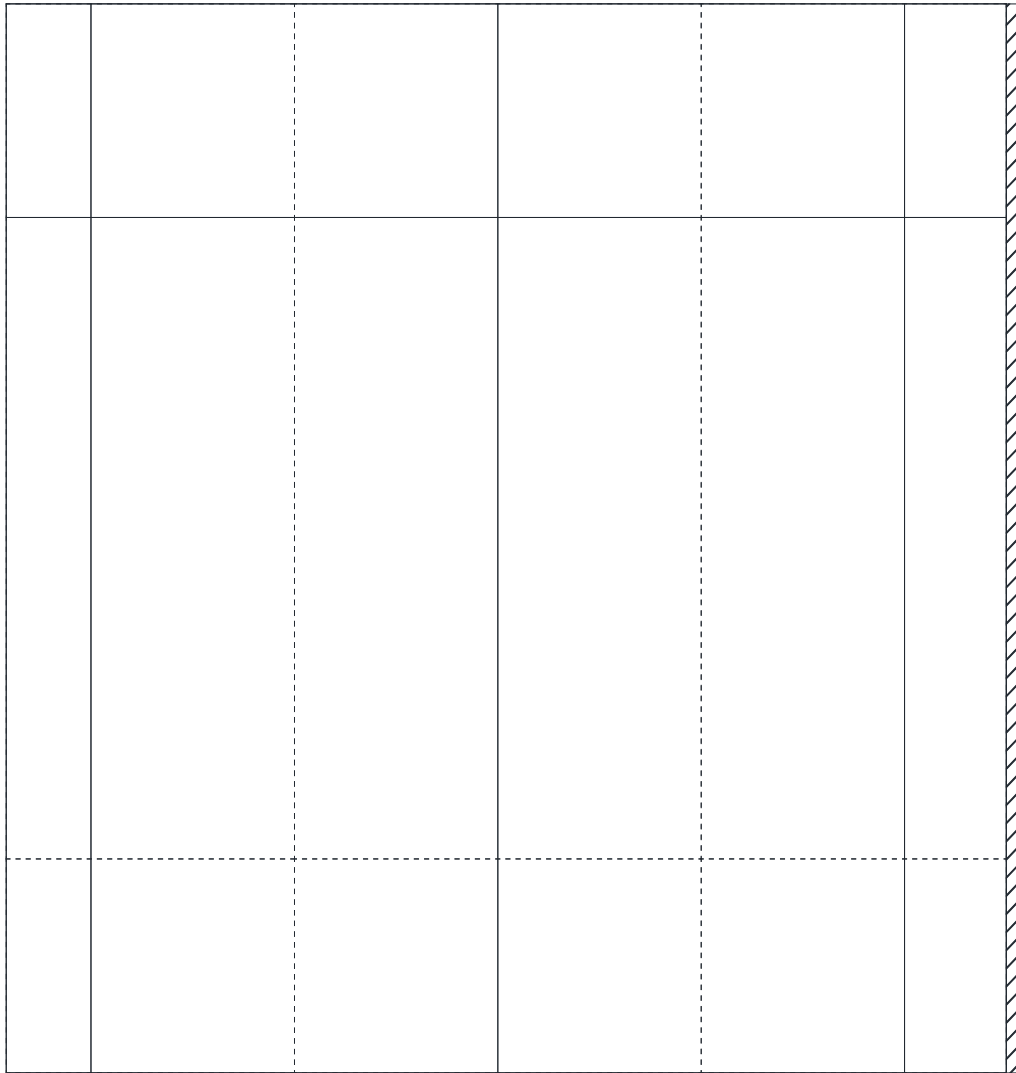
- Inner layer board layout
- Outer layer board layout

**Figure 3** – Unexposed face elevation.

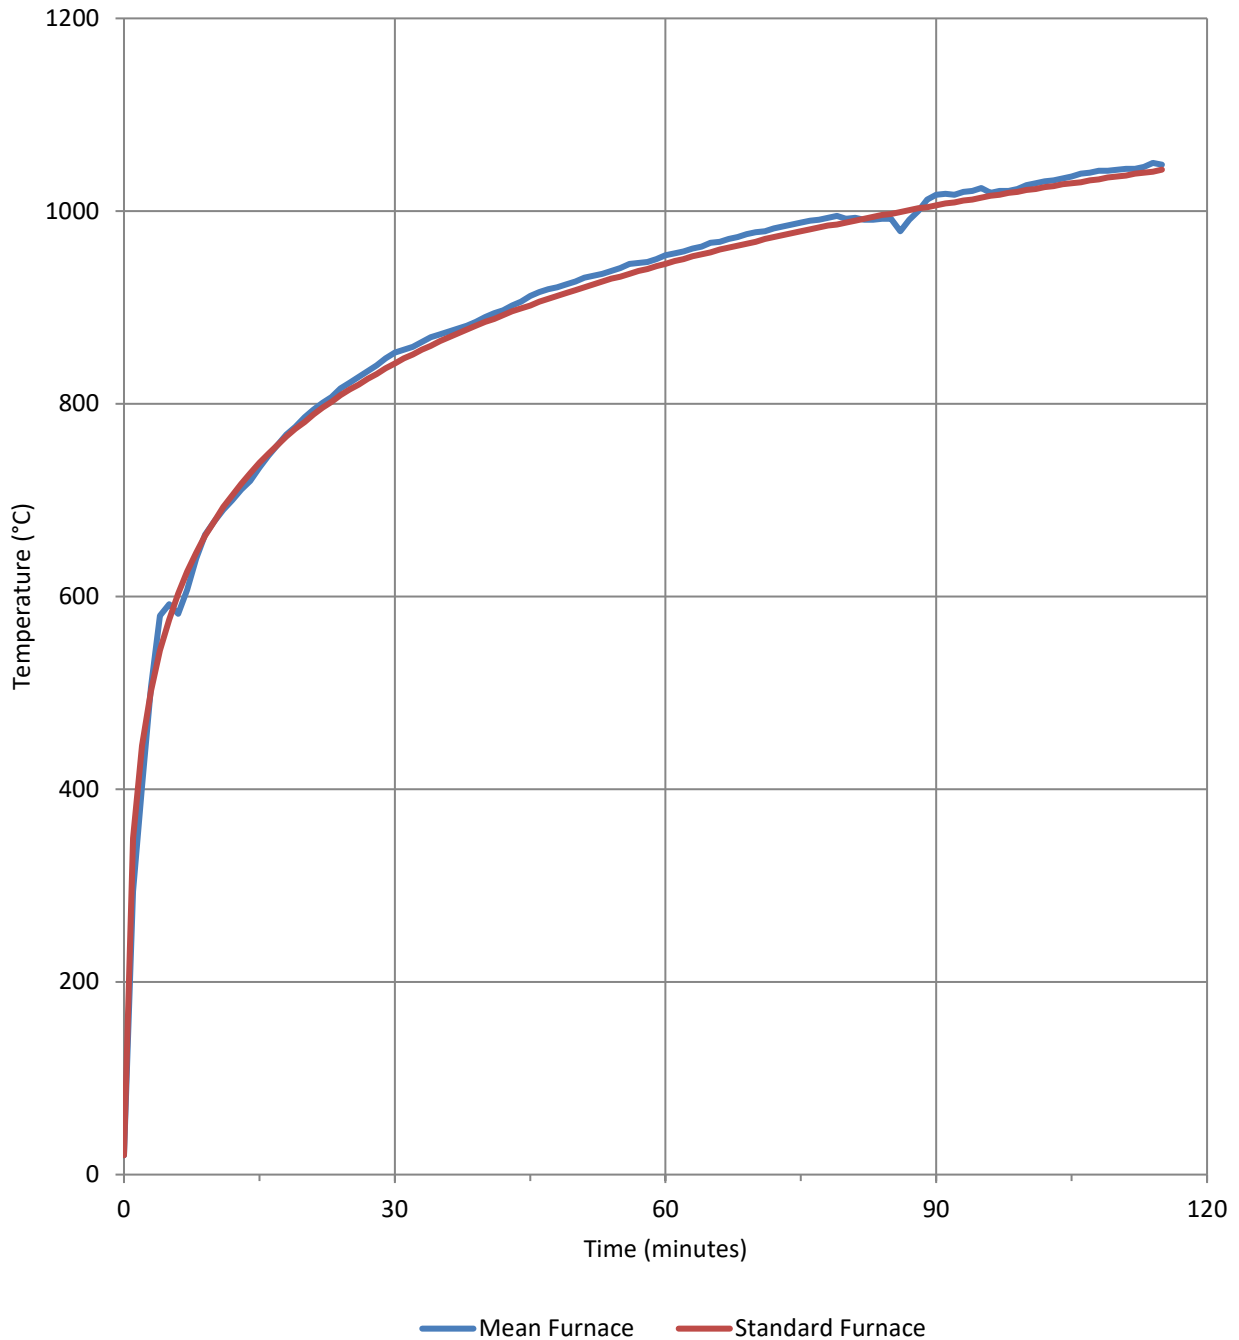
**Figure 4** – Furnace temperature graph.

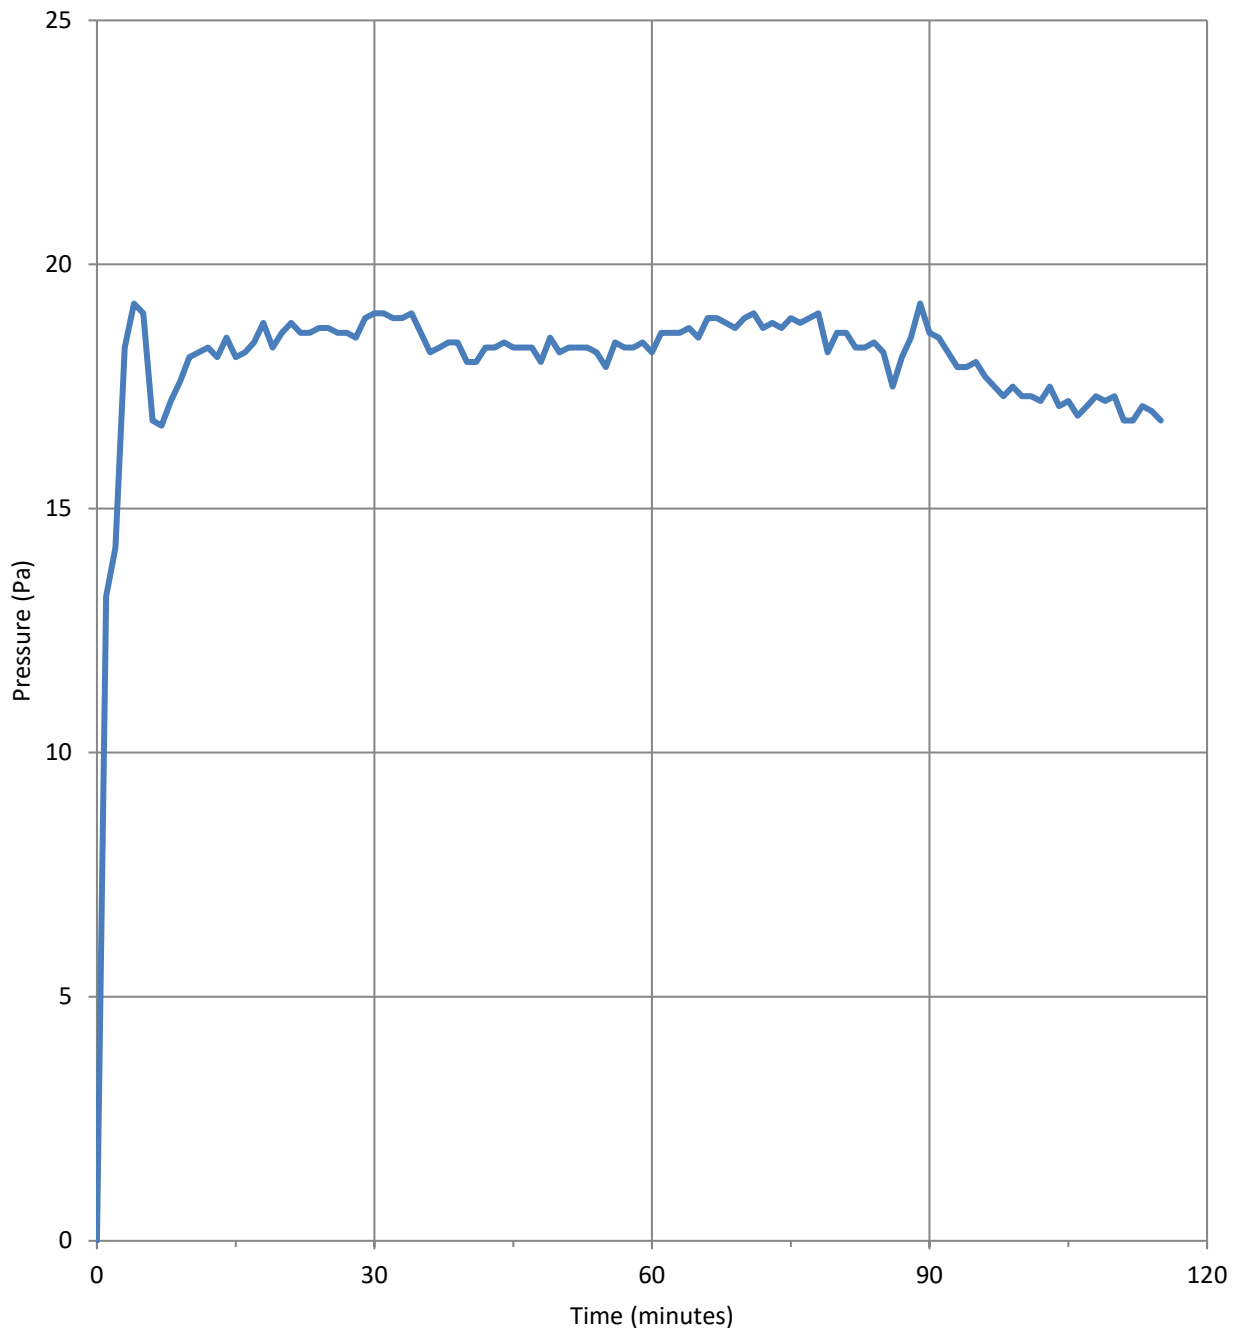
**Figure 5** – Furnace pressure graph.

The furnace pressure was set to control at  $18 \pm 2$  Pa positive with respect to atmosphere, at the top of the specimen. Furnace pressure data is shown in **Figure 5**.

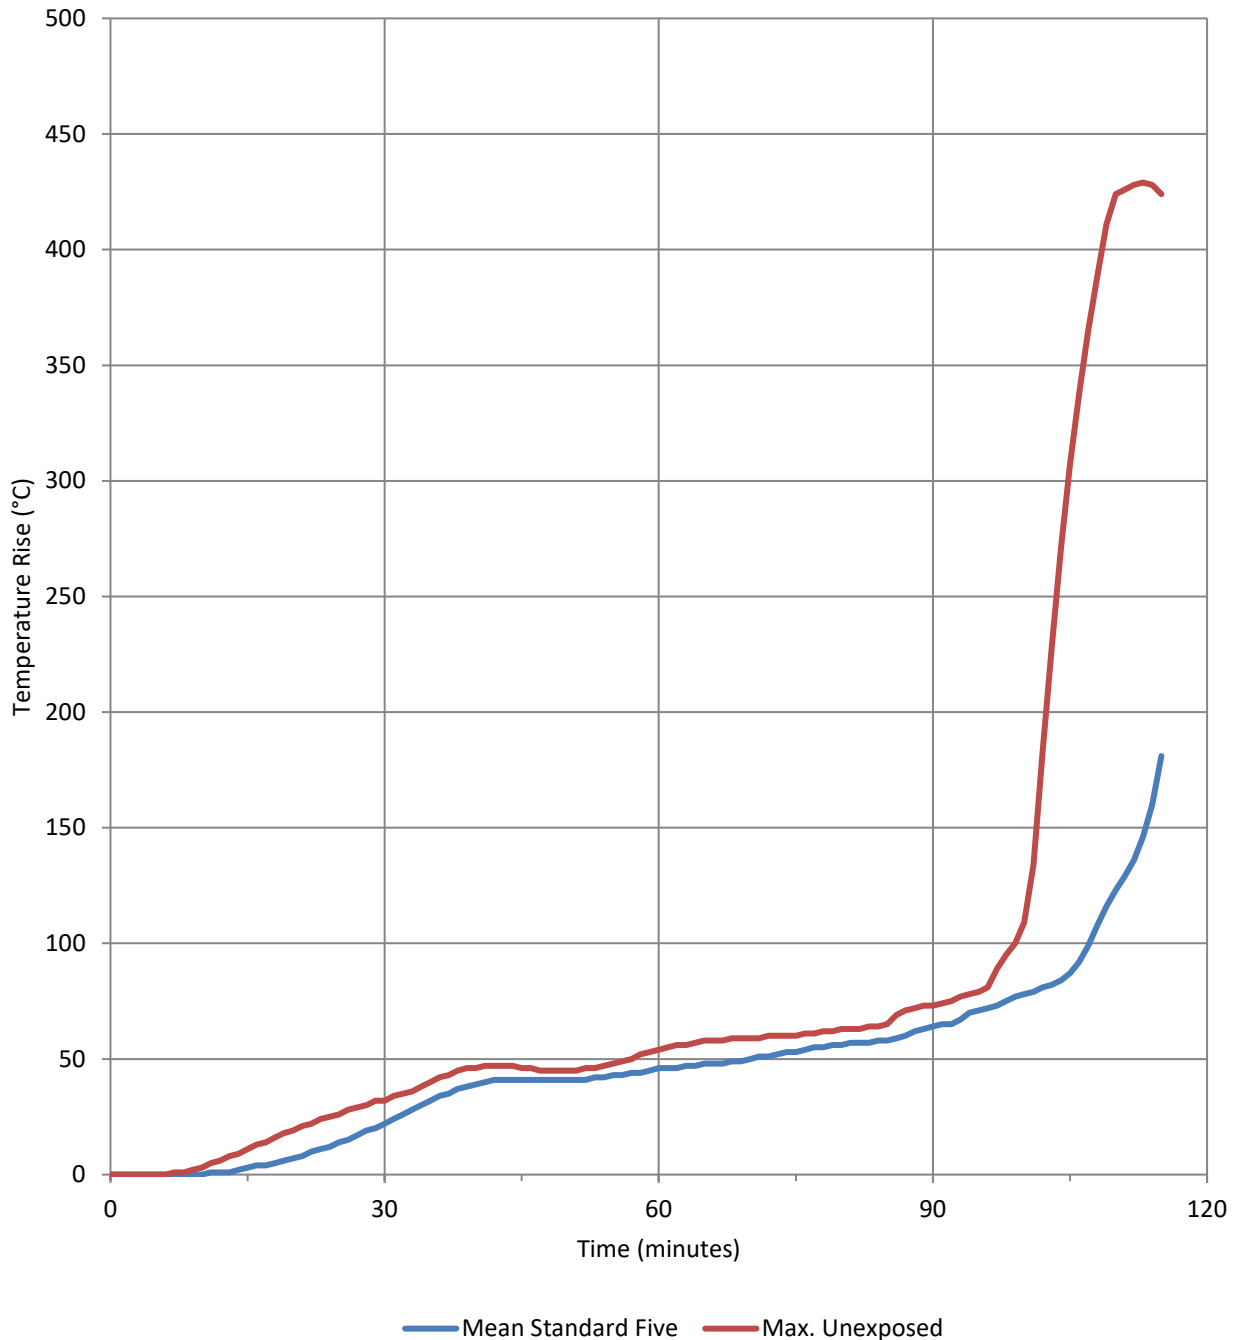
Figure 6 – Unexposed face temperature graph.

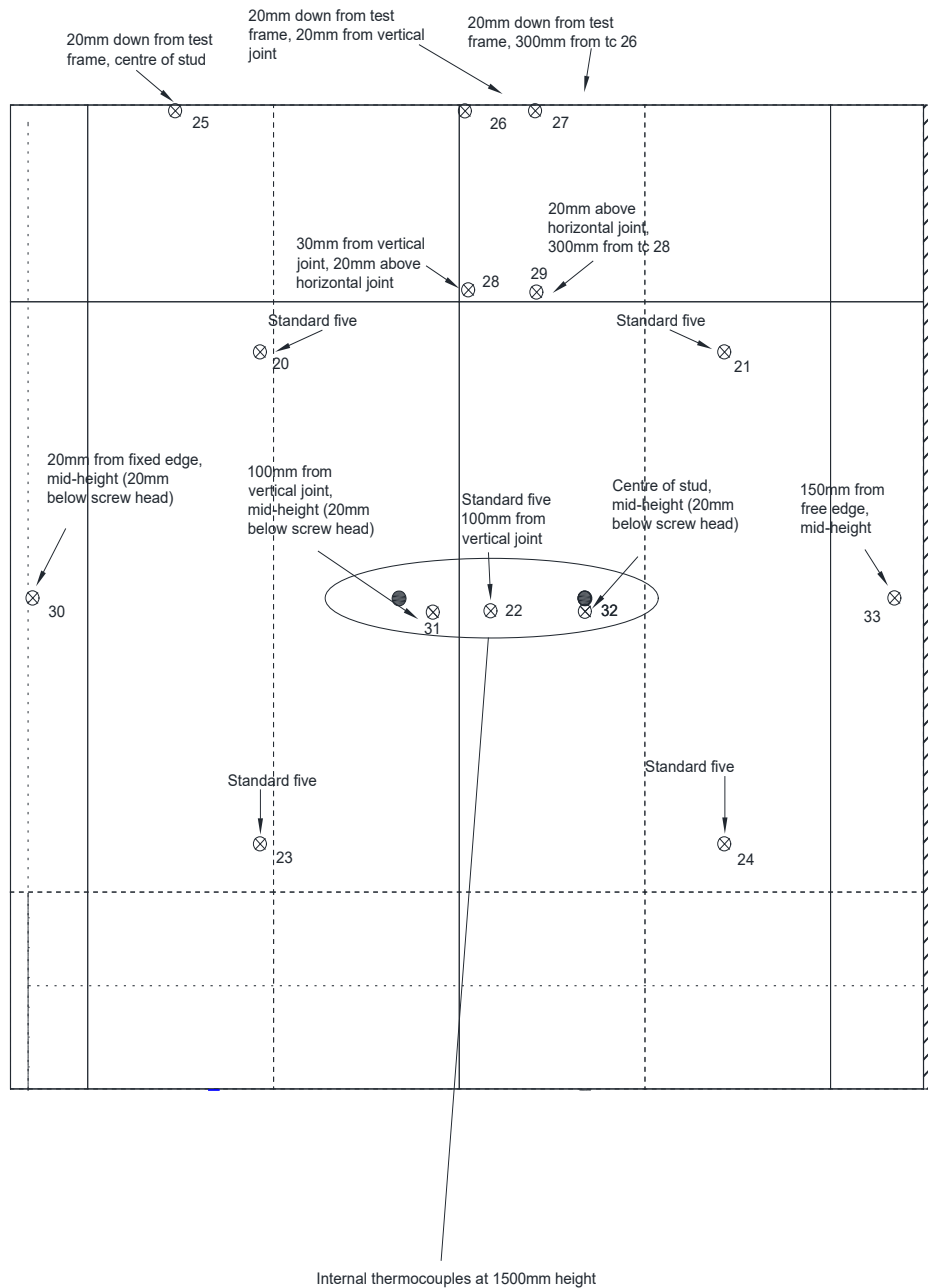
**Figure 7** – Unexposed face thermocouple layout.

See **Figure 7** for the location of the thermocouples.
