Report Number BTC 13481F

A FIRE RESISTANCE TEST ON A BRITISH GYPSUM GYPWALL QUIET SF PARTITION CLAD WITH A DOUBLE LAYER OF 12.5mm GYPROC SOUNDBLOC EACH SIDE OF GYPFRAME 70S50 STUDS AND GYPFRAME RB1 RESILIENT BAR, CONDUCTED IN ACCORDANCE WITH BS EN 1364-1: 1999.

Test Date: 7th September 2004

Customer: British Gypsum Limited
East Leake
Loughborough
Leicestershire
LE12 6HX

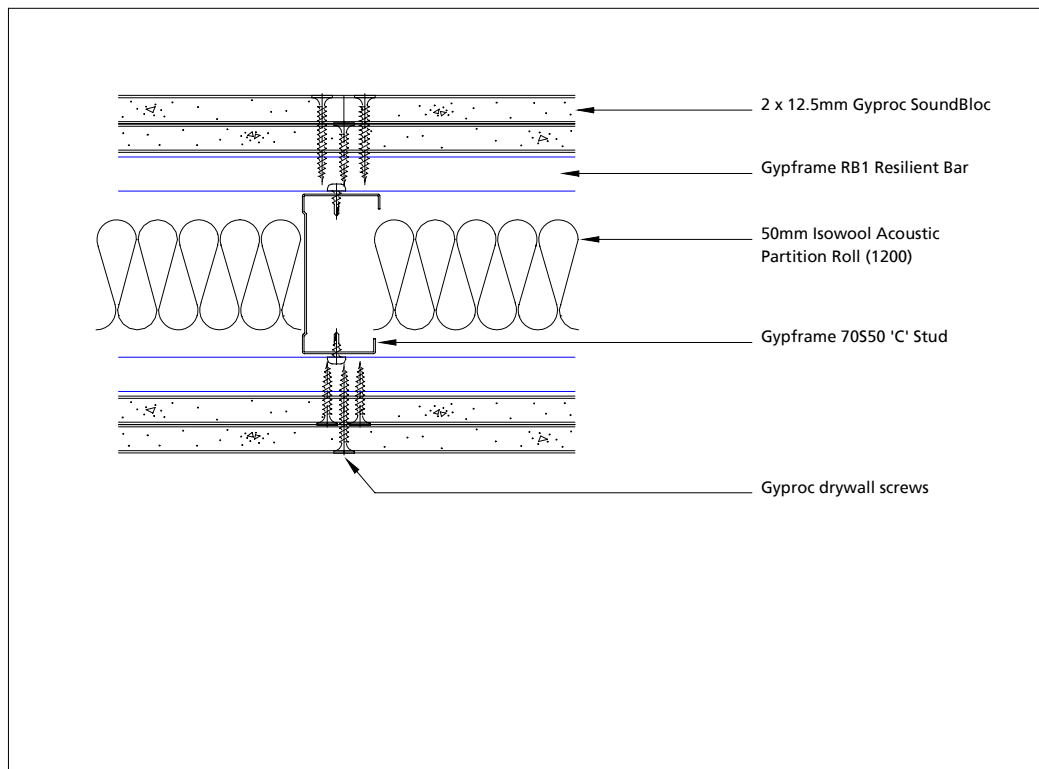
Figure 1. Cross-section of partition specimen.

Gypframe 72C50 Standard Floor & Ceiling Channels were fixed to the head and base of the test aperture at 600mm centres with 60mm fire resistant fixings. Gypframe 70S50 'C' Studs were positioned at 600mm centres between the channels. The right hand stud viewed from unexposed face was not fixed to the perimeter test frame, and the gap between the stud and the frame lining was filled with a 25mm rock mineral fibre gasket. At the left-hand end a Gypframe 70S50 'C' Stud was used to fix the partition to the test frame with 60mm fire resistant fixings at 600mm centres.

Gypframe RB1 Resilient Bar was fixed horizontally to the metal framework on both sides at 600mm centres with Gyproc Wafer Head Drywall Screws. The Gypframe RB1 Resilient Bar was positioned such that it backs the partitions horizontal joints (see below). Sections of Gypframe RB1 Resilient Bar were fixed vertically to the fixed end stud using two Gyproc Wafer Head Drywall Screws per section.

The Gypframe RB1 resilient Bar was lined both sides with a double layer of 12.5mm Gyproc SoundBloc board. The inner layer was fixed around the perimeter and within the field of the board with 25mm Gyproc drywall screws at 300mm centres. The outer layer was fixed around the perimeter and within the field of the board with 36mm Gyproc drywall screws at 300mm centres. All joints were staggered between layers.

Horizontal joints were positioned 2400mm from the base for the outer layers on both the exposed and unexposed faces of the construction. Horizontal joints were positioned 600mm from the base for the inner layers on both the exposed and unexposed faces of the construction. All horizontal joints coincided with the Gypframe RB1 Resilient Bar positions.

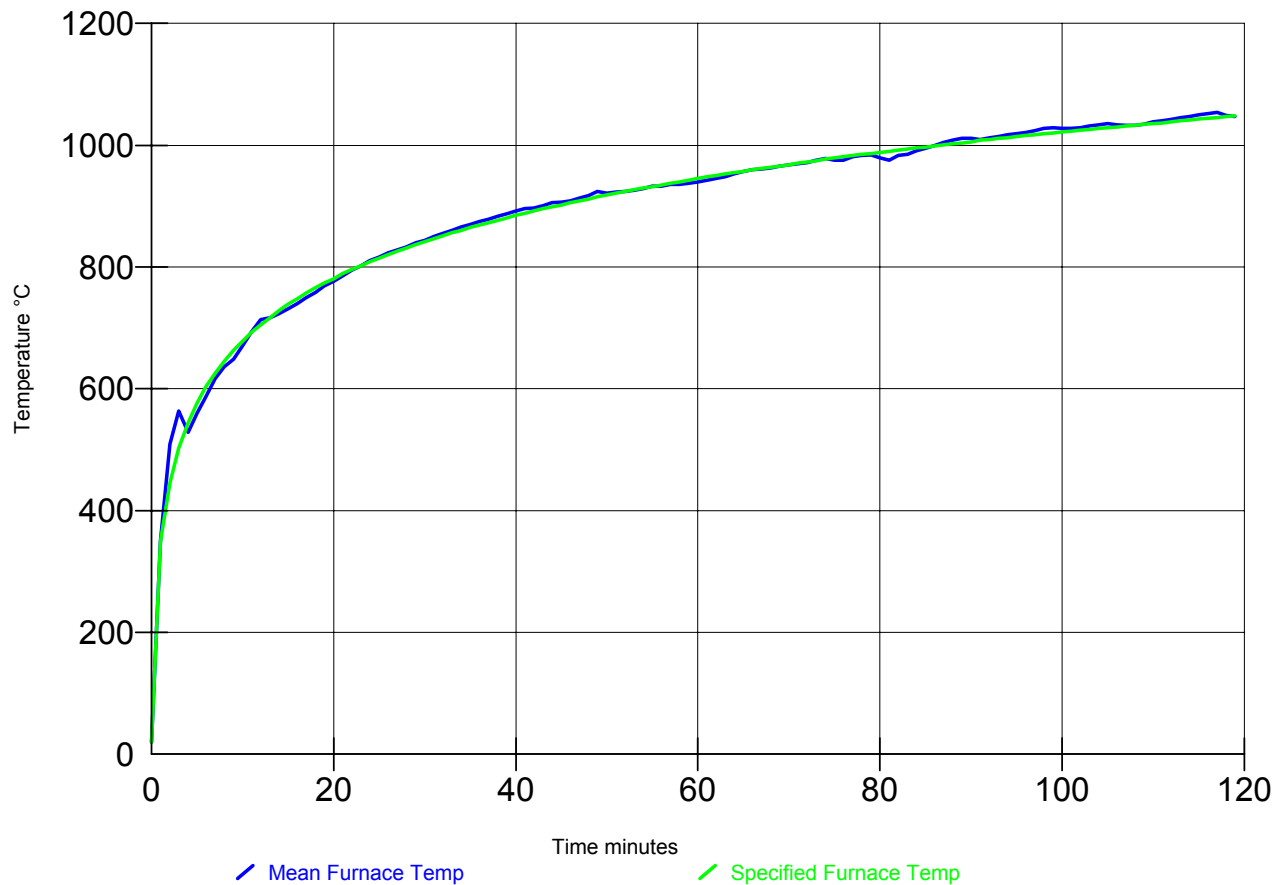
Figure 2. Furnace temperature graph.

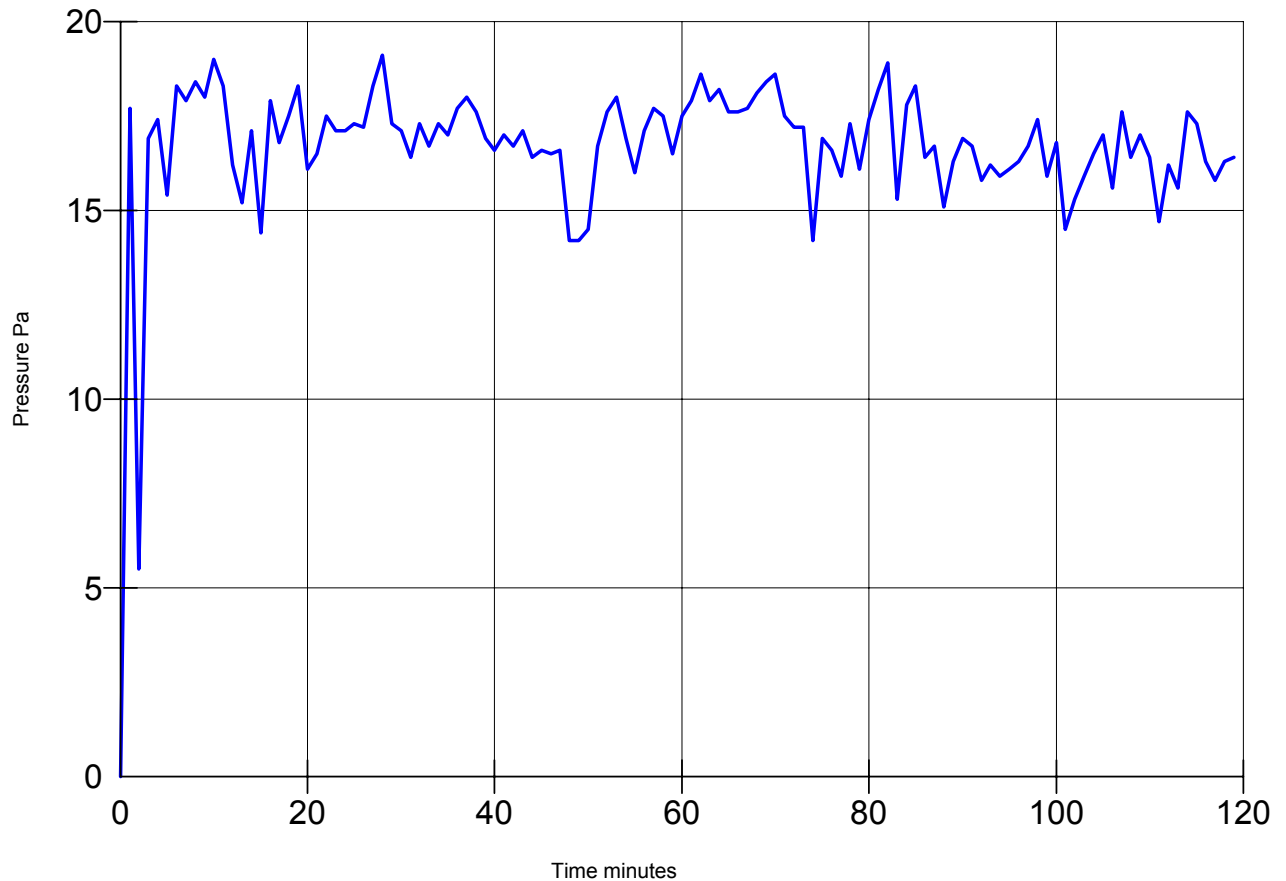
Figure 3. Furnace pressure graph.

The furnace pressure was outside of the allowable tolerance at 15, 48-50, 74, 101 and 111 minutes.

The furnace pressure was set to control at 18 ± 2 Pa positive with respect to atmosphere, at the top of the specimen, except during the first 5 minutes of the test.

The allowable tolerances are ± 5 Pa from 5 minutes to 10 minutes and ± 3 Pa from 10 minutes onwards. It is of the opinion of the laboratory that the variations in the furnace pressure exceeding the tolerances stated in BS EN 1363-1:1999 have not unduly influenced the results of this test. Furnace pressure data is shown on page 16.

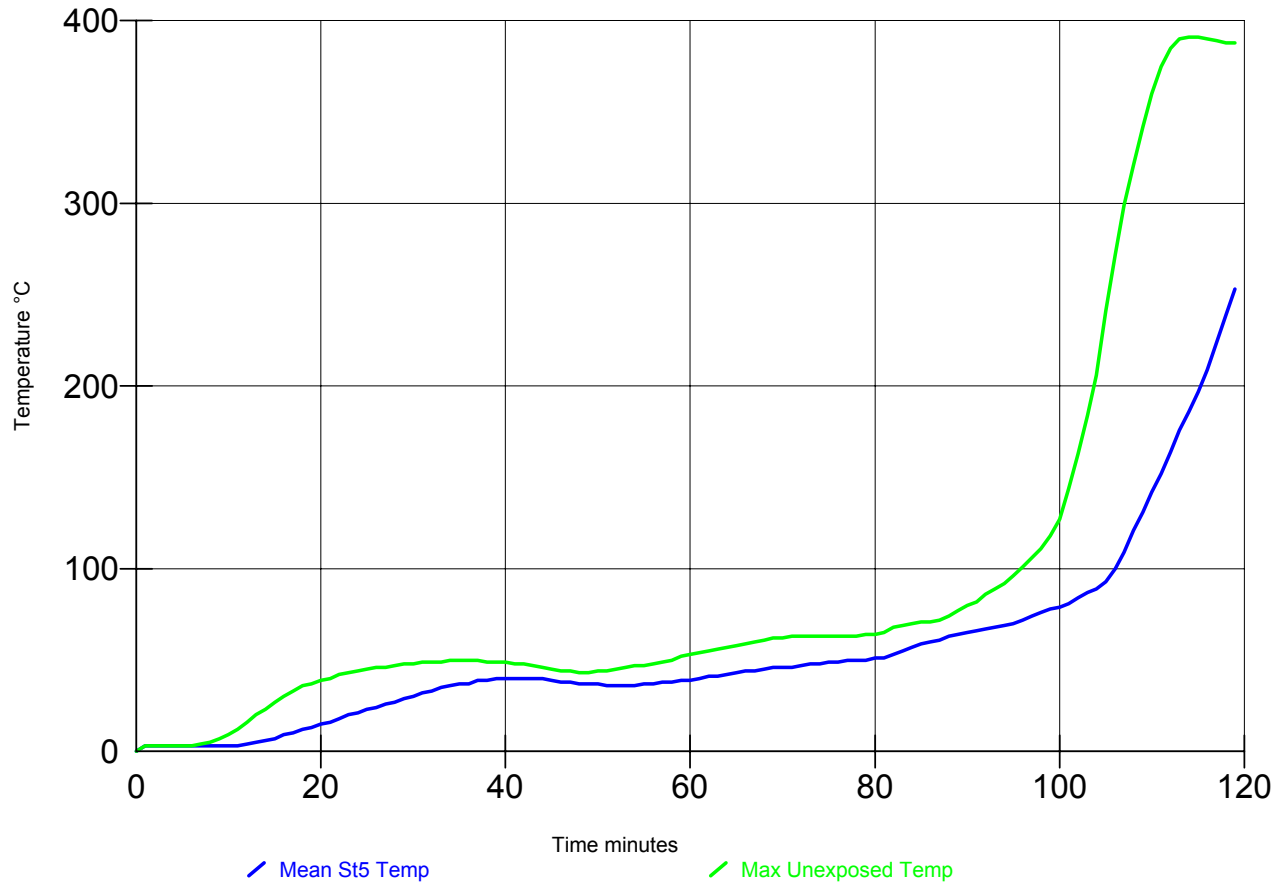
Figure 4. Unexposed face temperature graph.

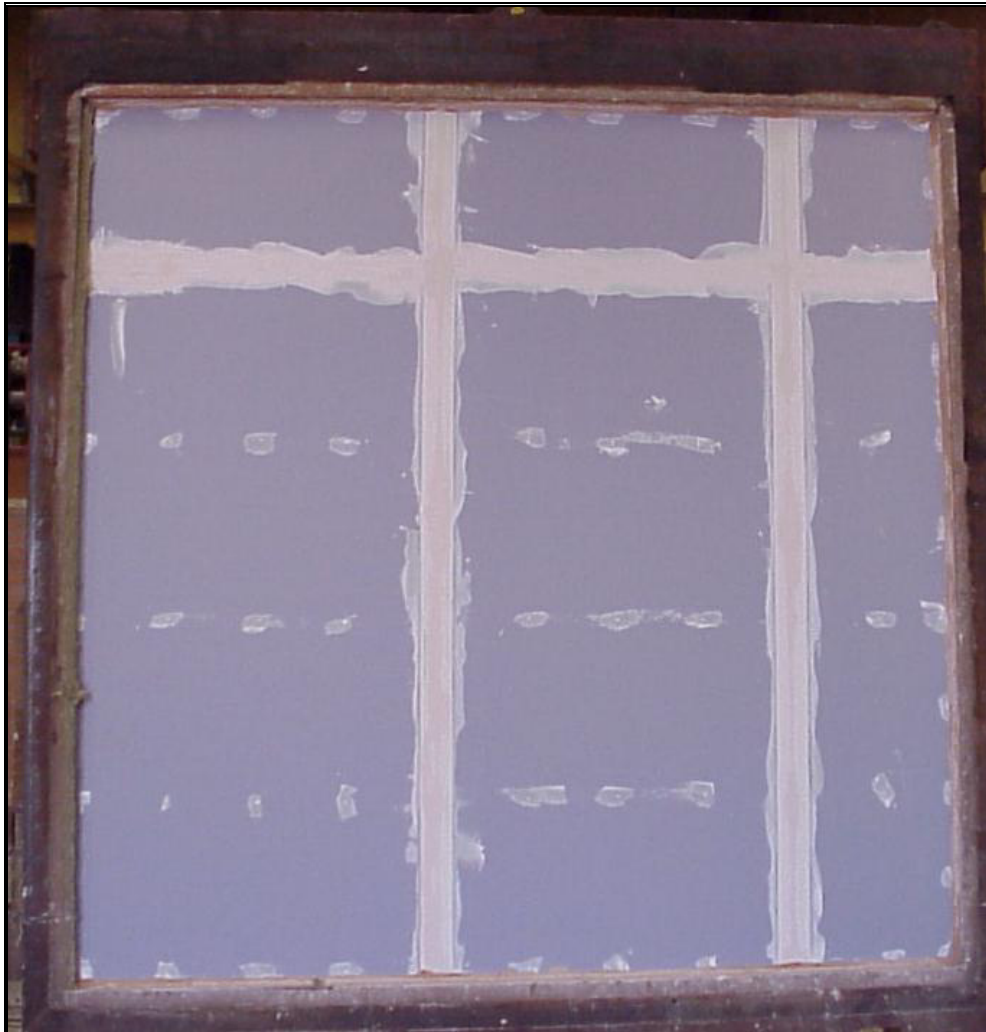
Photograph 1. View of the exposed face prior to test.

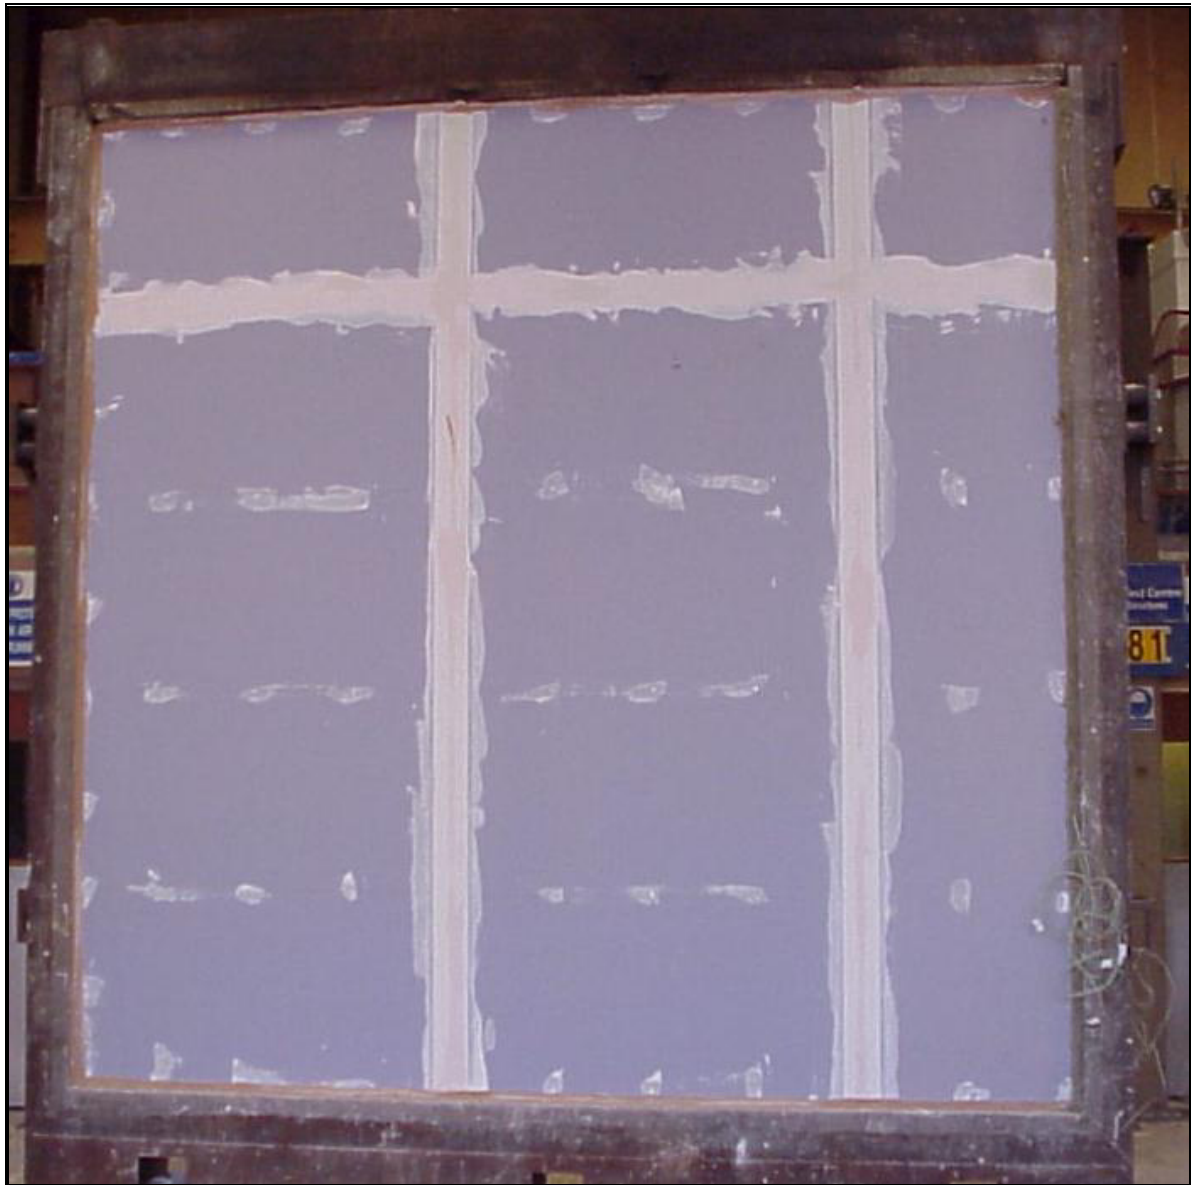
Photograph 2. View of the unexposed face prior to test.

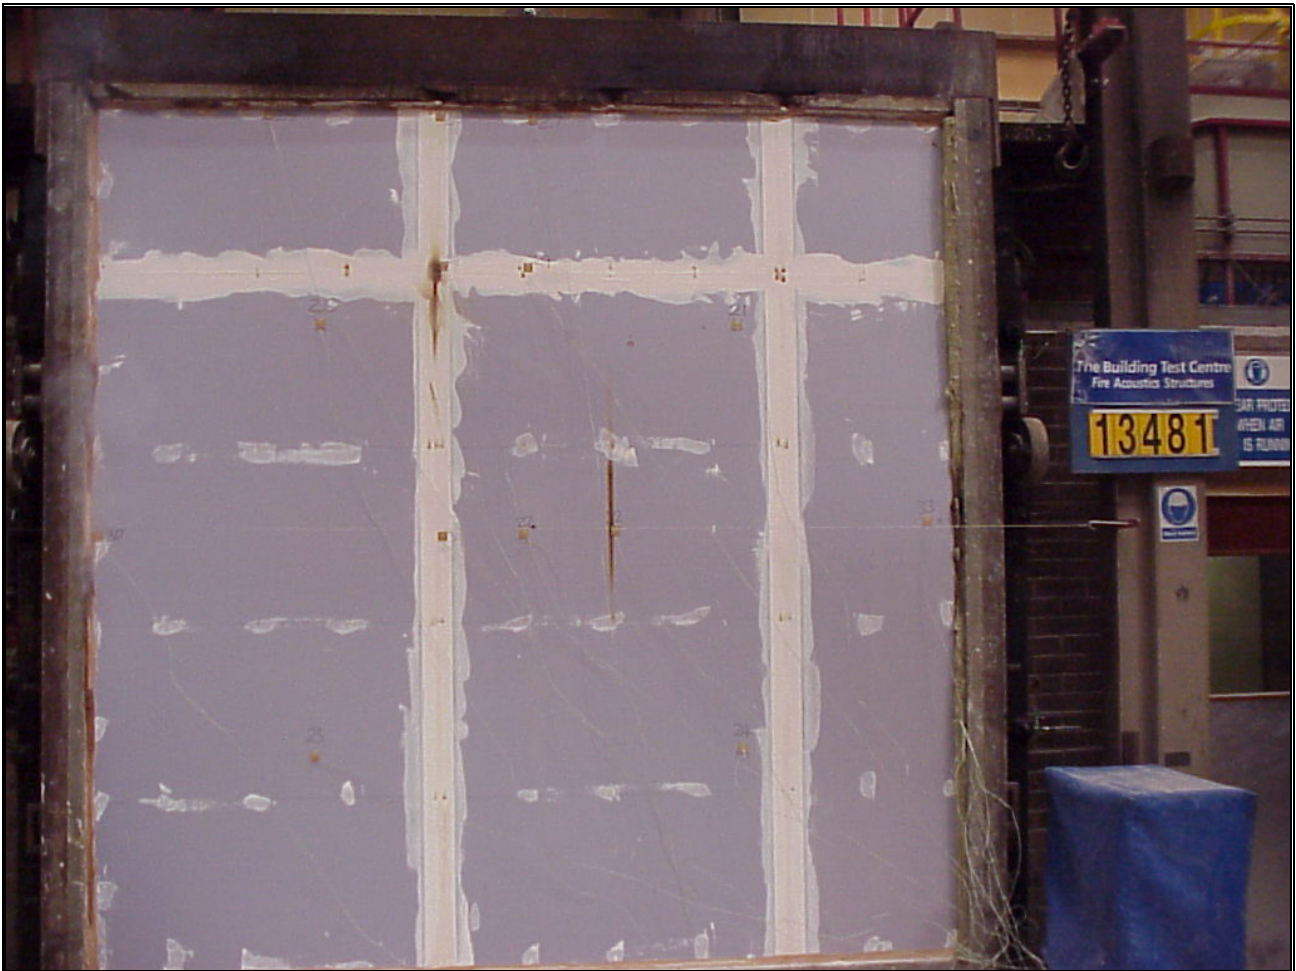
Photograph 3. View of the unexposed face at 101 minutes (after insulation failure).

Integrity:	Sustained flaming	119 minutes (no failure test discontinued at the request of the customer)
	25mm Gap gauge	119 minutes
	6mm Gap gauge	119 minutes
	Cotton pad	117 minutes
Insulation:		101 minutes

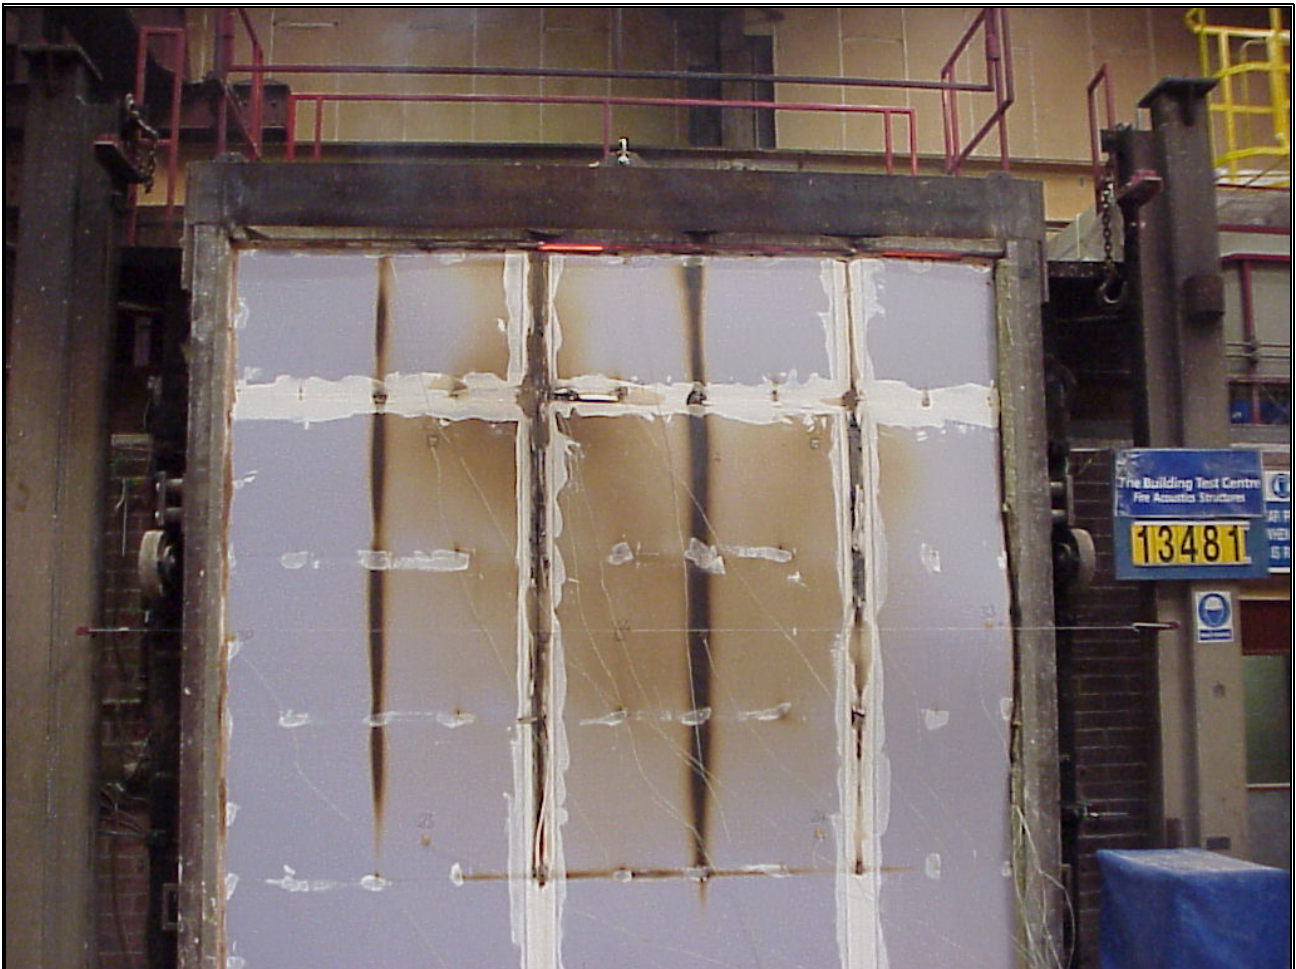
Photograph 4. View of the unexposed face at 117 minutes (after integrity failure).

Time		Observations
hrs	mins	
		All observations refer to exposed face unless otherwise stated.
1	56	<i>Unexposed face</i> A glow was visible at the head at approximately mid-width of the specimen. A cotton pad was used on the above location but did not glow or ignite.
1	57	<i>Unexposed face</i> INTEGRITY FAILURE. The cotton pad glowed when used at the head at approximately mid-width of the specimen.
1	58	<i>Unexposed face</i> A glow was visible on the left-hand vertical joint at approximately 1500-2400mm height. A glow was visible at the head of the specimen from approximately mid-width to the free end.
1	59	<i>Unexposed face</i> FURTHER INTEGRITY FAILURE. The 6mm x 150mm gap gauge would have entered the furnace through left-hand vertical joint at approximately 1500mm height. FURTHER INTEGRITY FAILURE. The 25mm gap gauge would have entered the furnace through left-hand vertical joint at approximately 1500mm height. The right-hand half of the specimen collapsed. TEST TERMINATED at the request of the customer.
