Report Number BTC 12492F

A FIRE RESISTANCE TEST ON A BRITISH GYPSUM GYPWALL PARTITION CLAD WITH A SINGLE LAYER OF 12.5mm GYPROC SOUNDBLOC BOARD EACH SIDE OF GYPFRAME 70S50 STUDS AND 50mm ISOWOOL 1200 IN THE CAVITY, CONDUCTED IN ACCORDANCE WITH BS EN 1364-1: 1999.

Test Date: 18th March 2003

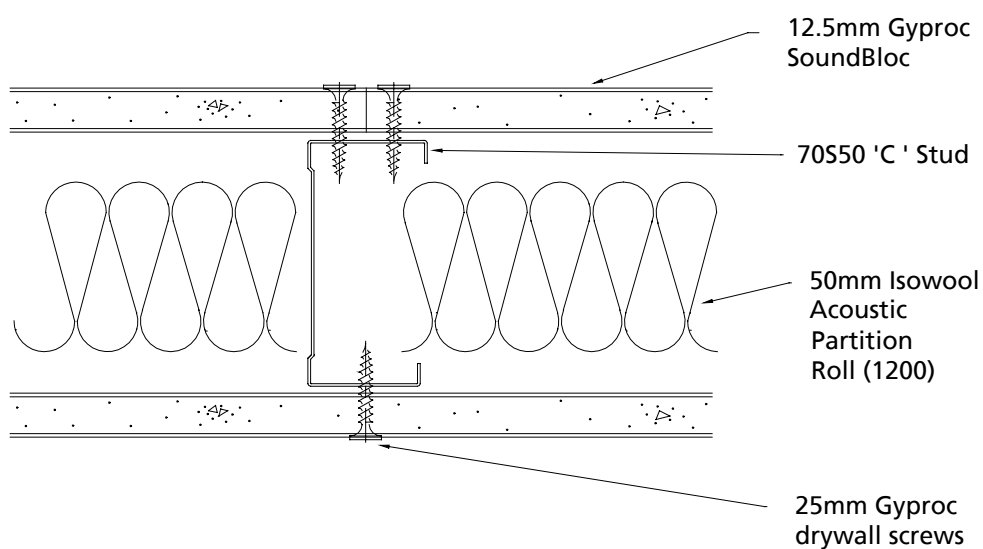
Figure 1. Cross-section of partition specimen.

The specimen was constructed in a refractory concrete lined steel restraint frame having an opening of 3000mm high x 3000mm wide.

Gypframe 72C50 Standard Floor & Ceiling Channels were fixed to the head and base of the test aperture at 600mm centres with 60mm fire resistant fixings. Gypframe 70S50 'C' Studs were positioned at 600mm centres between the channels. The right hand stud viewed from unexposed face was not fixed to the perimeter test frame, and the gap between the stud and the frame lining was filled with a 25mm rock mineral fibre gasket. At the left-hand end a Gypframe 70S50 'C' Stud was used to fix the partition to the test frame with 60mm fire resistant fixings at 600mm centres.

50mm Isowool Acoustic Partition Roll (1200) was positioned in the partition cavity.

The framework was lined both sides with a single layer of 12.5mm Gyproc SoundBloc board fixed to the framework using 25mm Gyproc drywall screws at 300mm centres around the board perimeter and within the field of the board.

Horizontal joints were located at 2700mm from the base of the specimen on both sides of the partition. Gypframe GFS1 Fixing Strap was used behind the horizontal joints.

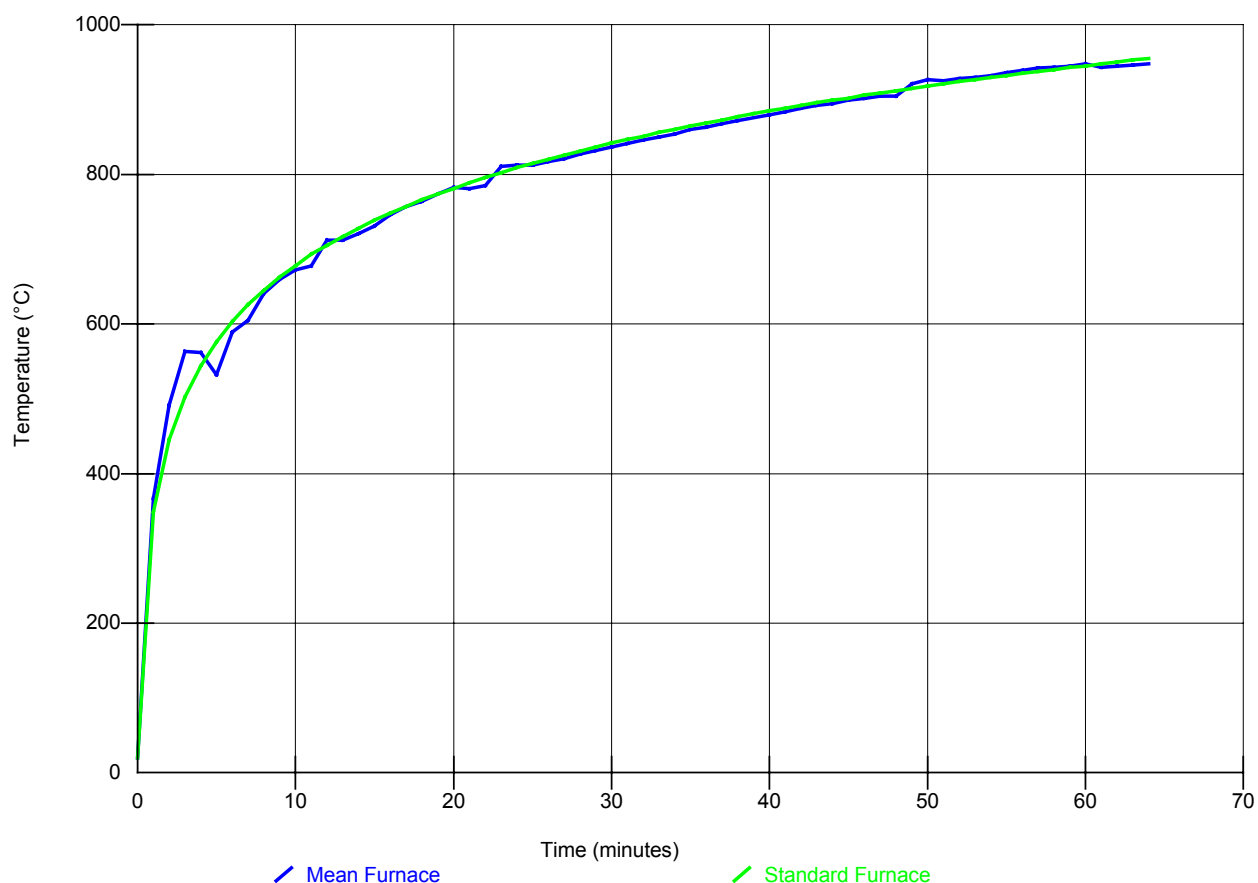
Figure 2. Furnace temperature graph.

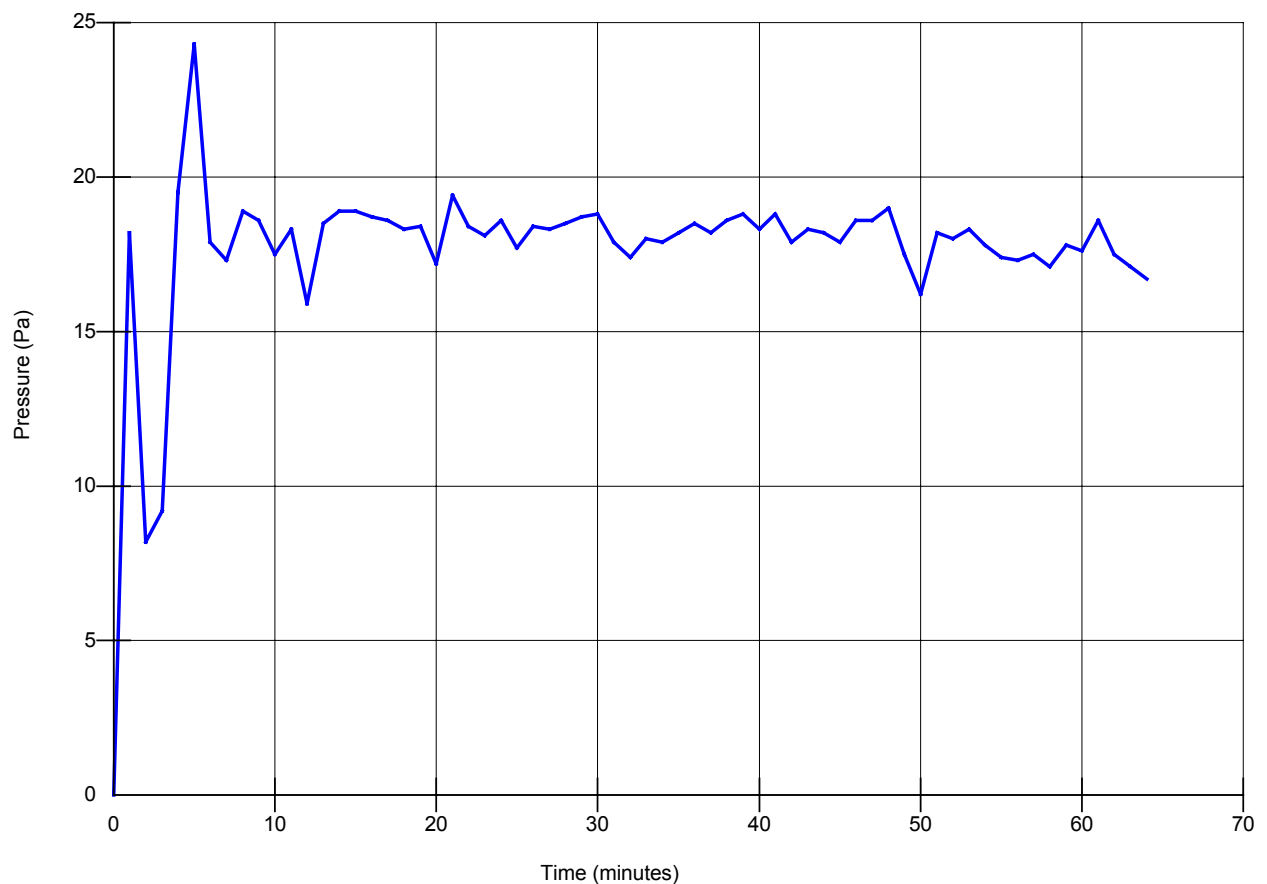
Figure 3. Furnace pressure graph.

The furnace pressure was set to control at 18 ± 2 Pa positive with respect to atmosphere, at the top of the specimen, except during the first 5 minutes of the test.

The allowable tolerances are ± 5 Pa from 5 minutes to 10 minutes and ± 3 Pa from 10 minutes onwards. It is of the opinion of the laboratory that the variations in the furnace pressure exceeding the tolerances stated in BS EN 1363-1:1999 have not unduly influenced the results of this test. Furnace pressure data is shown on page 15.

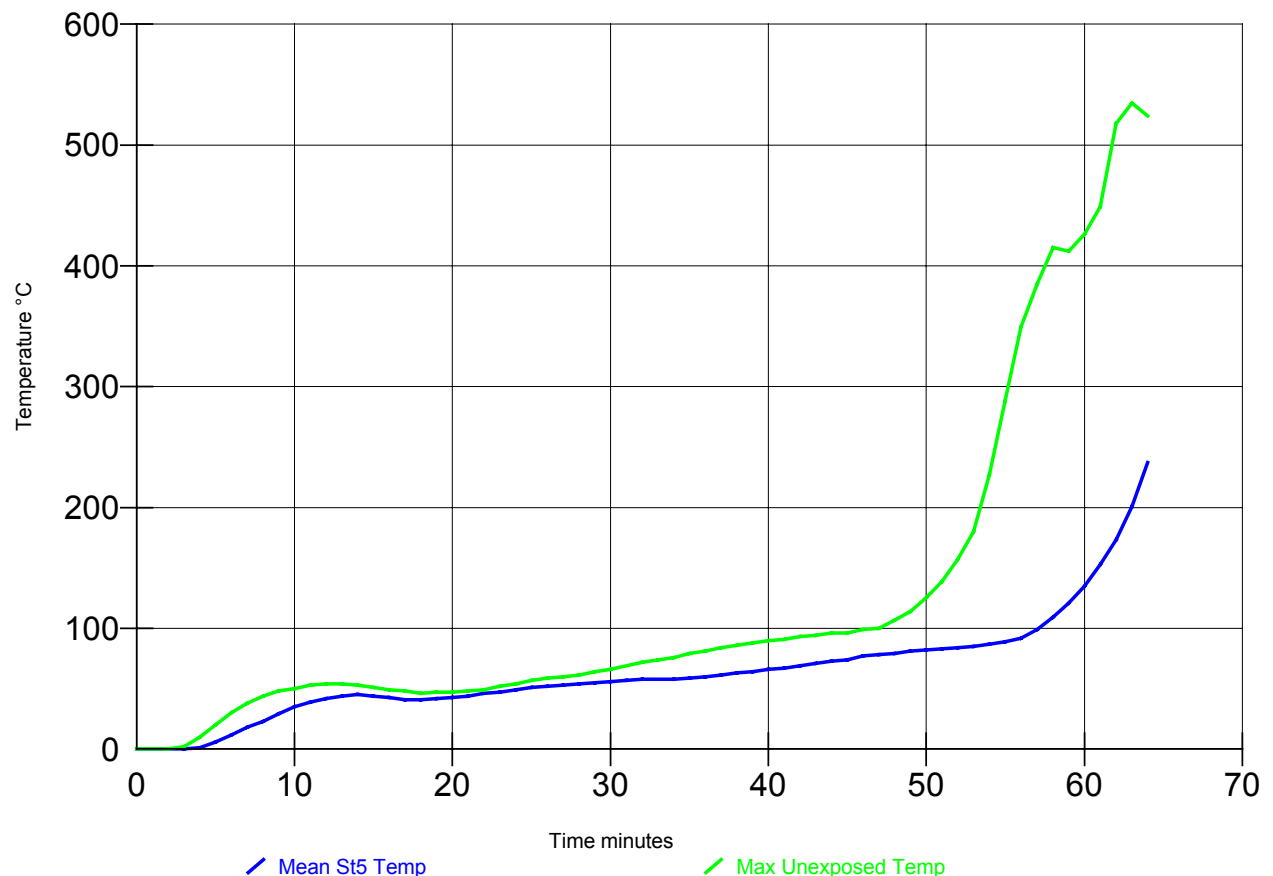
Figure 4. Unexposed face temperature graph.

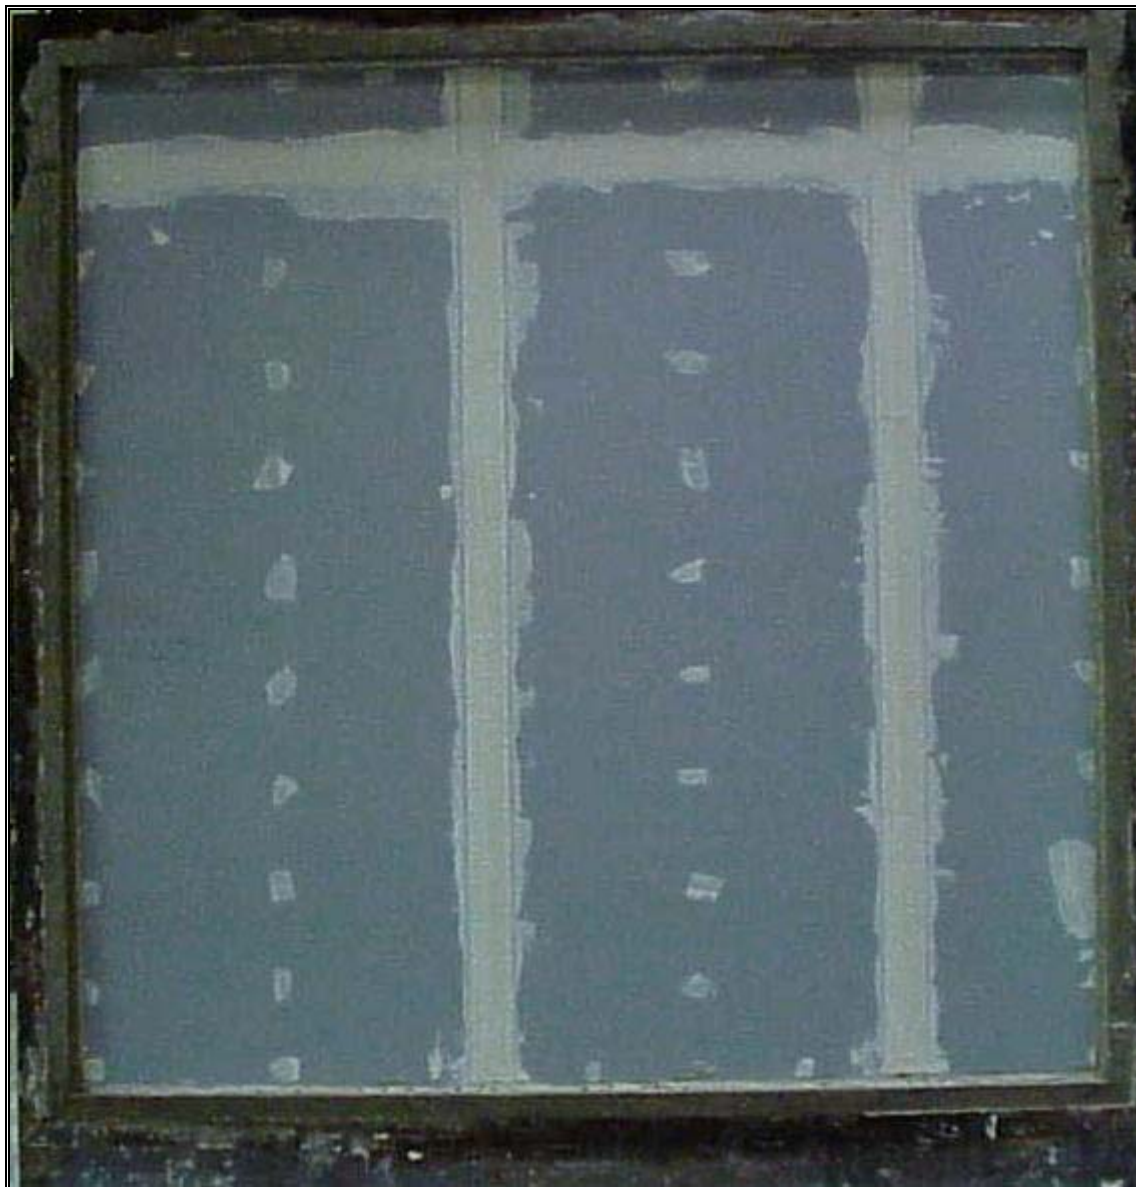
Photograph 1. Exposed face prior to test

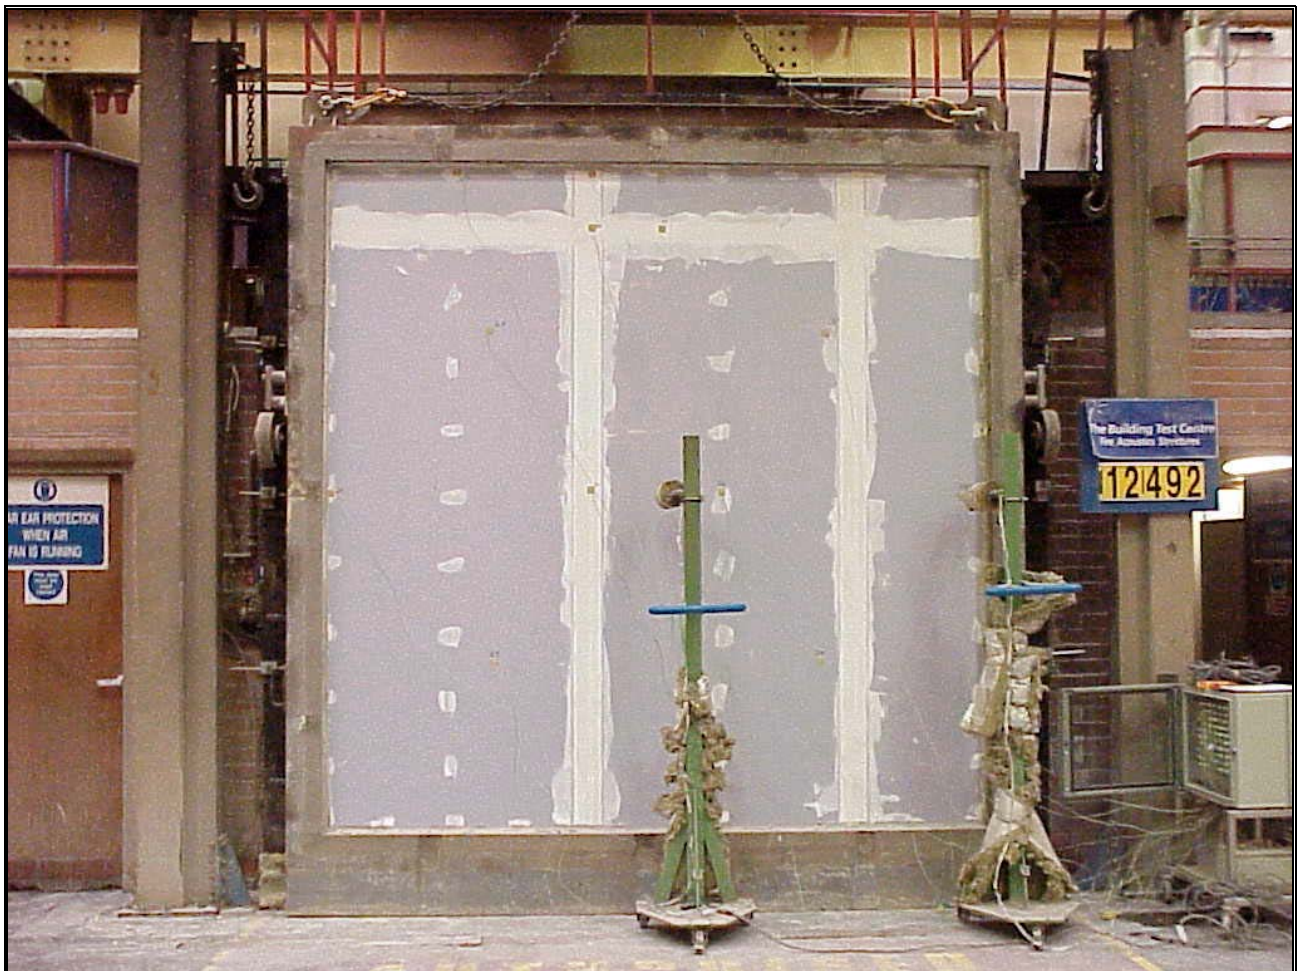
Photograph 2. Unexposed face prior to test.

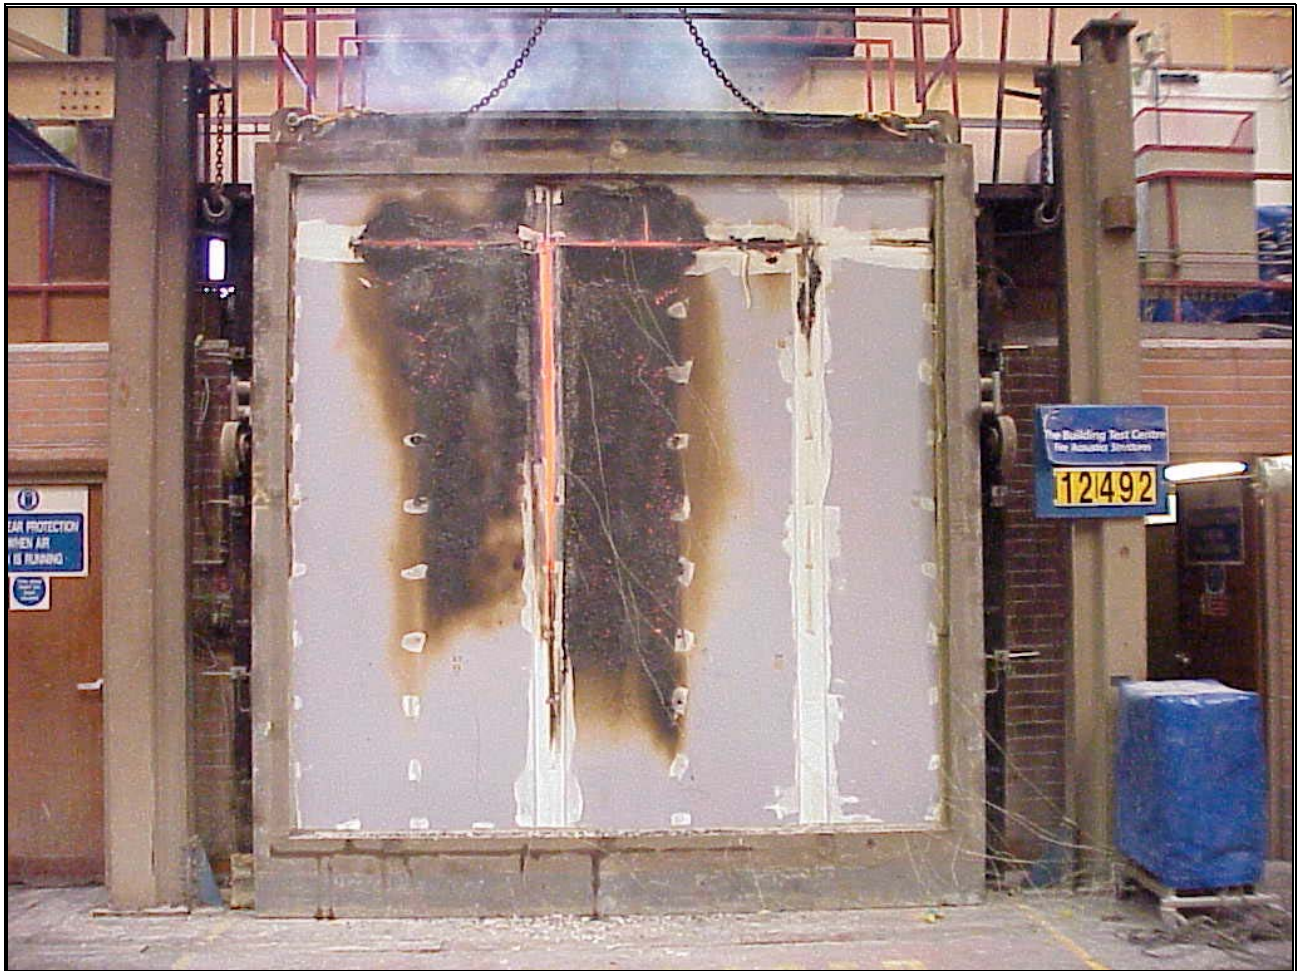
Photograph 3. Unexposed face after test termination.

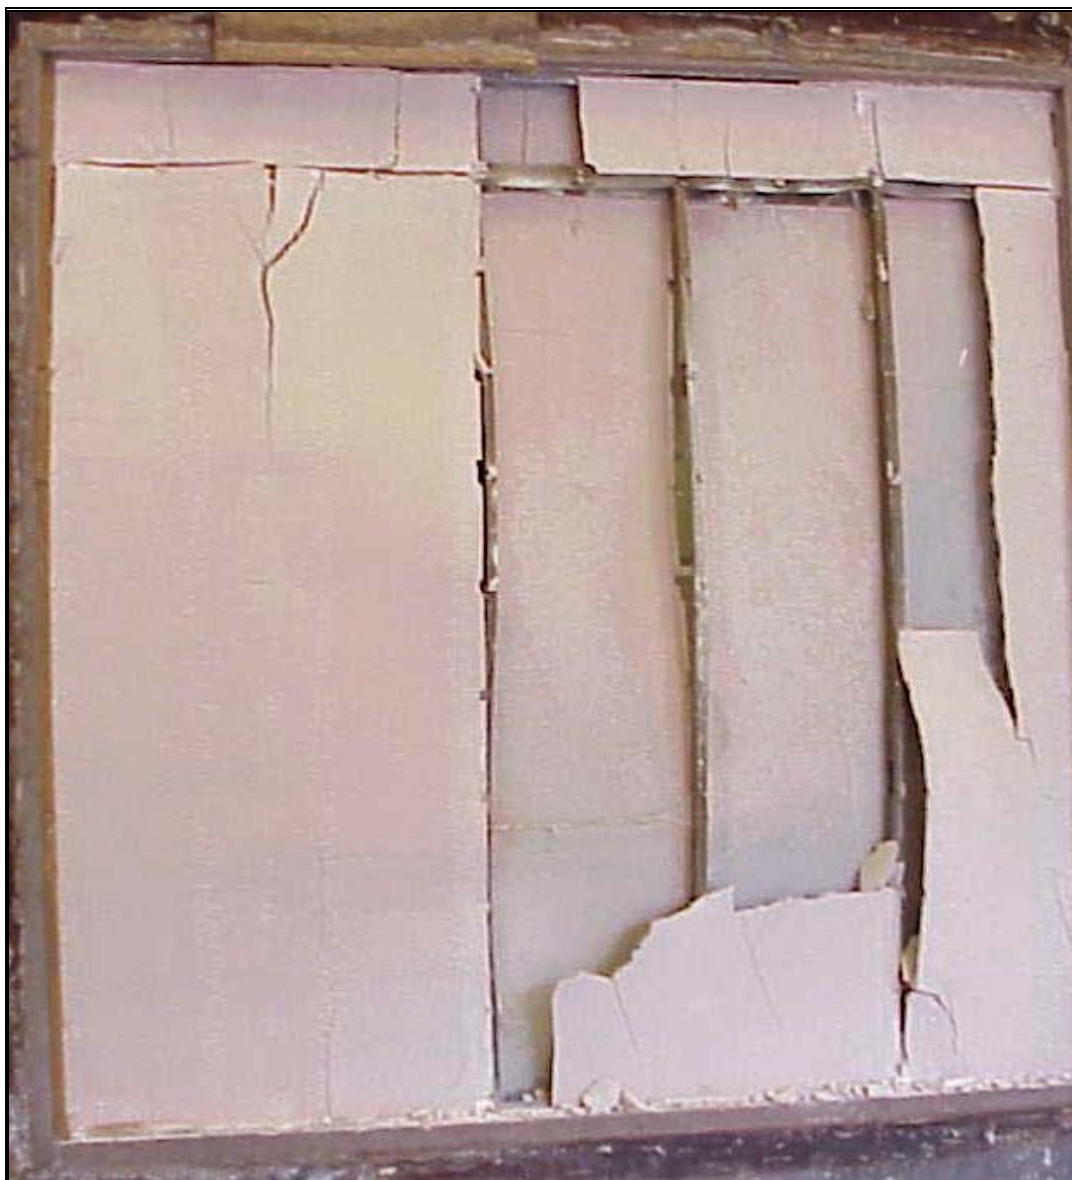
Photograph 4. Exposed face after test termination
