Report Number: **BTC 22869F**

A FIRE RESISTANCE TEST ON A 63 MM DEEP  
TIMBER STUD PARTITION CLAD EACH SIDE WITH A  
SINGLE LAYER OF 15 MM THICK GYPROC  
WALLBOARD 15MM, INCORPORATING 25 MM THICK  
ISOVER ACOUSTIC PARTITION ROLL (APR 1200)  
INSULATION IN THE CAVITY, CONDUCTED IN  
ACCORDANCE WITH BS EN 1364-1: 2015.

Test Date: 16<sup>th</sup> August 2023

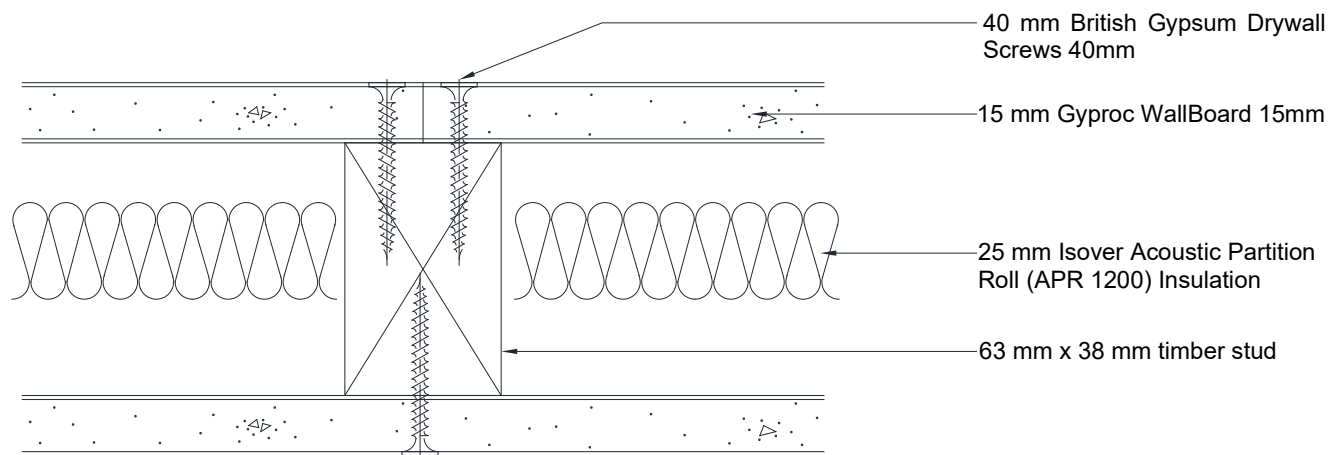
**Figure 1** – Horizontal cross section.

The specimen was constructed in a refractory concrete lined steel restraint test frame with an opening of 3000 mm (high) x 3000 mm (wide).

63 mm x 38 mm timber head and sole plates were fixed to the head and base of the test aperture at 600 mm centres using 100 mm long fire-resistant fixings.

63 mm x 38 mm timber studs were positioned at 600 mm centres between the head and sole plates and skew fixed using 65 mm long British Gypsum Drywall Screws 65mm. The right-hand stud viewed from the unexposed face was not fixed to the perimeter of the test frame, and the gap between the stud and the frame lining was filled with 25 mm thick rock mineral fibre gasket.

At the left-hand edge, a 63 mm x 38 mm timber stud was used to fix the partition to the test frame using 100 mm long fire-resistant fixings at 600 mm centres.

63 mm x 38 mm timber stud noggings were positioned between the studs at 2400 mm from the base of the specimen and skew fixed using 65 mm long British Gypsum Drywall Screws 65mm.

A layer of 25mm Isover Acoustic Partition Roll (APR 1200) Insulation was positioned in the stud cavity.

Both the unexposed face and the exposed face of the specimen were clad with a single layer of 15 mm thick Gyproc WallBoard 15mm. The boards were fixed with 40 mm long British Gypsum Drywall Screws 40mm at 300 mm centres around the perimeter and within the field of the boards.

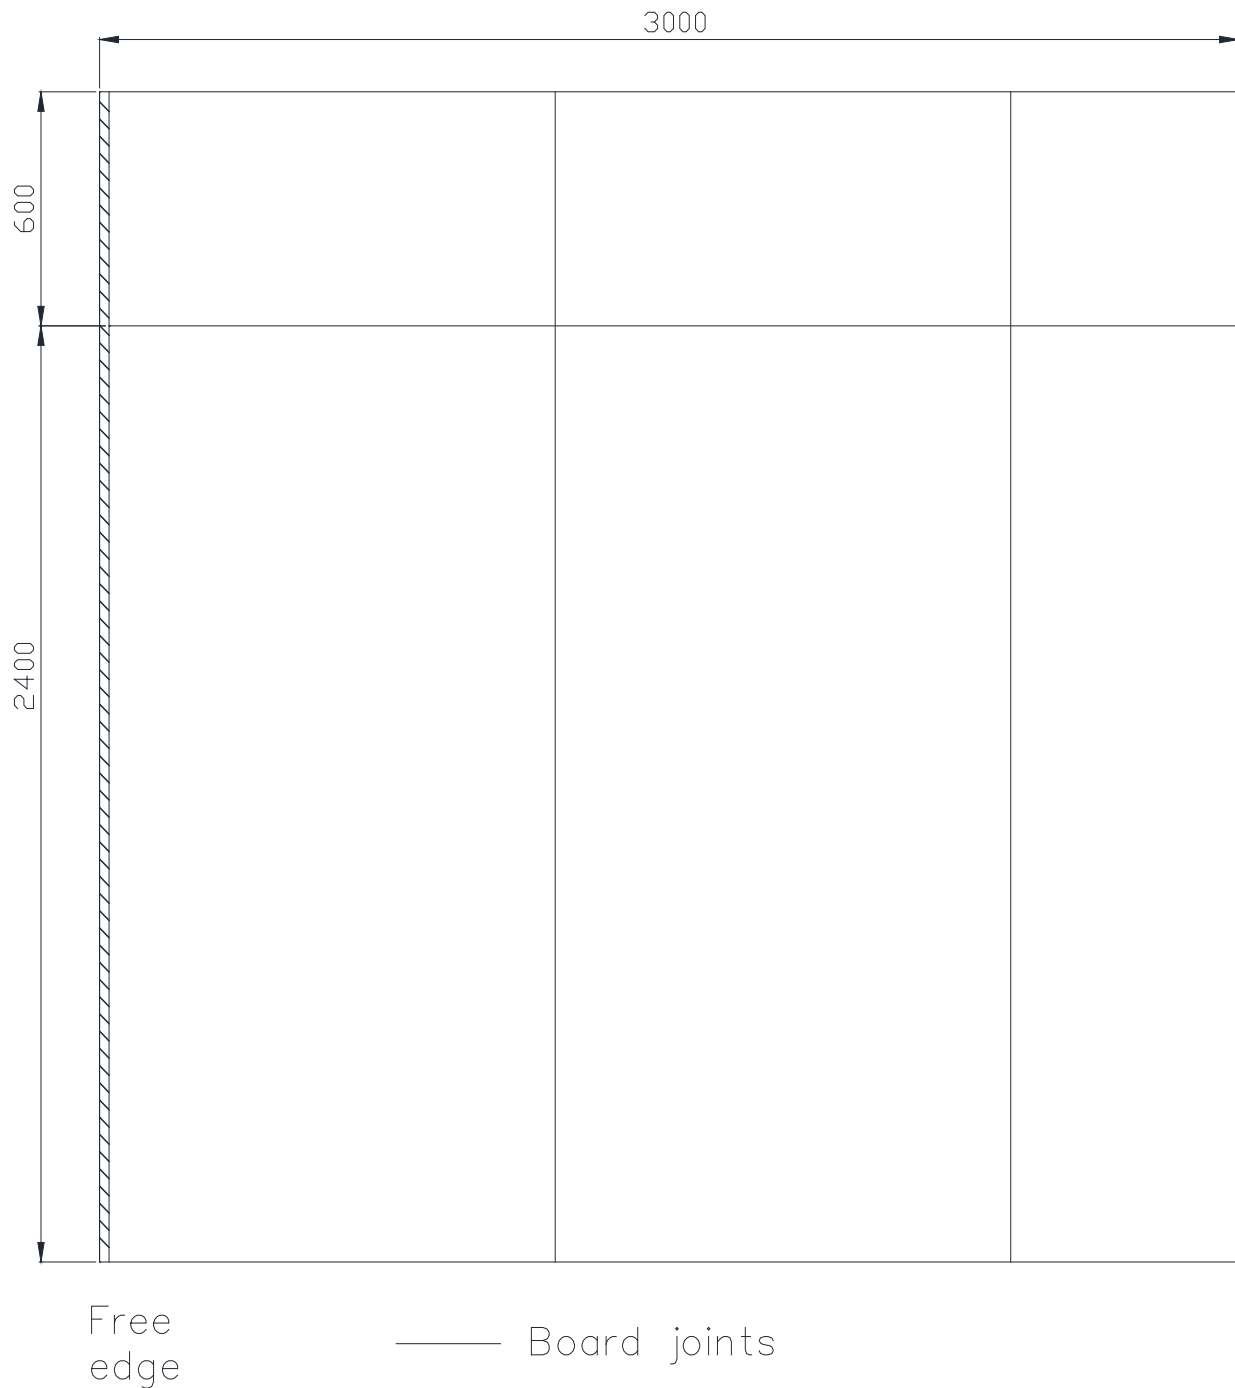
**Figure 2** – Exposed face elevation.

All vertical joints were staggered between layers, with a full board at the free end of the exposed face.

A horizontal joint was positioned at 2400 mm from the base on the outer layer boards on both faces of the specimen.

All external board joints were taped and filled using Gyproc Paper Joint Tape and Gyproc Joint Filler as appropriate. All screw heads were spotted using Gyproc Joint Filler.

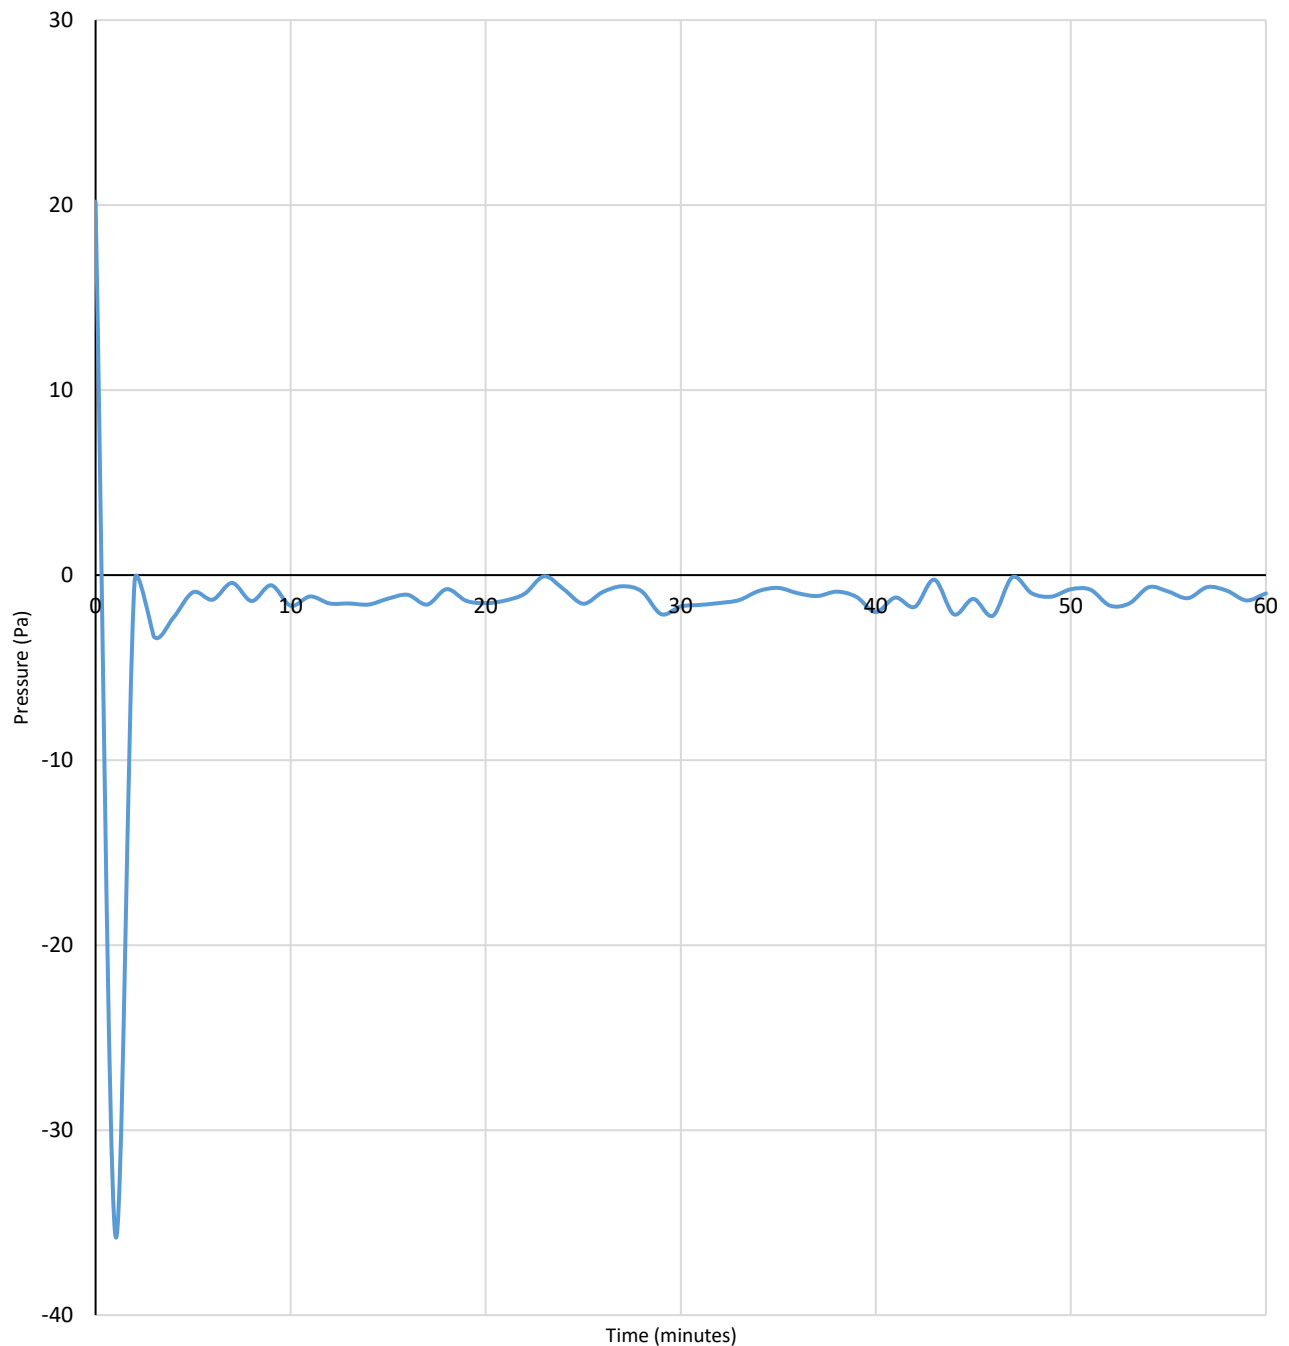
**Figure 5** – Furnace pressure graph.

The furnace pressure was set to control at  $-1.1 \pm 2$  Pa positive with respect to atmosphere, at a point 750 mm from the base of the specimen equating to  $18 \pm 2$  Pa at the top of the specimen. Furnace pressure data is shown in **Figure 5**.

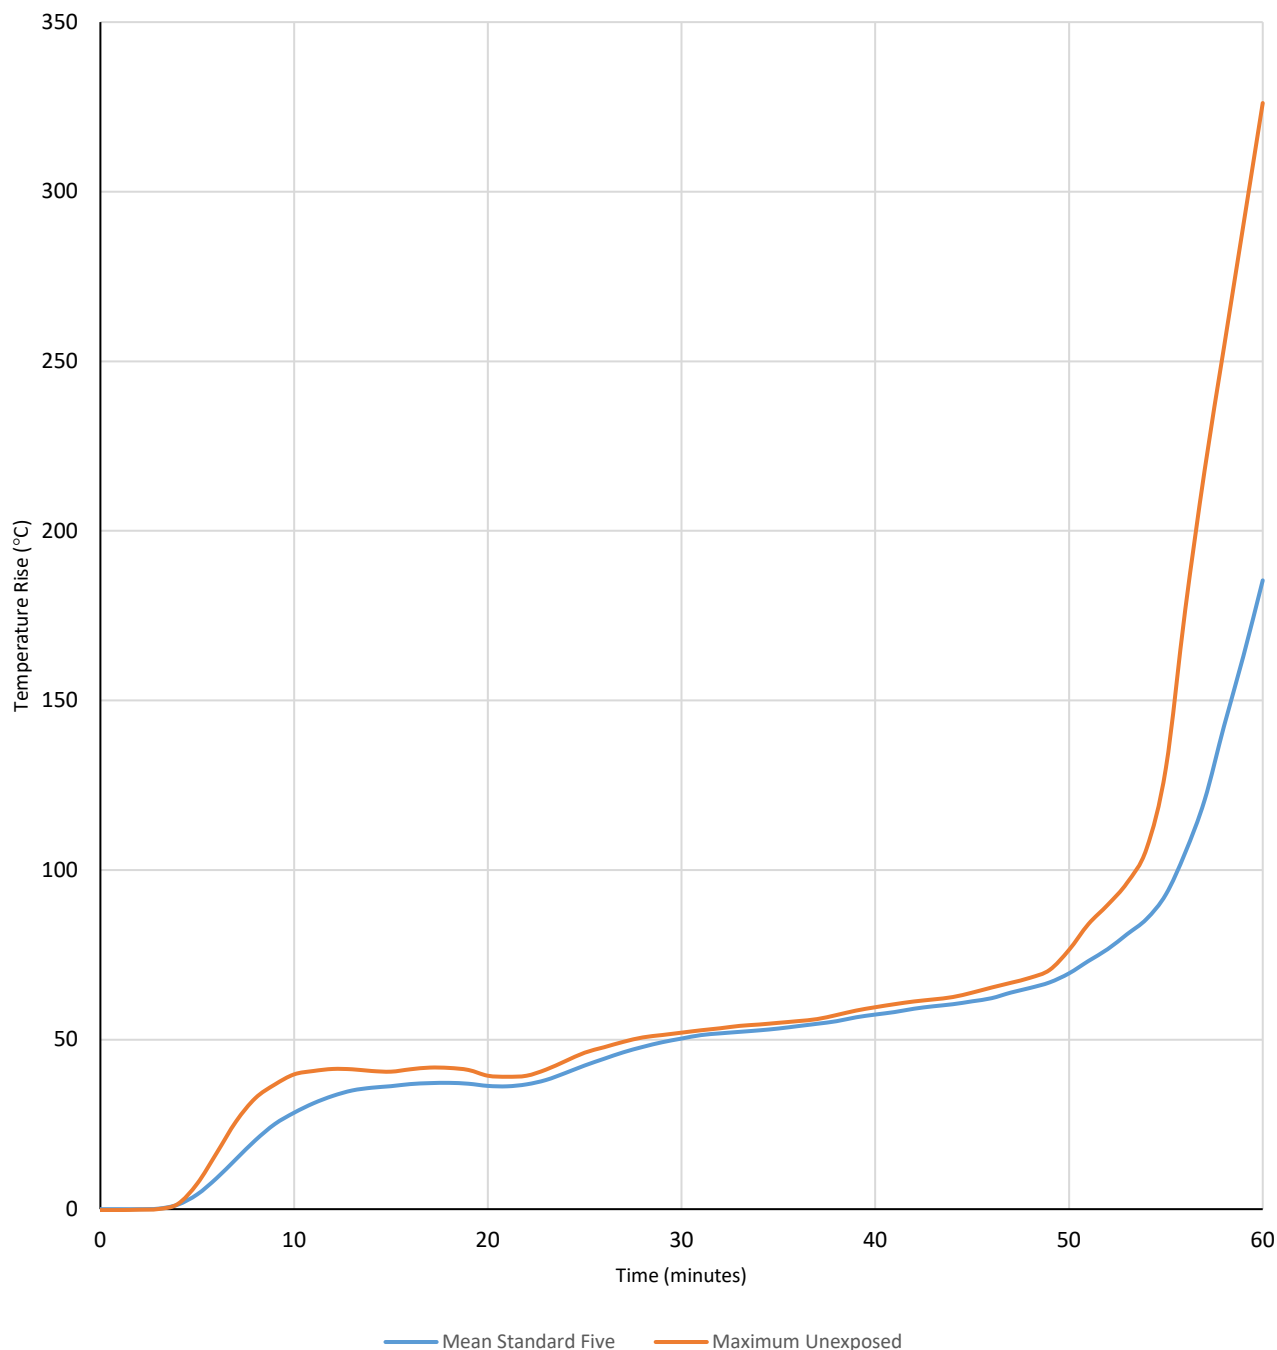
**Figure 6** – Unexposed face temperature graph.

Time		Observations
Hours	Minutes	
0	54	<p><i>Unexposed face</i></p> <p><b>INSULATION FAILURE.</b> The temperature rise at a point approximately to the right-hand side of the centre of the specimen at mid-height on the lower centre board, exceeded 180 °C (roving thermocouple). A vertical crack, approximately 300 mm long had appeared at approximately mid-height on the centre of the lower centre board.</p>
0	56	<p><i>Unexposed face</i></p> <p>Cotton pad attempt – the cotton pad was placed over the vertical crack at approximately mid-height on the centre of the lower centre board – no failure.</p>
0	57	<p><i>Unexposed face</i></p> <p>The mean temperature rise of the standard five thermocouples exceeded 140°C.</p>
0	58	<p><i>Unexposed face</i></p> <p>Cotton pad attempt – the cotton pad was placed over the vertical crack at approximately 1650 mm height on the centre of the lower centre board – no failure. The vertical crack at approximately mid-height on the centre lower centre board had opened to approximately 5 mm and was approximately 1300 mm in length.</p>

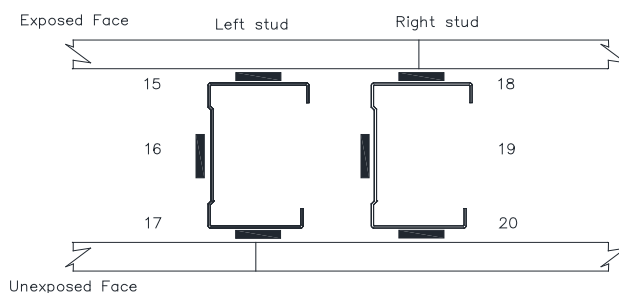
**Figure 7 – Unexposed face thermocouple layout.**

Thermocouples were added to the timber studs at mid-height on the web, hot and cold flanges of the central two studs.

See **Figure 7** for the location of the thermocouples.

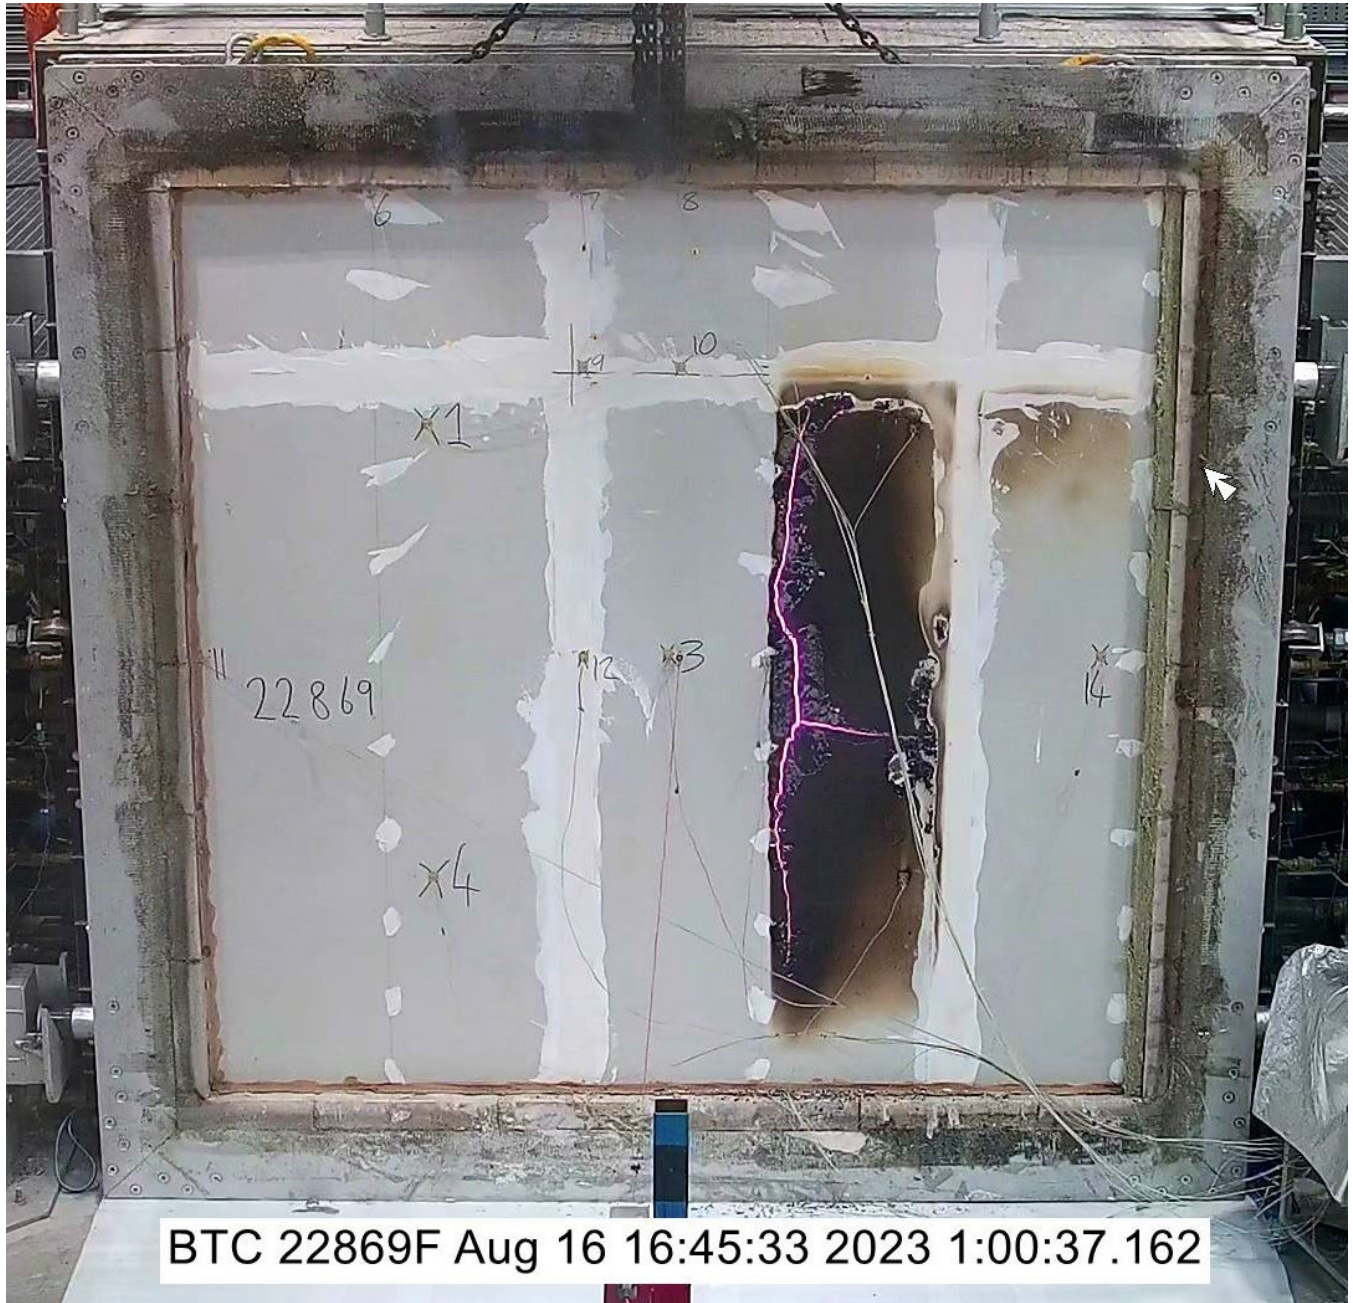
## Unexposed Face at 1 Hour, at Test Termination

0	59	<p><i>Unexposed face</i></p> <p>Discolouration had increased to the whole right-hand side of the lower-centre board. A horizontal crack had appeared on the right-hand side of the lower centre board at approximately 1200 mm height.</p>
1	00	<p><i>Unexposed face</i></p> <p><b>INTEGRITY FAILURE.</b> The cotton pad ignited (flamed) when placed on the vertical crack to the right-hand side of centre, at approximately 1600 mm height on the lower centre board.</p> <p><b>TEST TERMINATED</b> at the request of the sponsor.</p>
