Report Number: **BTC 22891F**

A FIRE RESISTANCE TEST ON A 63 MM DEEP TIMBER  
STUD PARTITION CLAD EACH SIDE WITH A SINGLE  
LAYER OF 15 MM THICK GYPROC FIRELINE 15MM,  
CONDUCTED IN ACCORDANCE WITH  
BS EN 1364-1: 2015.

Test Date: 1<sup>st</sup> September 2023

**Customer:** **British Gypsum**  
East Leake  
Loughborough  
Leicestershire  
LE12 6HX

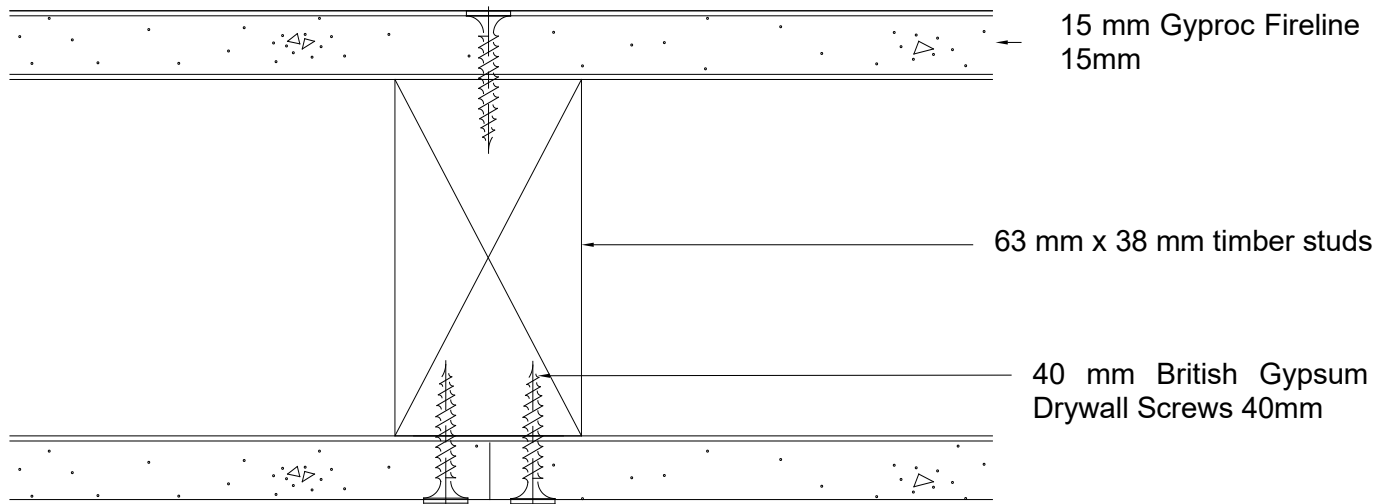
**Figure 1** – Horizontal cross section.

The specimen was constructed in a refractory concrete lined steel restraint test frame with an opening of 3000 mm (high) x 3000 mm (wide).

63 mm x 38 mm timber head and sole plates were fixed to the head and base of the test aperture at 600 mm centres using 100 mm long fire-resistant fixings.

63 mm x 38 mm timber studs were positioned at 600 mm centres between the head and sole plates and skew fixed using 65 mm long British Gypsum Drywall Screws 65mm. The right-hand stud viewed from the unexposed face was not fixed to the perimeter of the test frame and the gap between the stud and the frame lining was filled with a 25 mm thick rock mineral fibre gasket.

At the left-hand edge, a 63 mm x 38 mm timber stud was used to fix the partition to the test frame using 100 mm long fire-resistant fixings at 600 mm centres.

Both the unexposed face and the exposed face of the specimen were clad with a single layer of 15 mm thick Gyproc Fireline 15mm. The boards were fixed with 40 mm British Gypsum Drywall Screws 40mm at 300 mm centres around the perimeter and within the field of the boards.

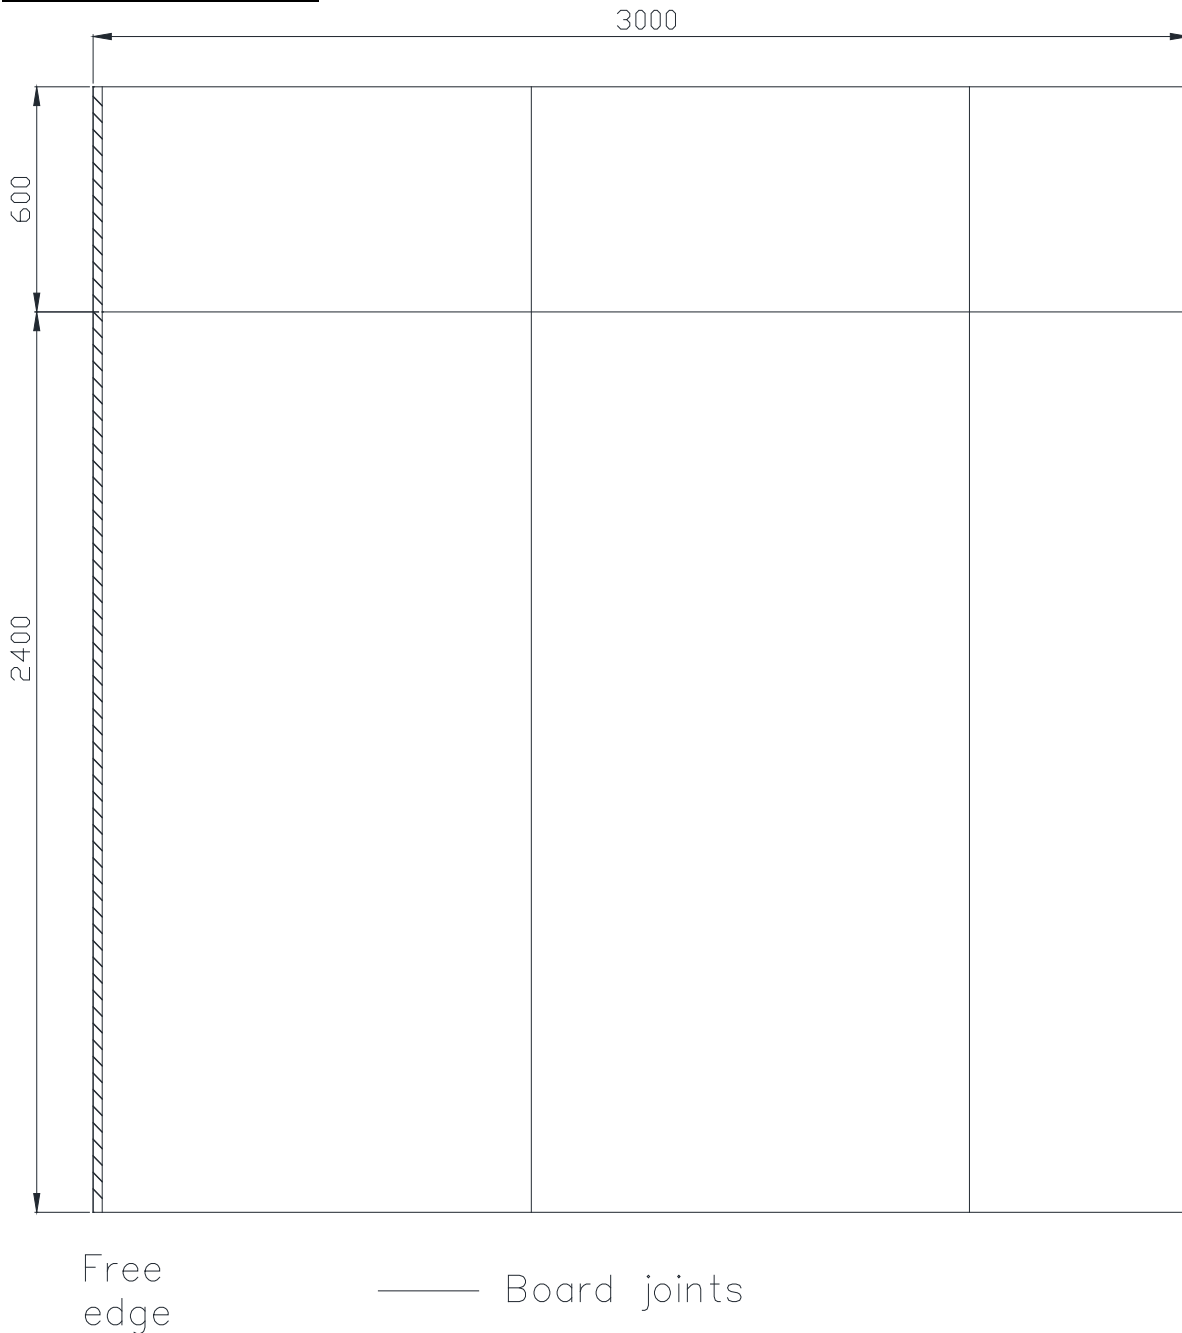
**Figure 2** – Exposed face elevation.

63 mm x 38 mm timber stud noggings were positioned between the studs at 2400 mm from the base of the specimen and skew fixed using 65 mm long British Gypsum Drywall Screws 65mm.

All vertical joints were staggered between layers, with a full board at the free end of the exposed face.

A horizontal joint was positioned at 2400 mm from the base on the outer layer boards on both faces of the specimen.

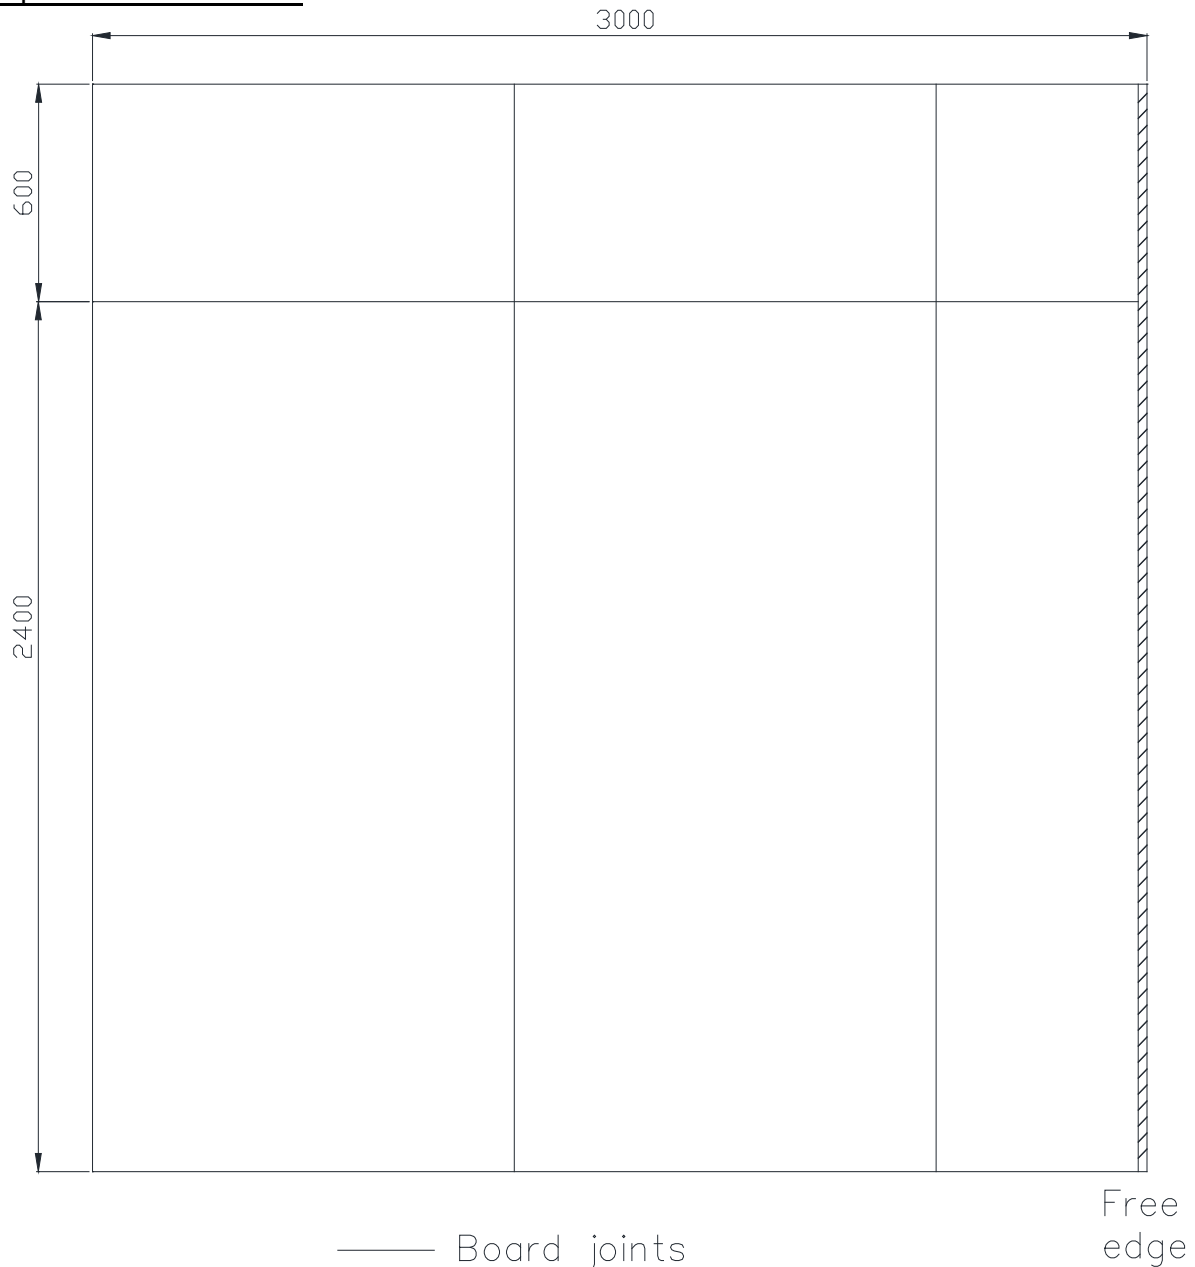
**Figure 3** – Unexposed face elevation.

Thermocouples were added to the timber studs at mid height on the web, hot and cold flanges of the central two studs.

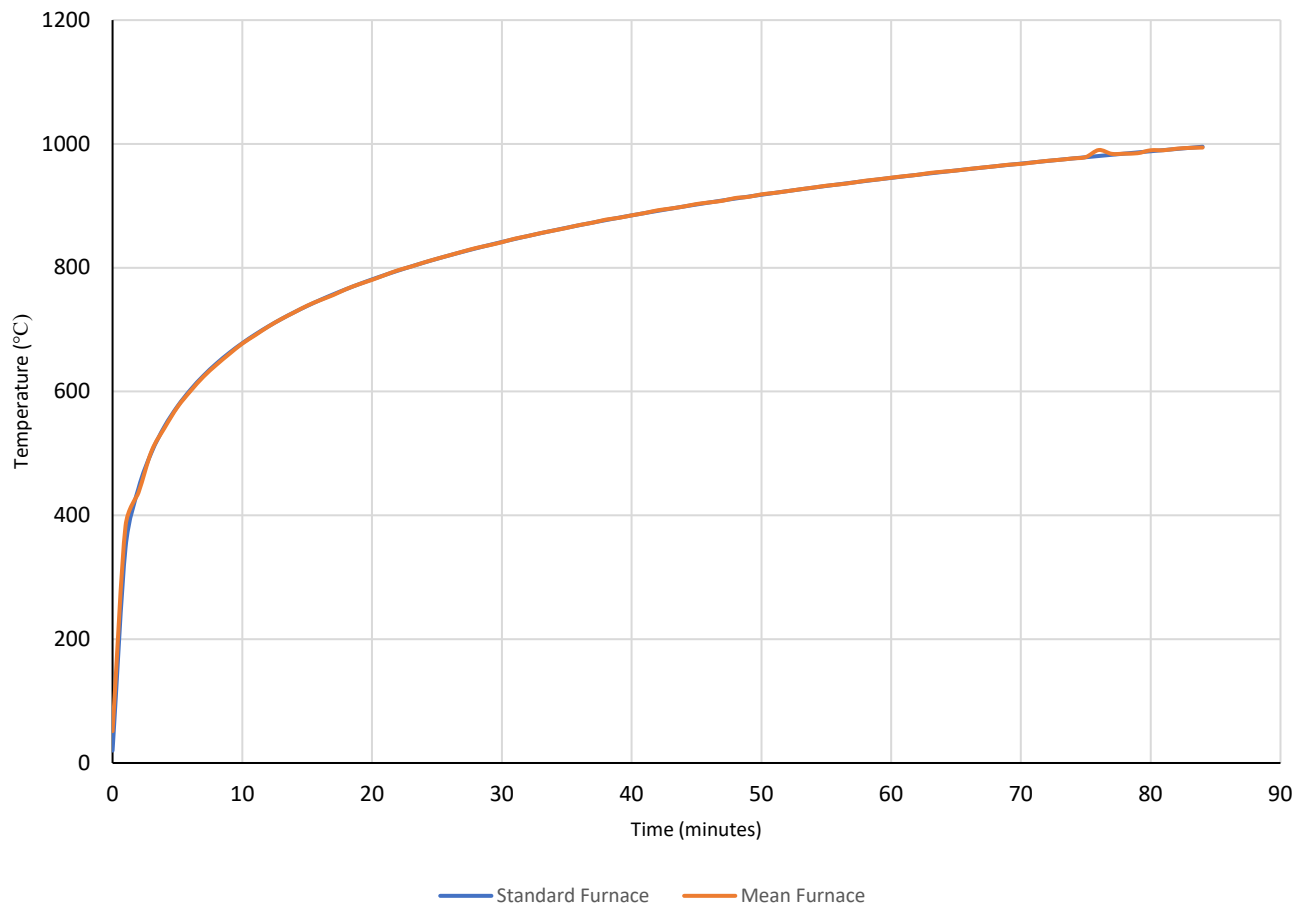
**Figure 4** – Furnace temperature graph.

The test was conducted fully in accordance with BS EN 1364-1: 2015. The specimen was subjected to fire from one side, as specified in BS EN 1364-1: 2015.

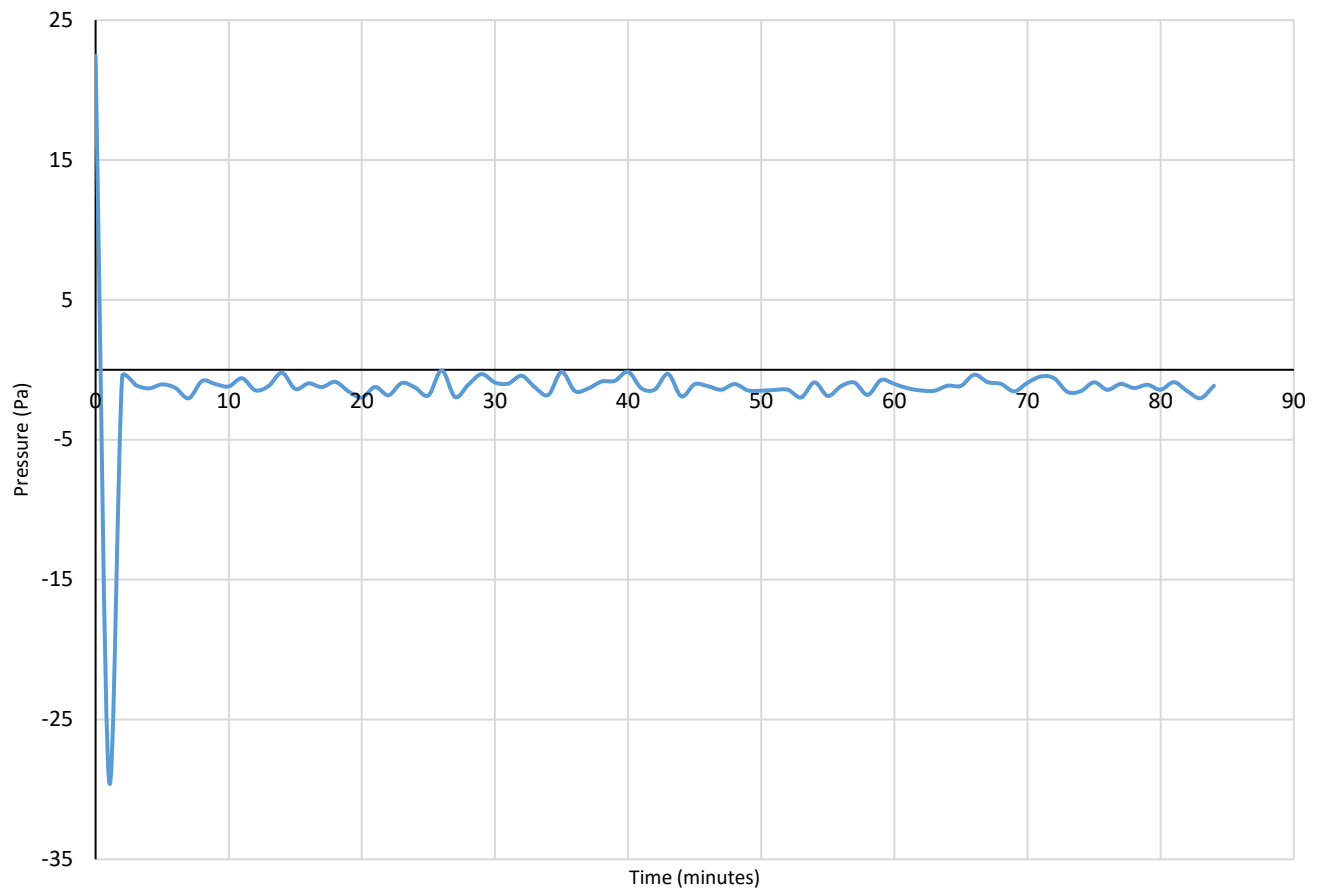
**Figure 5** – Furnace pressure graph.

The furnace pressure was set to control at  $-1.1 \pm 2$  Pa positive with respect to atmosphere, at a point 750 mm from the base of the specimen equating to  $18 \pm 2$  Pa at the top of the specimen. Furnace pressure data is shown in **Figure 5**.

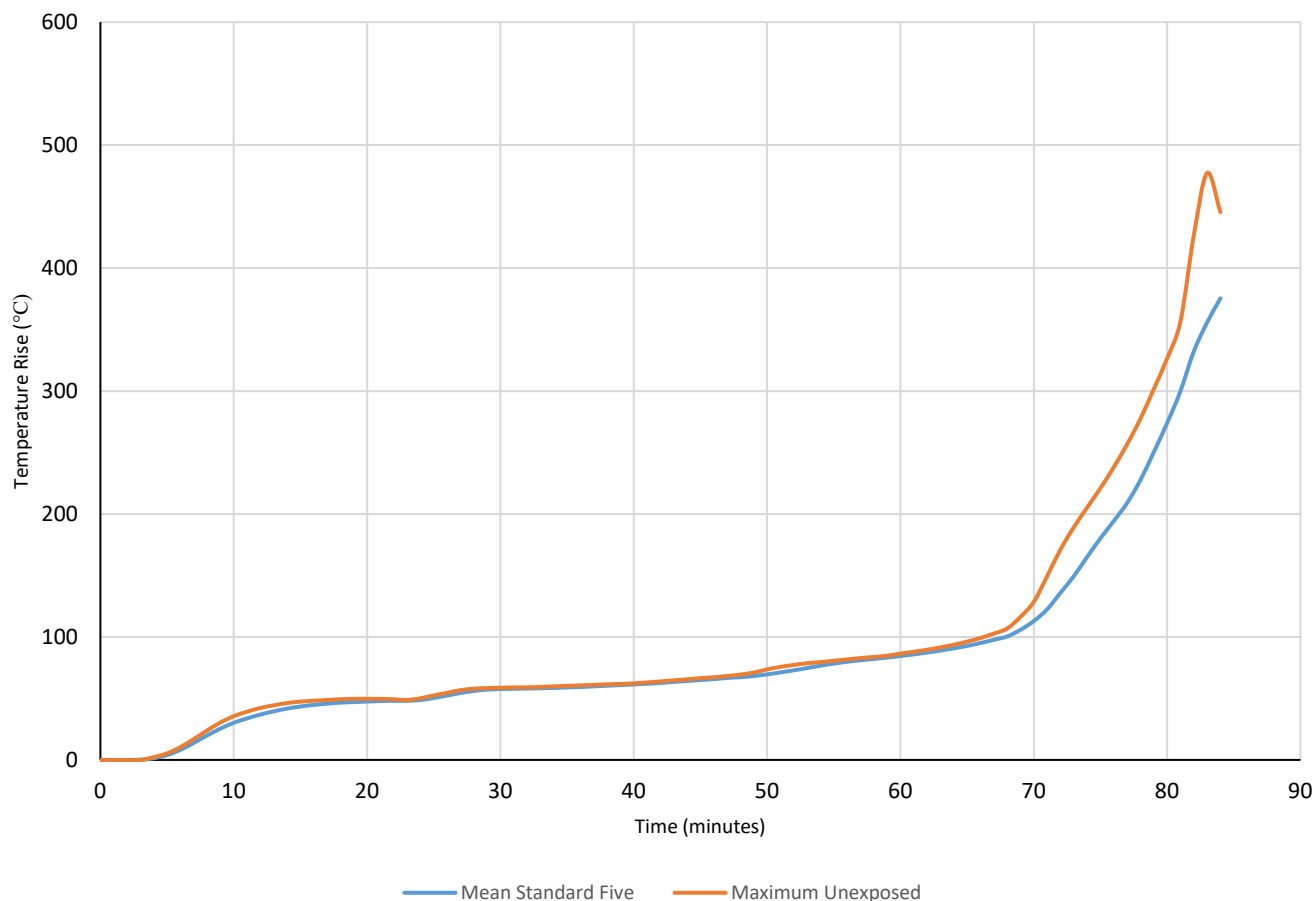
**Figure 6** – Unexposed face temperature graph.

<b>Integrity</b>	<b>Sustained Flaming</b>	<b>83 minutes.</b>
	<b>6 mm Gap Gauge</b>	<b>84 minutes, no failure.</b>
	<b>25 mm Gap Gauge</b>	<b>84 minutes, no failure.</b>
	<b>Cotton Pad</b>	<b>83 minutes.</b>
<b>Insulation</b>		<b>72 minutes.</b>
<b>Test Terminated</b>		<b>84 minutes, at the request of the sponsor.</b>

Figures highlighted in red indicate the minute in which the temperature rise exceeded 180 °C and the mean temperature rise exceeded 140 °C.

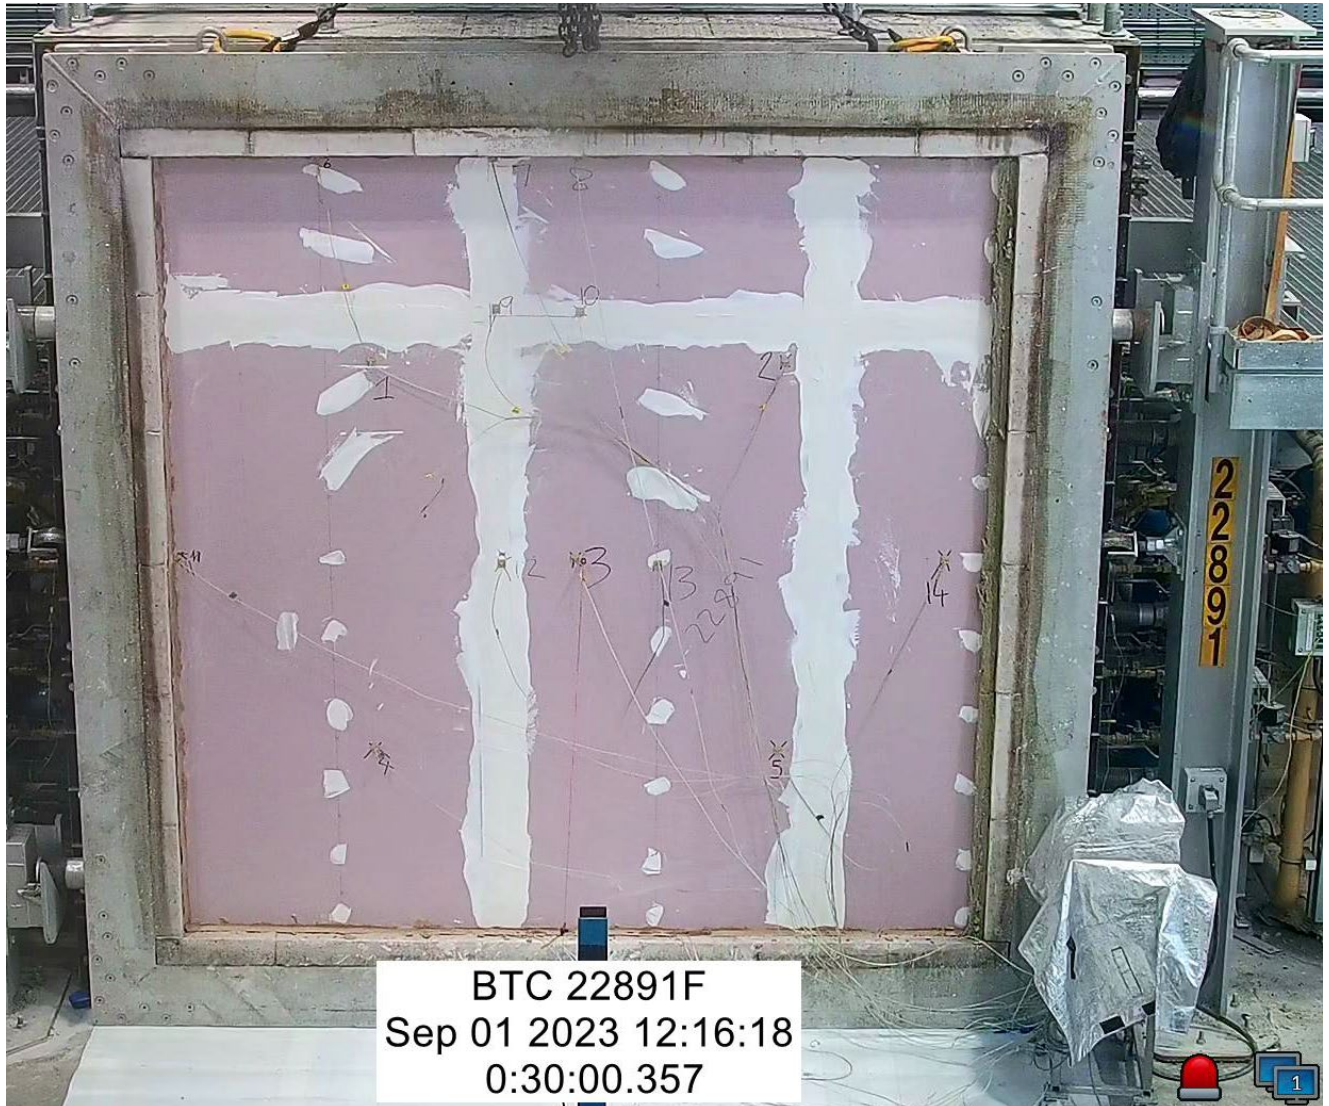
## Unexposed Face at 30 Minutes

Time		Observations
Hours	Minutes	
0	00	Test started.
0	10	Jointing material was flaking away. Face papers had charred.
0	20	Left-hand vertical joint had opened up to approximately 2-3 mm. Right-hand vertical joint had opened up to approximately 2-3 mm. Horizontal joint had opened up to approximately 2-3 mm.
0	30	Left-hand vertical joint had opened up to approximately 8-10 mm. Right-hand vertical joint had opened up to approximately 6-8 mm. Horizontal joint had opened up to approximately 6-8 mm. Flaming coming from all joints. Cracks had formed around screw heads.  <i>Unexposed face</i> No visible change.
0	40	Left-hand vertical joint had opened up to approximately 14-16 mm. Right-hand vertical joint had opened up to approximately 12-14 mm. Horizontal joint had opened up to approximately 10-12 mm.  <i>Unexposed face</i> Crackling noises could be heard coming from the specimen.
0	50	No visible change.

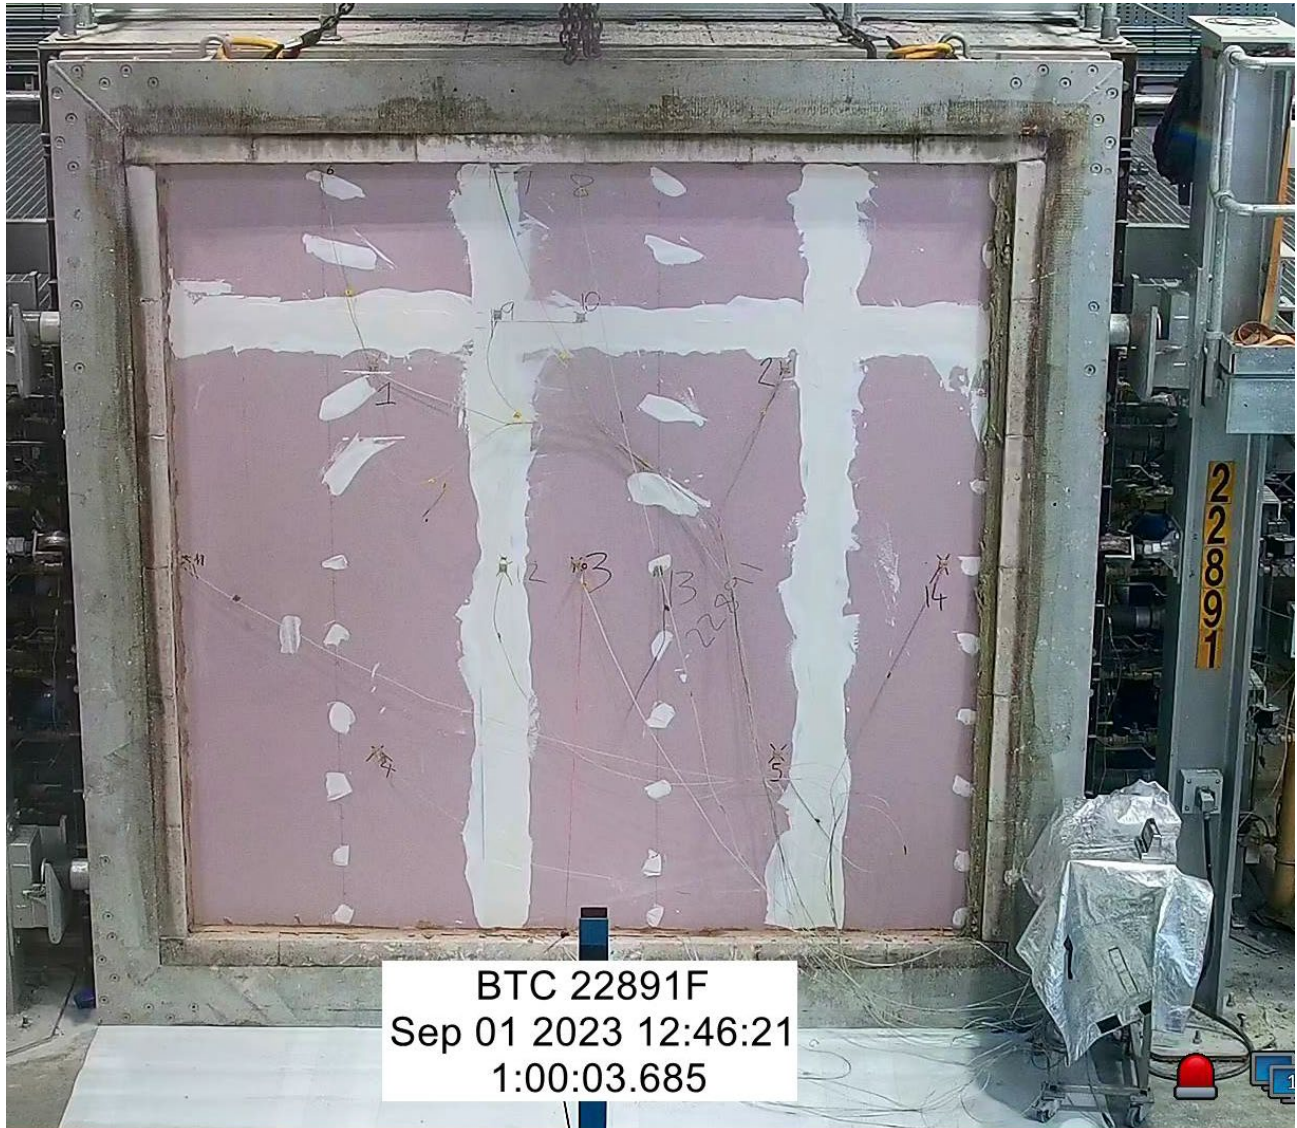
## Unexposed Face at 1 Hour

1	00	No visible change.  <i>Unexposed face</i> No visible change.

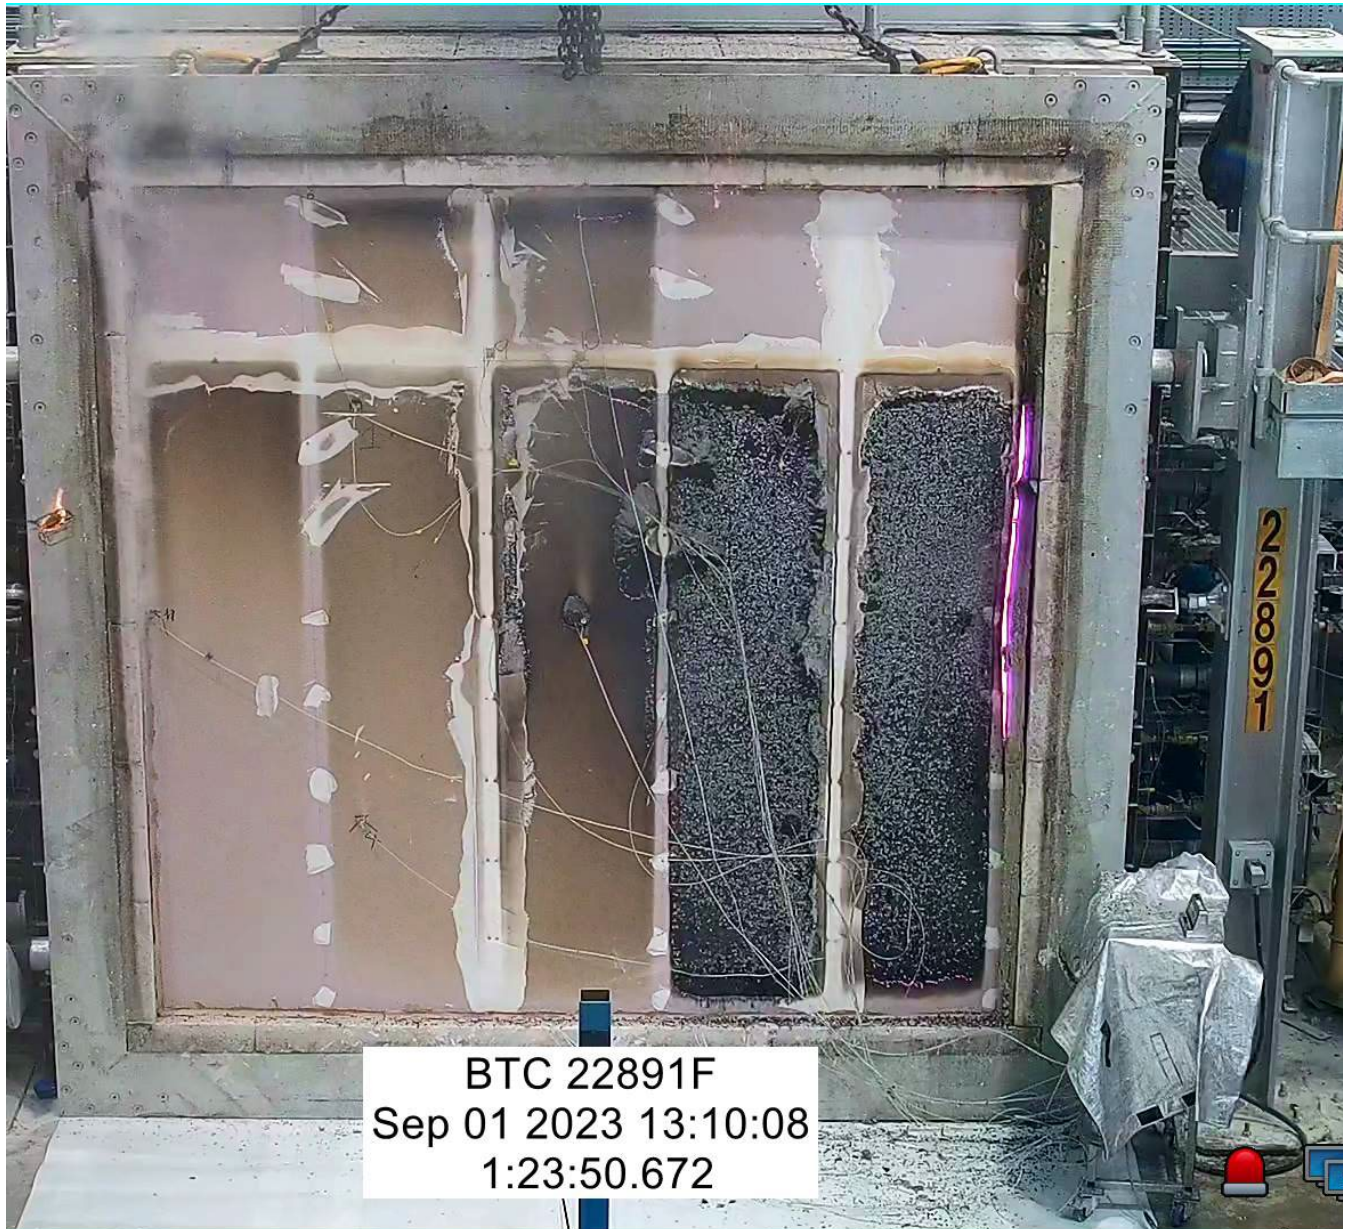
Unexposed Face at 1 Hour, 24 Minutes, at Test Termination

Time		Observations
Hours	Minutes	
1	21	<i>Unexposed face</i> The free edge flamed approximately 1200 mm – 2200 mm height. Lower right-hand board had charred up to full height. Right-hand side of the lower centre board had charred up to full height.
1	22	<i>Unexposed face</i> Left-hand side upper centre board had discoloured up to full height. Left-hand side of the upper right-hand board had discoloured.
1	23	<i>Unexposed face</i> <b>INTEGRITY FAILURE.</b> The cotton pad ignited (flamed) when placed on the head approximately 1500 mm from the free edge. <b>FURTHER INTEGRITY FAILURE.</b> Sustained flaming, at the head of the specimen approximately 100 mm – 1500 mm from the free edge. Water had been sprayed on the free edge due to flaming.
1	24	<b>TEST TERMINATED</b> at the request of the sponsor.
