Report Number BTC 13478F

A FIRE RESISTANCE TEST ON A BRITISH GYPSUM GYPWALL PARTITION CLAD WITH A SINGLE LAYER OF 15mm GYPROC SOUNDBLOC EACH SIDE OF GYPFRAME 92S50 STUDS AND 3 LAYERS OF 25mm ISOWOOL 1200 IN THE CAVITY, CONDUCTED IN ACCORDANCE WITH BS EN 1364-1: 1999.

Test Date: 26th August 2004

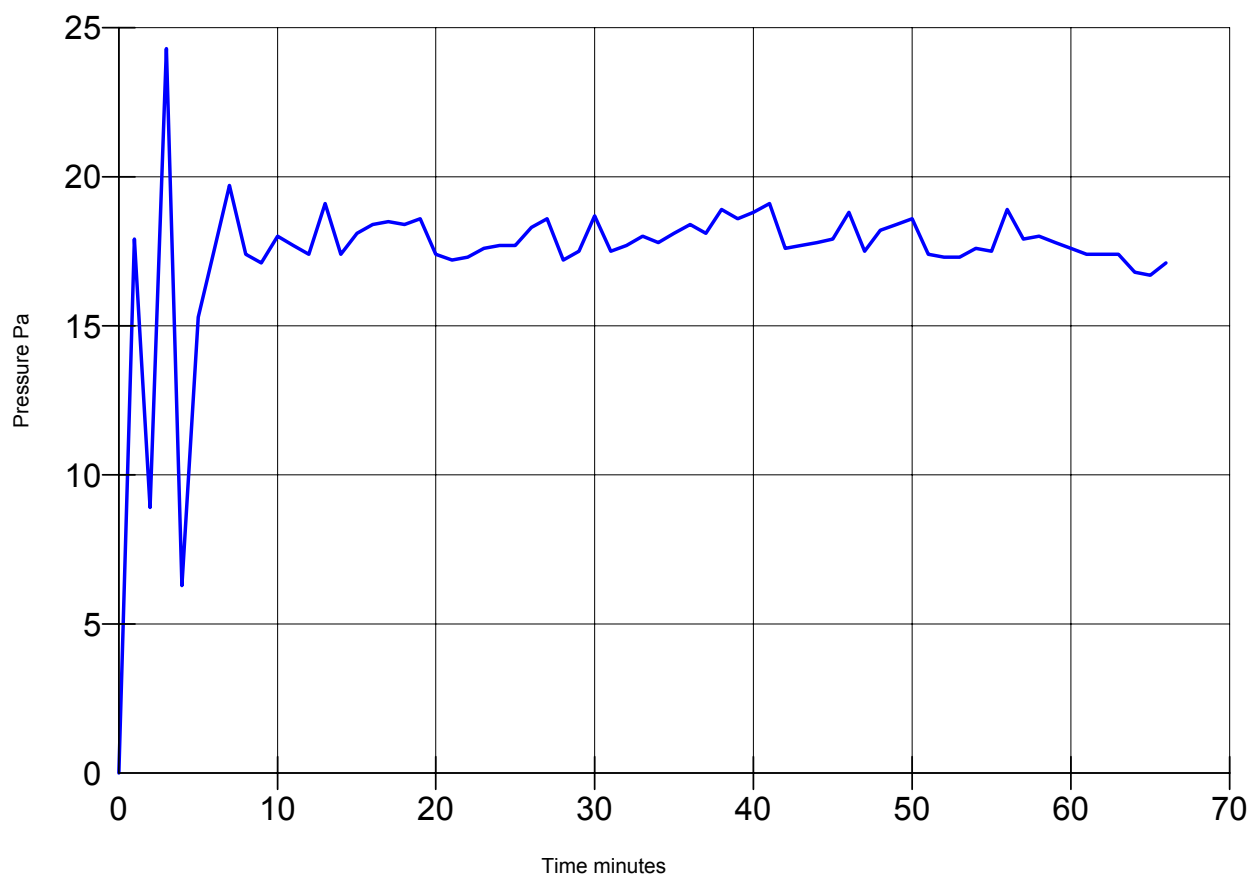
Figure 3. Furnace pressure graph.

The test conditions did not meet the full requirements of BS EN 1363-1:1999 as the test frame stiffness did not fully comply. The test centre is of the opinion that this deviation from the documented method will not unduly effect the result of the test.

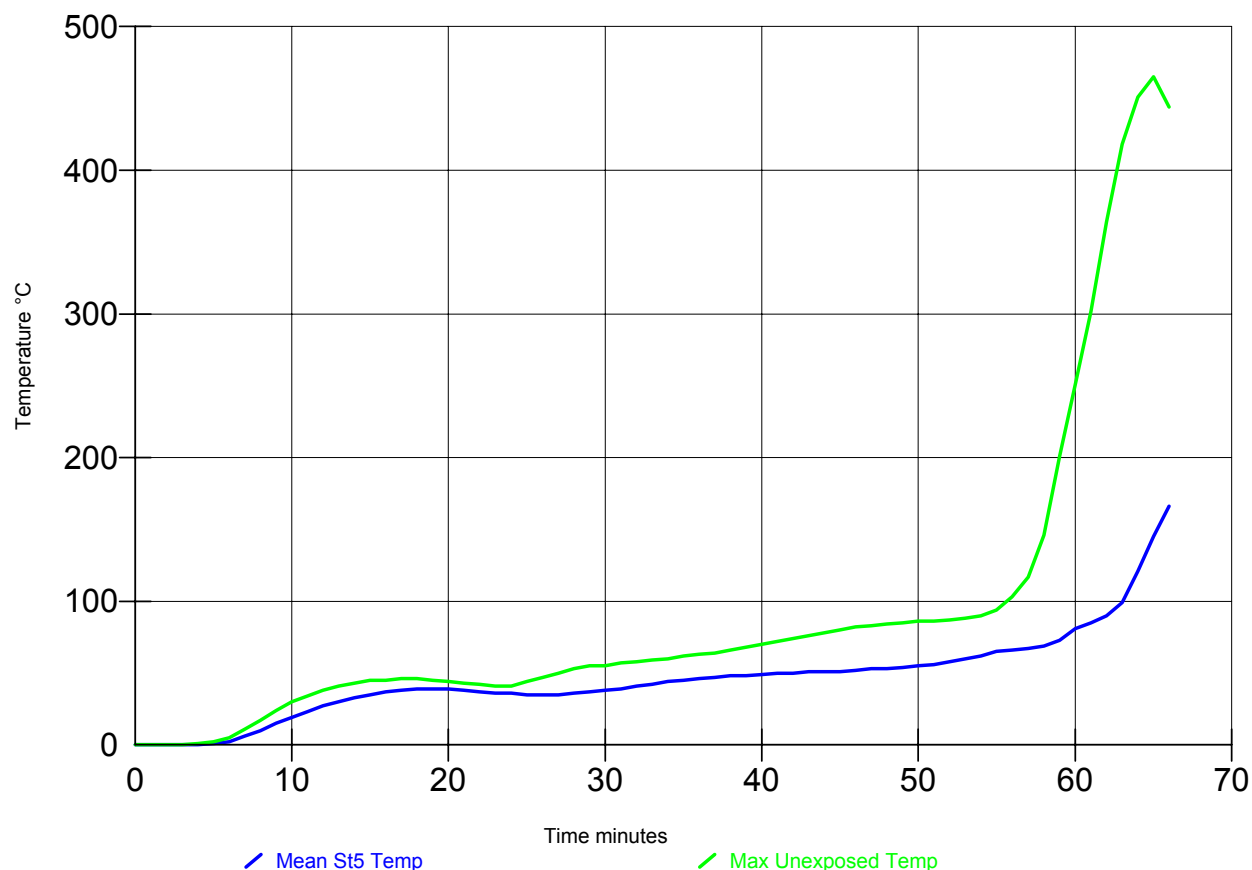
Figure 4. Unexposed face temperature graph.

Integrity:	Sustained flaming	66 minutes (no failure test discontinued at the request of the customer)
	25mm Gap gauge	66 minutes
	6mm Gap gauge	65 minutes
	Cotton pad	64 minutes
Insulation:		58 minutes

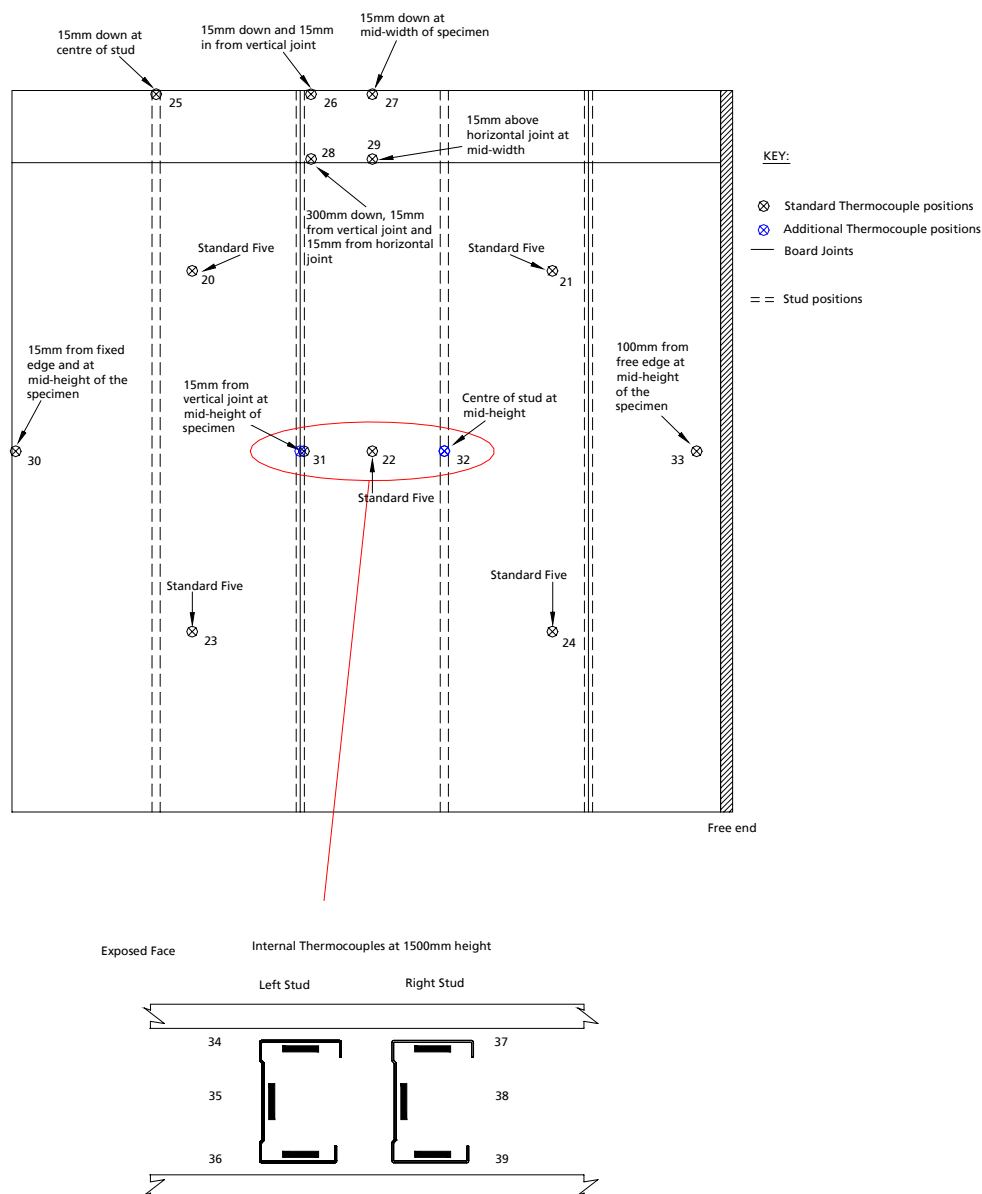
Figure 5. Unexposed face thermocouple layout.

Thermocouple No. 28 was located on a screw head therefore is discounted from the failure criteria.

Thermocouple No. 29 was located on a screw head therefore is discounted from the failure criteria.

Figures shown in red indicate the time and position of insulation failure.

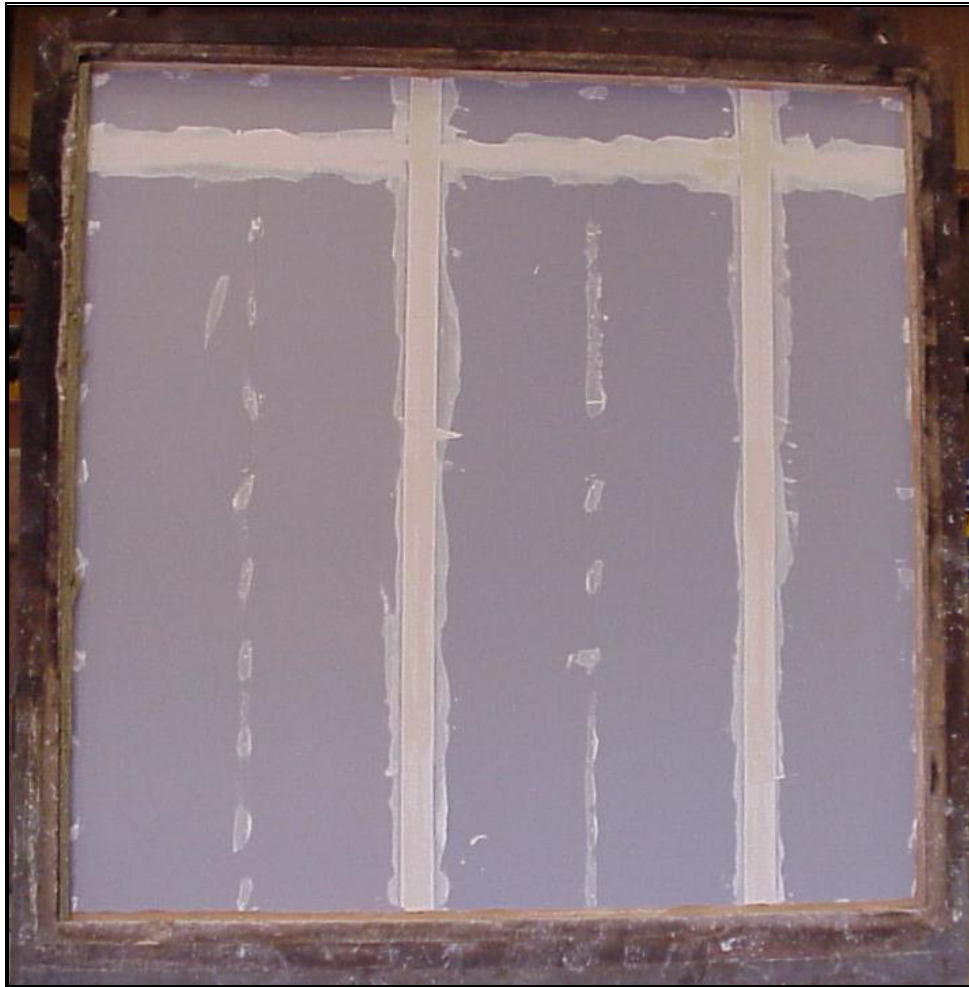
Photograph 1. View of the exposed face prior to test.

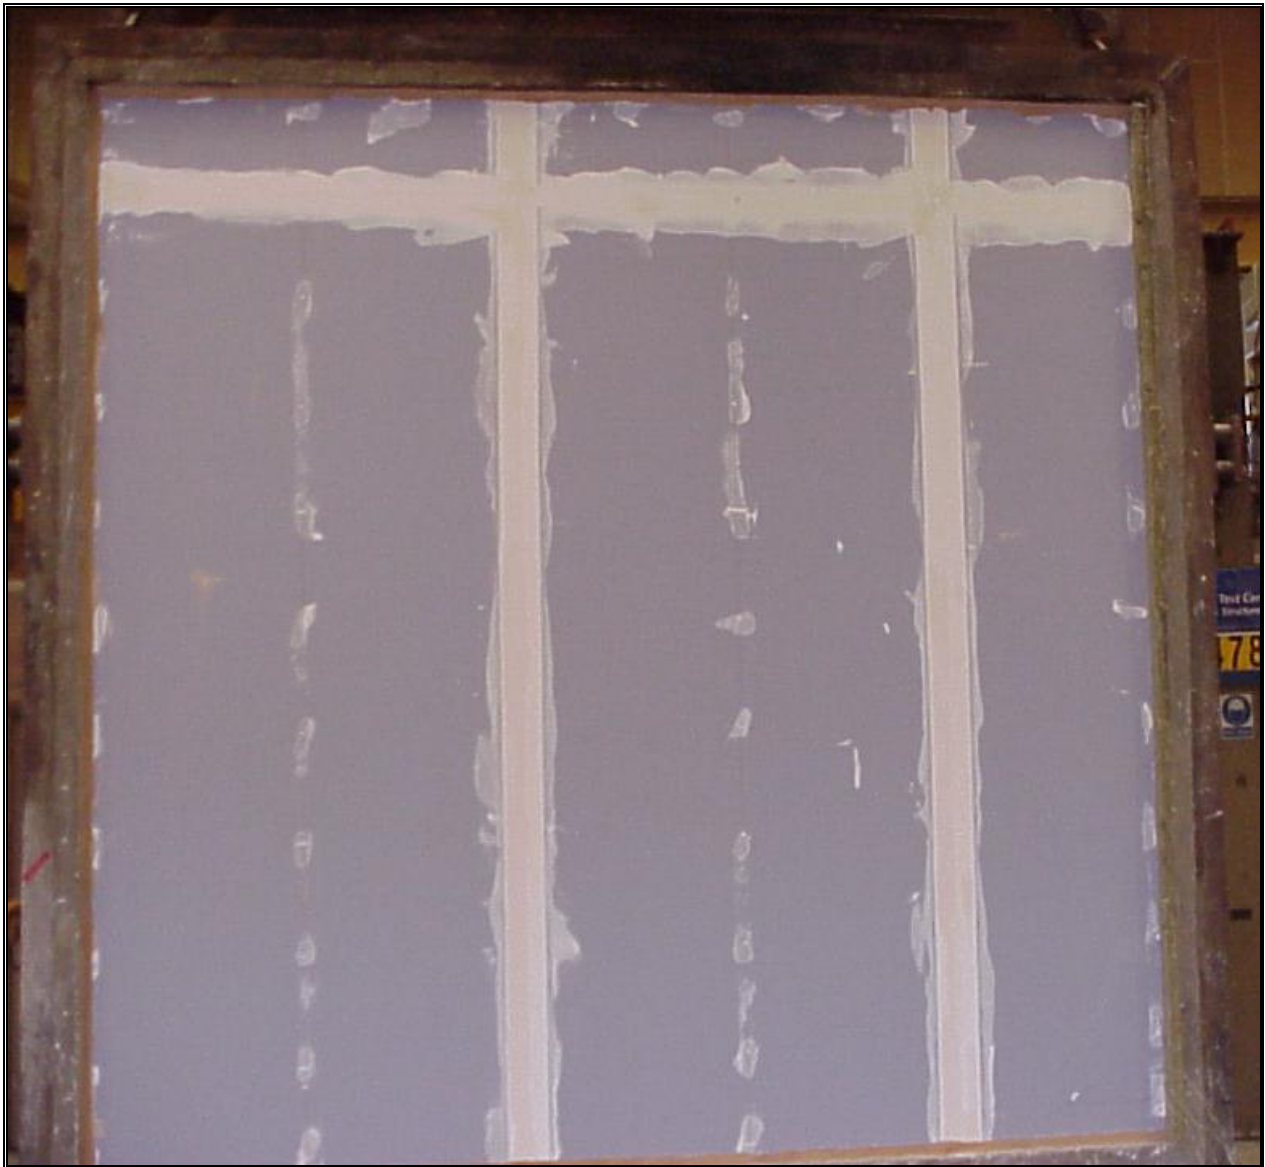
Photograph 2. View of the unexposed face prior to test.
