Report Number **BTC 12026F**

A FIRE RESISTANCE TEST ON A GYPROC GYPWALL PARTITION INCORPORATING A SINGLE LAYER OF 12.5mm SOUNDBLOC EACH SIDE OF 48550 STUDS WITH 25mm ISOWOOL 1200 IN THE CAVITY, CONDUCTED IN ACCORDANCE WITH BS EN 1364-1:1999.

Test Date: 10th July 2002

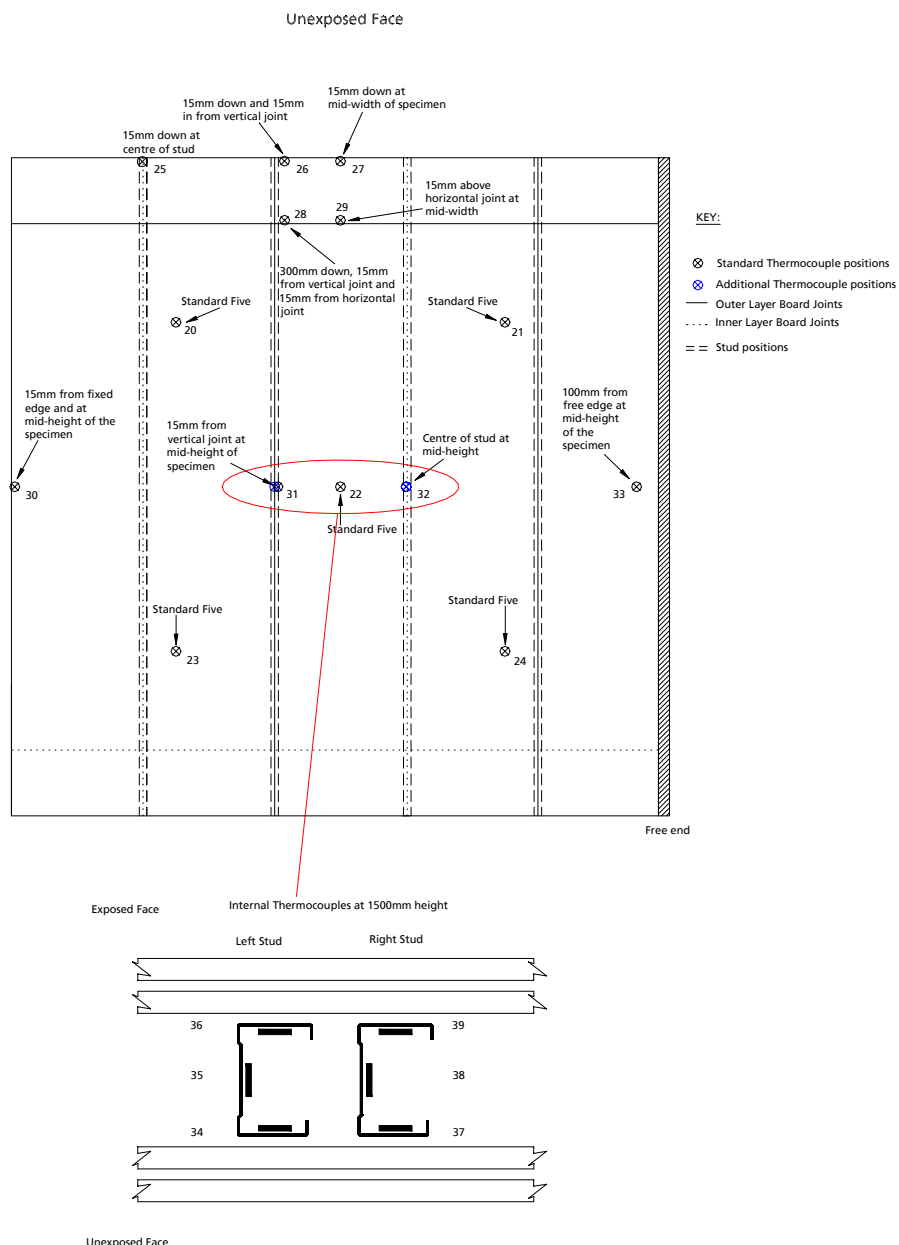
Figure 5. Unexposed face thermocouple layout.

Time		Observations
hrs	Mins	
		All observations refer to the exposed face unless otherwise stated.
	44	<i>Unexposed face</i> INSULATION FAILURE. The temperature rise exceeded 180°C on thermocouple No. 31 (15mm from vertical joint at mid-height of specimen). INTEGRITY FAILURE. Sustained flaming left hand vertical joint mid-height for 30 seconds.
	45	<i>Unexposed face</i> INTEGRITY FAILURE. Cotton pad glowing left hand vertical joint.
	48	Lower centre board left hand side, a piece approximately 600mm x 1200mm peeled away from stud into furnace.
	49	<i>Unexposed face</i> INTEGRITY FAILURE. Inner board fell through left hand vertical joint. 6mm x 150mm gap and 25mm gap visual failure. TEST TERMINATED.
