Report Number BTC 18407F

A FIRE RESISTANCE TEST ON A GYPWALL METAL STUD PARTITION WITH 92MM STUD FRAMEWORK CLAD EACH SIDE WITH A SINGLE LAYER OF 15MM GYPROC SOUNDBLOC F EX KIRKBY THORE AND 100mm ISOVER MODULAR ROLL IN THE CAVITY, CONDUCTED IN ACCORDANCE WITH BS EN 1364-1:1999.

Test Date: 13th August 2013

Customer: British Gypsum
East Leake
Loughborough
Leicestershire
LE12 6HX

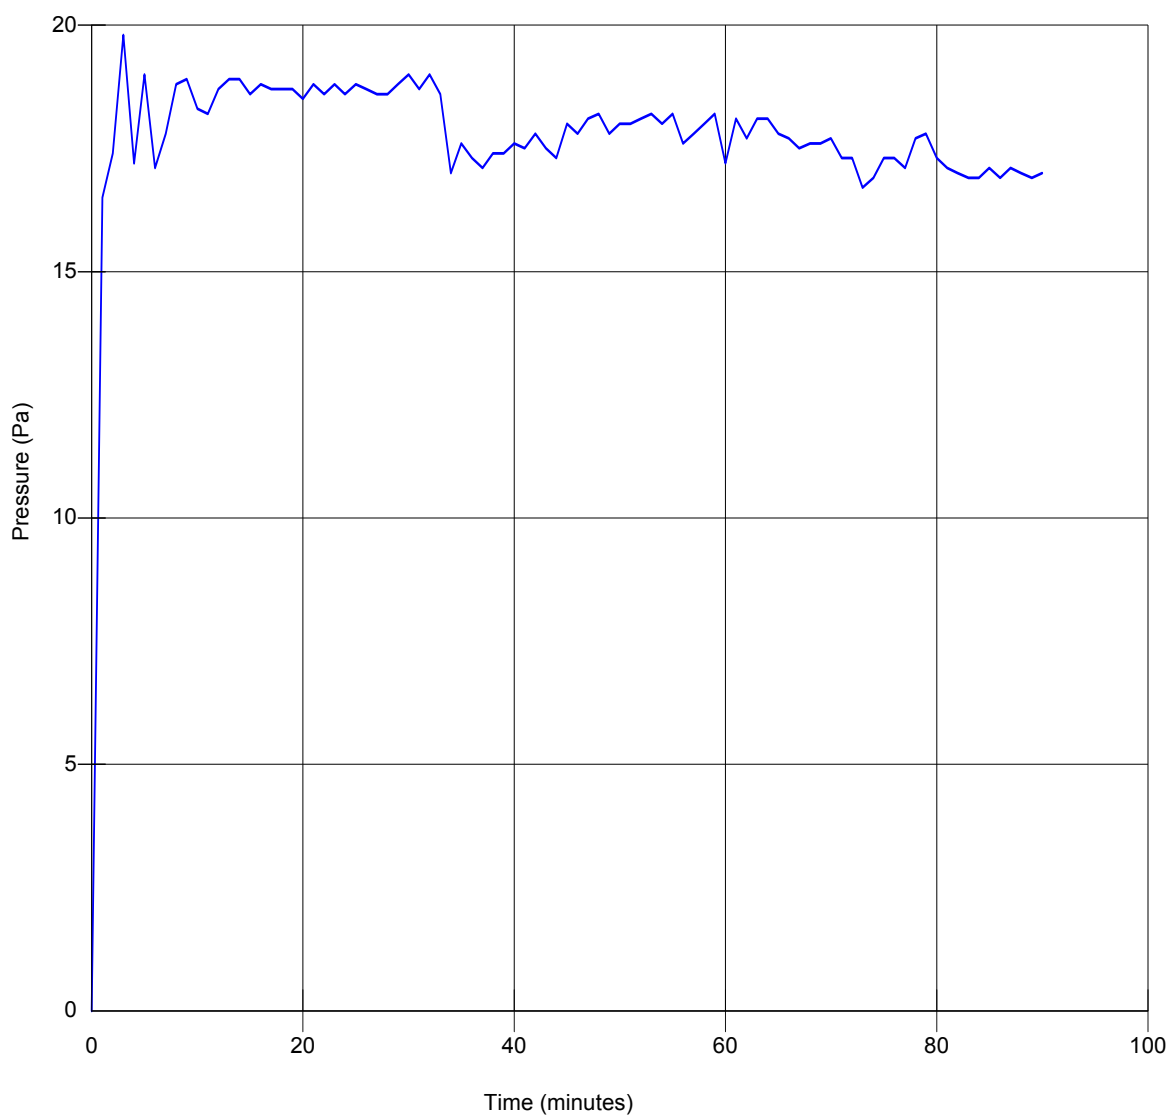
Figure 5 - Furnace pressure graph

The furnace pressure was set to control at 18 ± 2 Pa positive with respect to atmosphere, at the top of the specimen.

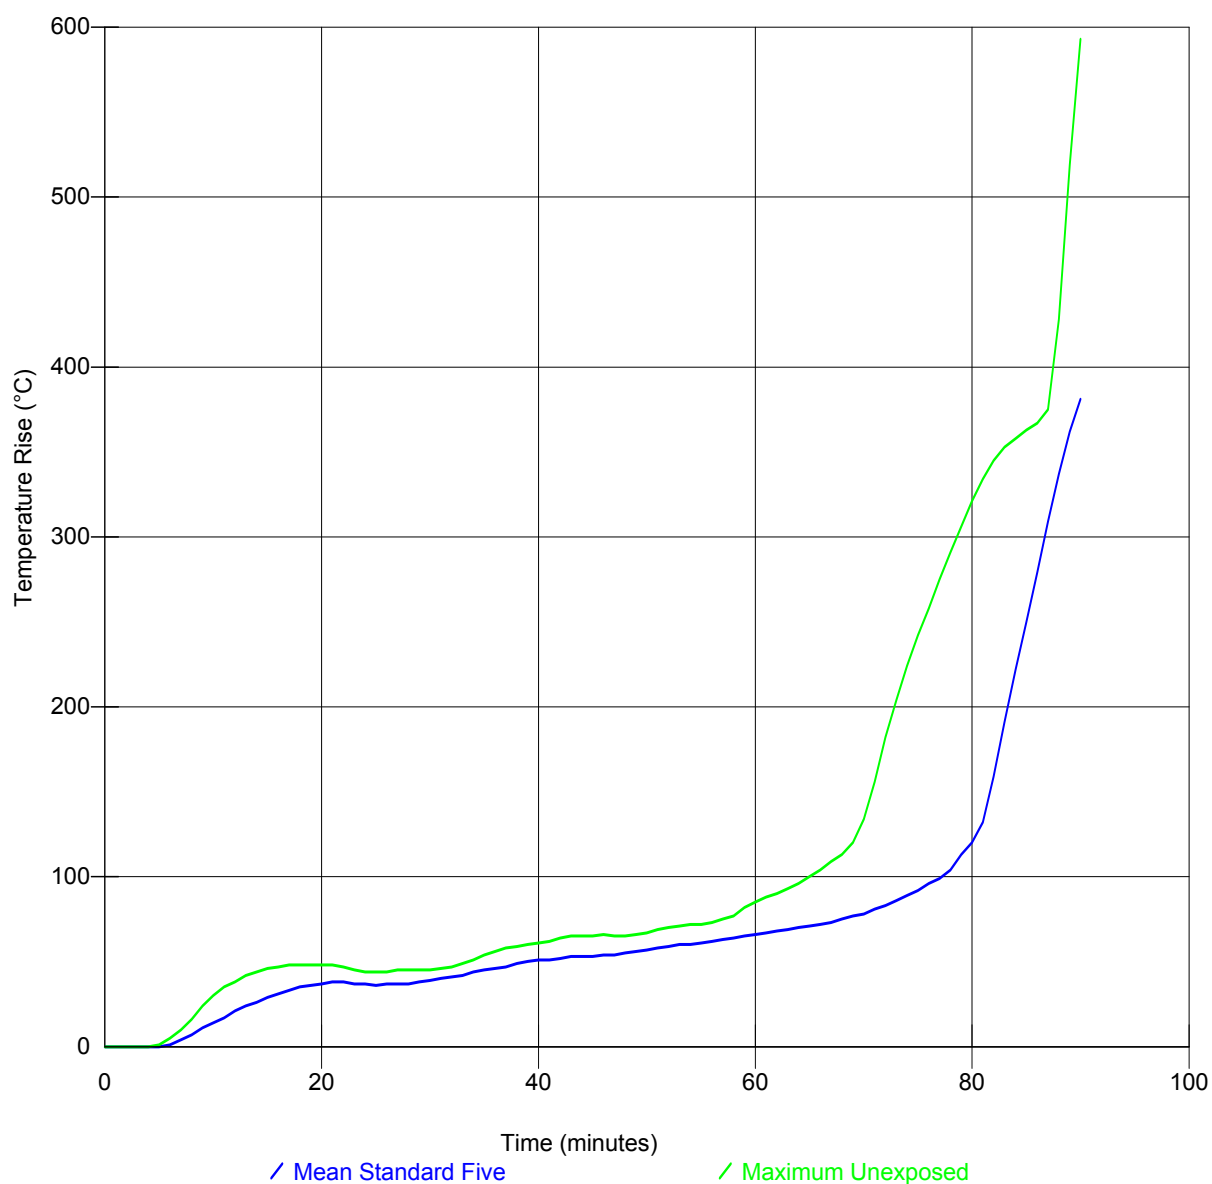
Figure 6 - Unexposed face temperature graph

| Time | | Observations |
|---|---|--|
| 1 | 11 | <p><i>Unexposed face</i> INSULATION FAILURE. The temperature rise of thermocouple no.32, positioned at mid height in the centre of the centre board, exceeded 180°C.</p> |
